Risultati relativi alle campagne sperimentali di breve e medio termine sui fenomeni di erosione/corrosione da litio liquido fluente nell'impianto Lifus 6

P.Favuzza, M.Cuzzani, G. Fasano

Settembre 2016

Progetto: B.3.2 – Attività di Fisica della Fusione Complementari a ITER

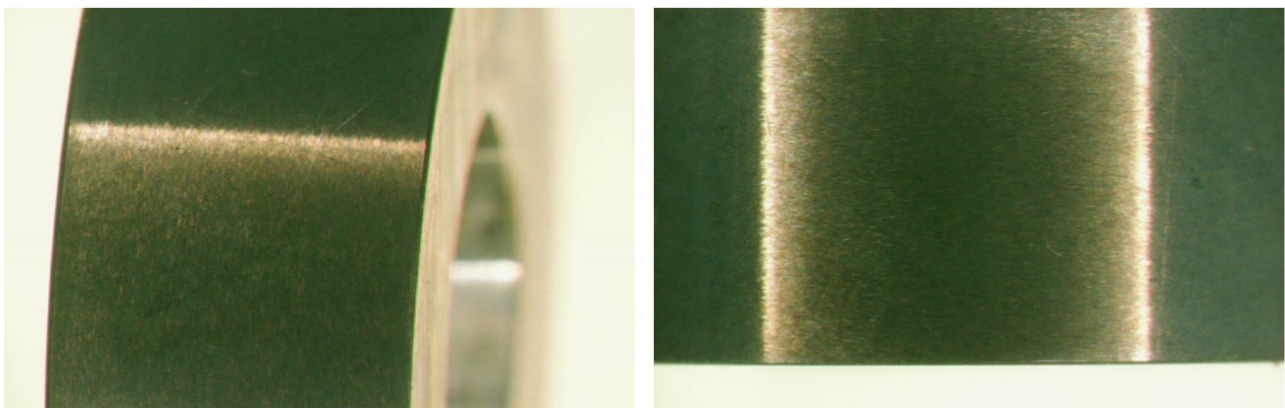
All the 8 specimens present, after the short term test, a smooth and regular surface, not different from that of the fresh specimens. Figure 11 and 12 show the surface of tested specimens n°2 (Eurofer 97) and n° 23 (F82H), as representative of all the investigated specimens.

Figure 11: visual inspection of the surface of tested specimen n°2 (Eurofer 97). Left: overall view; right: external (cylindrical) surface, from the top

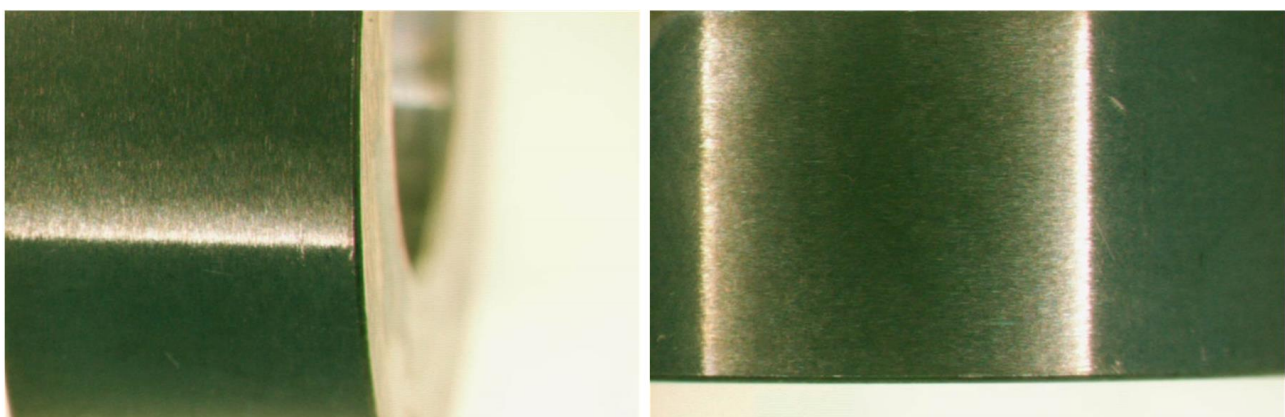
Figure 12: visual inspection of the surface of tested specimen n°23 (F82H). Left: overall view; right: external (cylindrical) surface, from the top

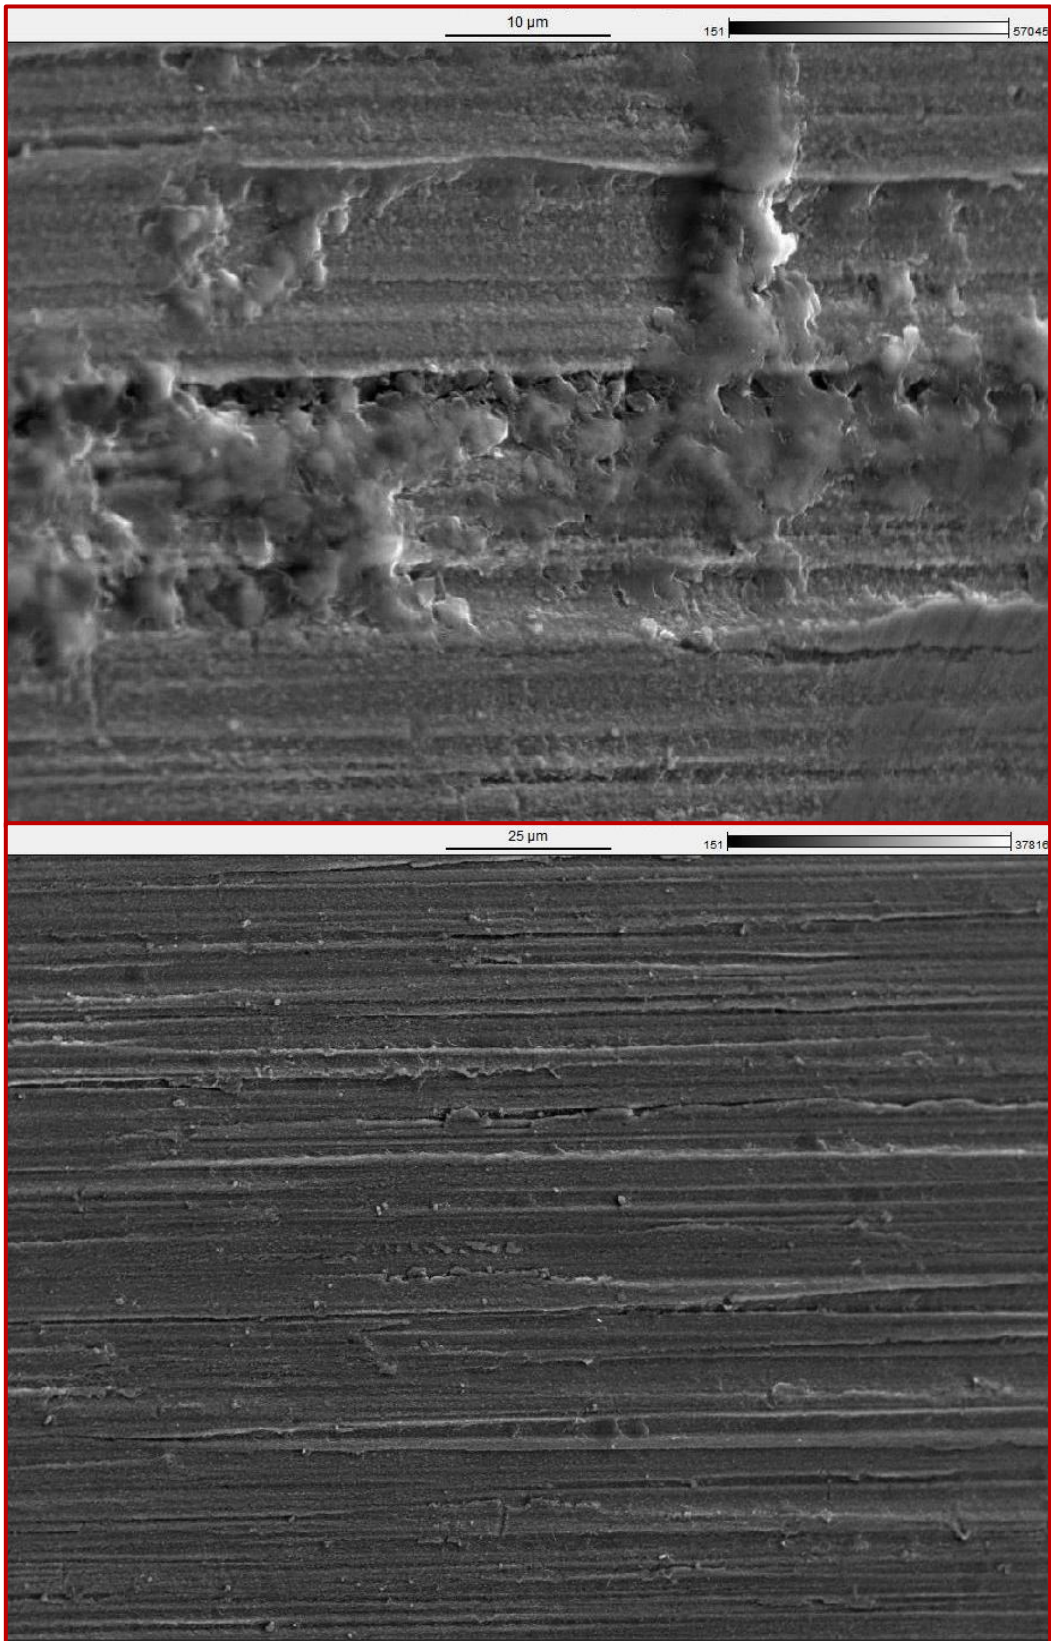
Figure 15: SEM images of specimen n°2 surface (secondary electrons) at different magnitudes. Scale bar above the image.

From the inspection of specimen n° 2 surface, no evident phenomenon of corrosion or erosion appears. All over the investigated surface are present instead the signs produced by the mechanical manufacturing, which precede the experimental test execution. Such signs are similar to the ones already observed on specimen n° 10 surface.

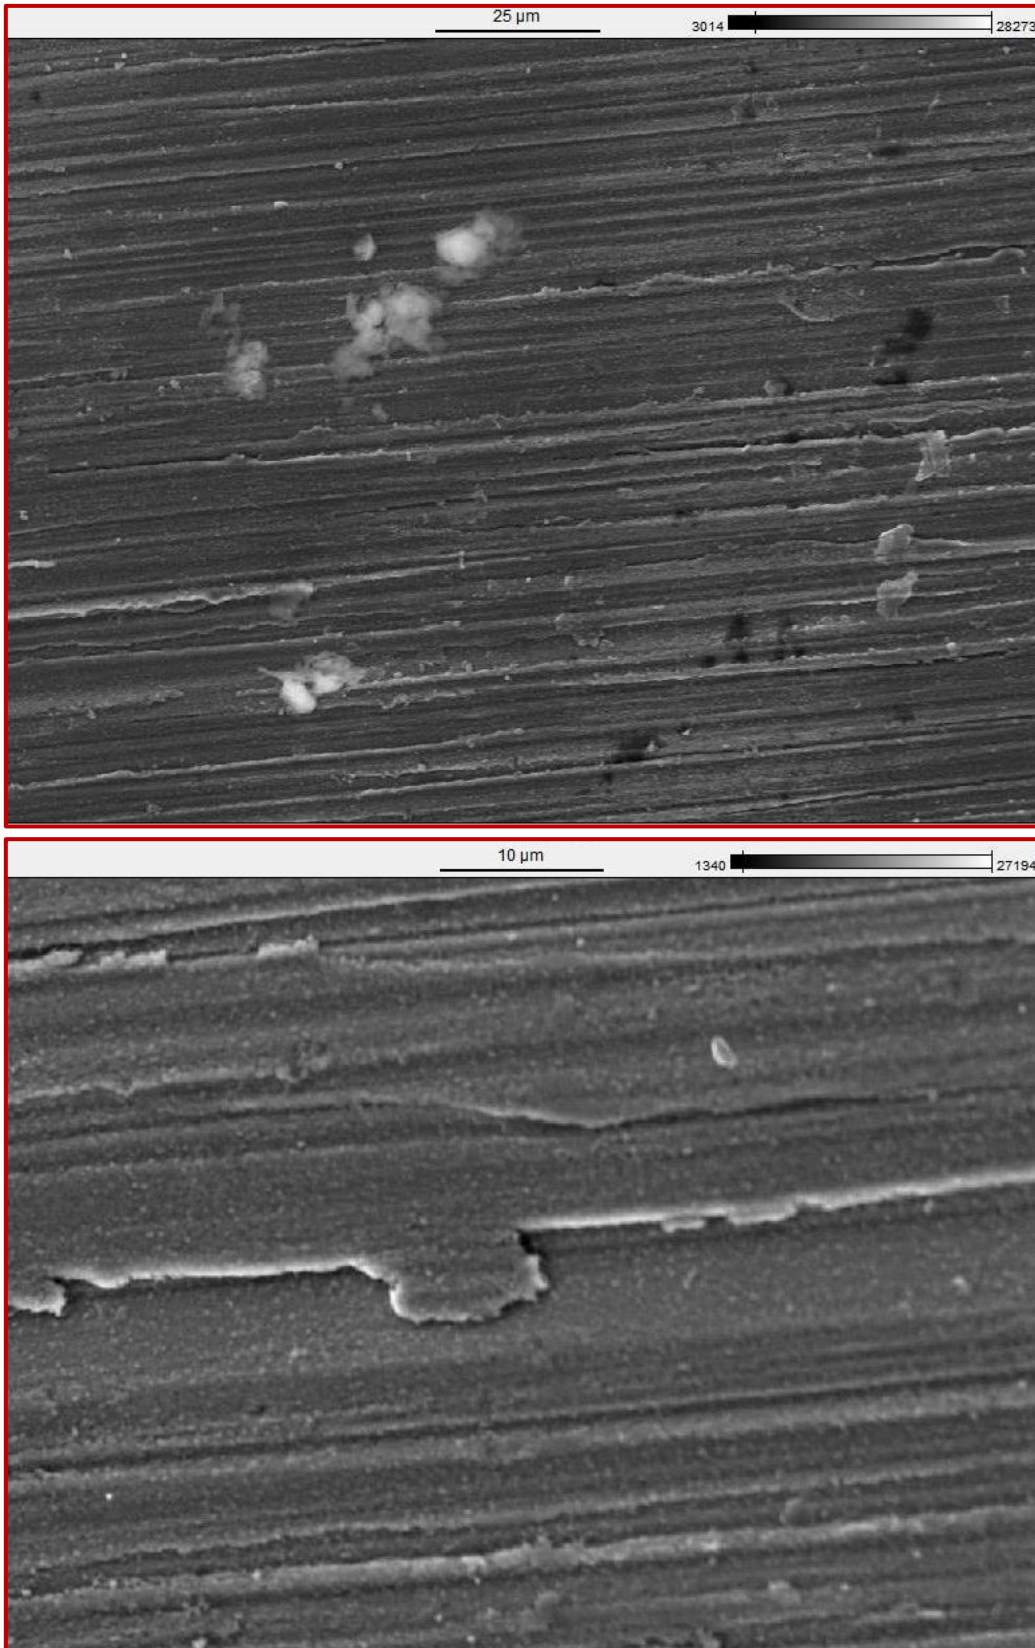
Figure 17: SEM images of specimen n° 3 surface (secondary electrons) at different magnitudes. Scale bar above the image.

Also for this specimen, the observed morphology is a consequence of the mechanical manufacturing executed before the erosion-corrosion test.

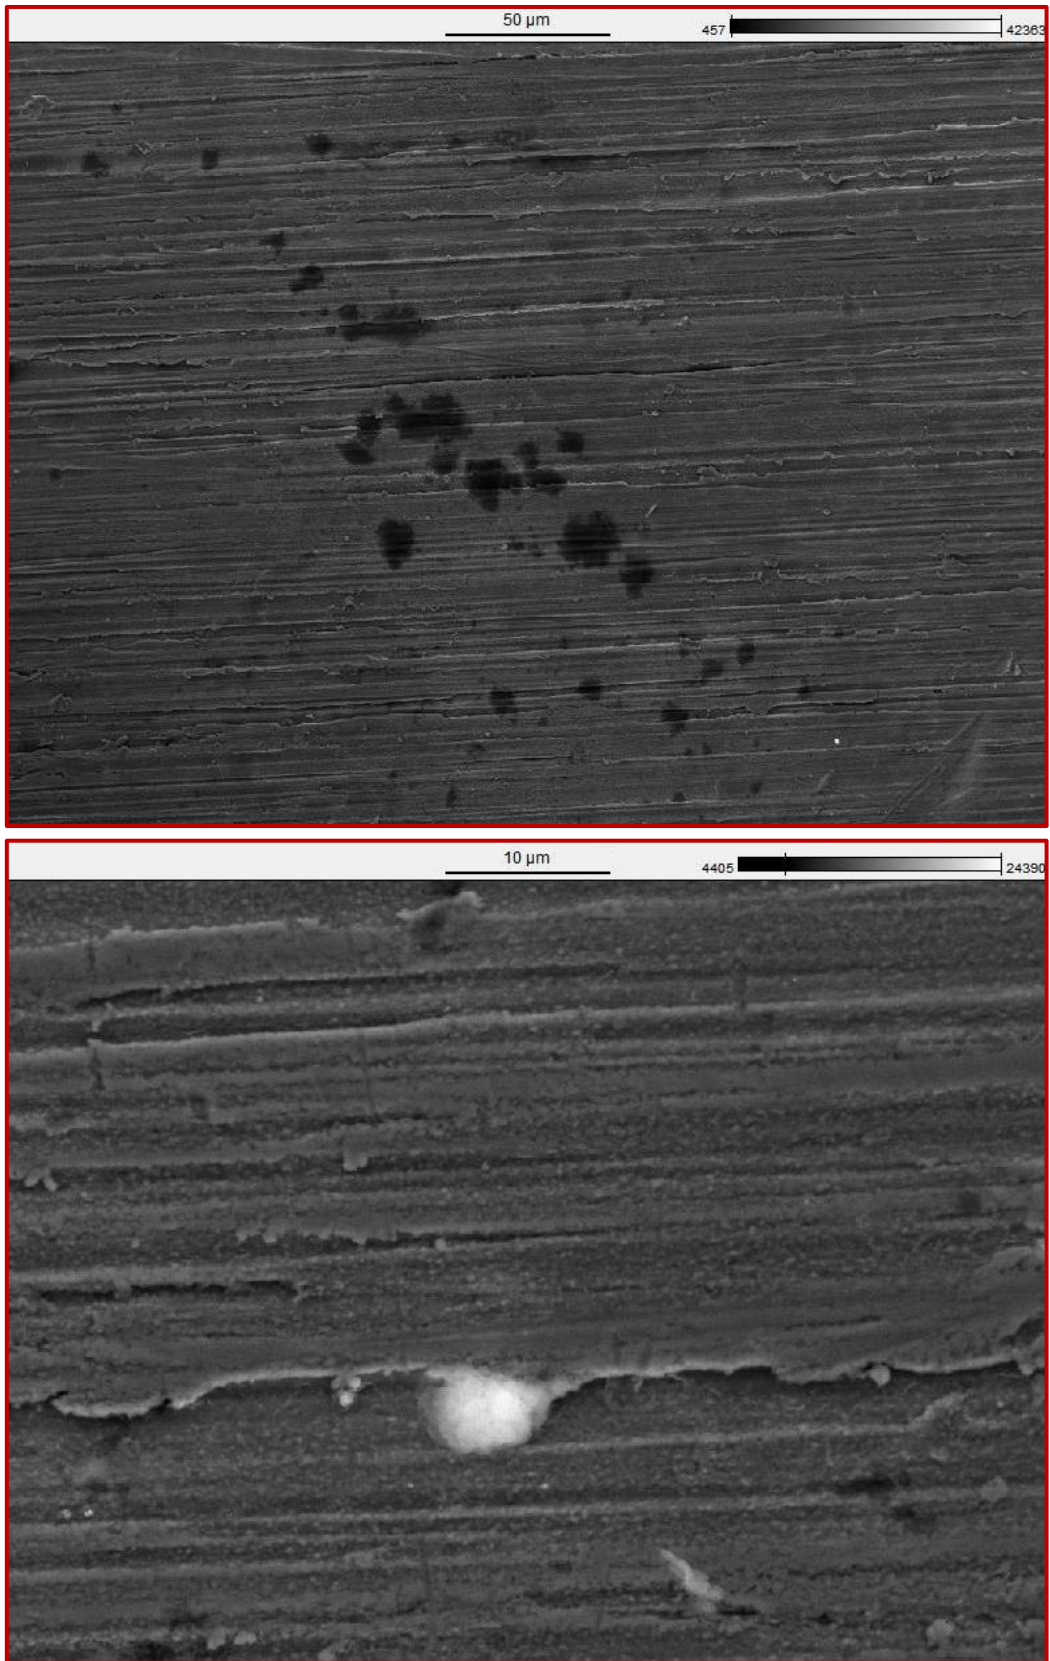
The surface of specimen n°5, at different magnitudes, is instead shown in Figure 21. Apart from the already observed signs of manufacturing, in this sample dark spots and white not conductive corpuscles (high resolution part of Figure 21) are evident. In both cases, the punctual EDS analysis of these specific regions has not indicated meaningful differences respect to the average surface composition (reported in Figure 22 and Table 10). It's possible that these features have organic nature (Carbon and Oxygen are not quantifiable with this kind of analysis) and are due to small contamination after the erosion-corrosion test.

Figure 21: SEM images of specimen n°5 surface (secondary electrons) at different magnitudes. Scale bar above the image.

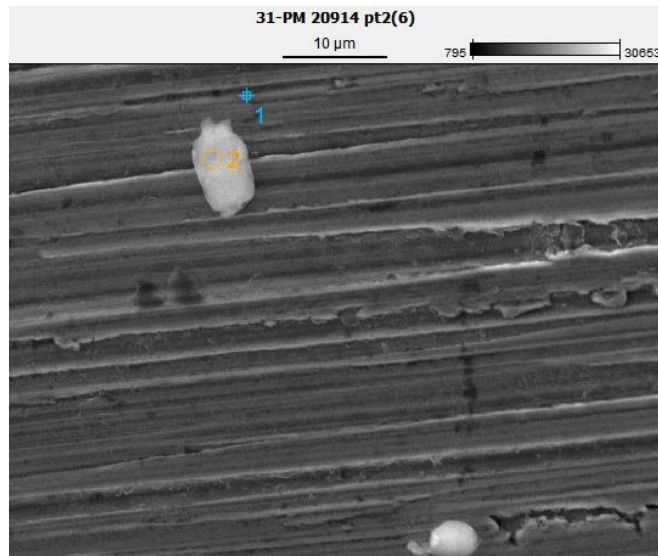
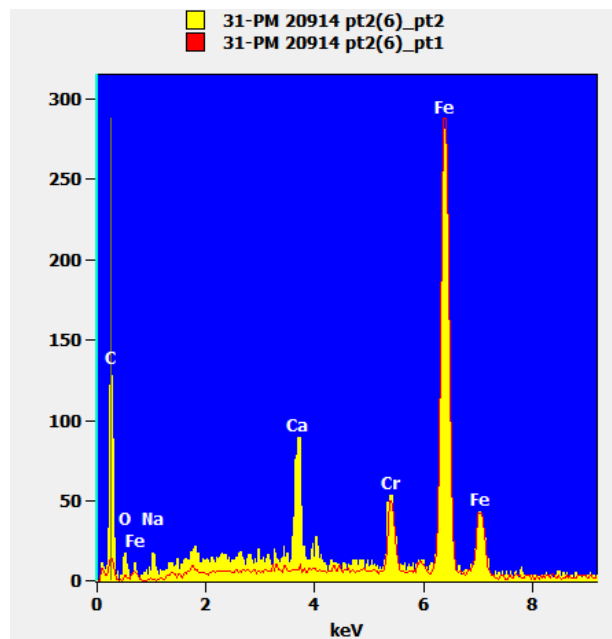
Figure 26 contemporary shows the two EDS spectra (position '1': red plot; position '2': yellow plot), pointing out that the white particle is characterized by a significant concentration of O, Na and mostly C and Ca (maybe some residue of alkaline carbonate). Since specimen n°31 was not exposed to Lithium, surely the presence of the just mentioned elements must be ascribed to the sample handling and its treatment before the execution of the analysis. In any case this conclusion allows to exclude, also for the really exposed specimens, that similar surface anomalies are somehow consequence of the action exerted by the liquid Lithium.

Figure 25: enlargement of the top image of Figure 23, centred on one of the unknown white bodies (secondary electrons). Scale bar above the image.

Figure 26: EDS spectrum obtained in correspondence of position '1' and position '2' on the surface of specimen n° 31; relative positions are indicated in Figure 25.

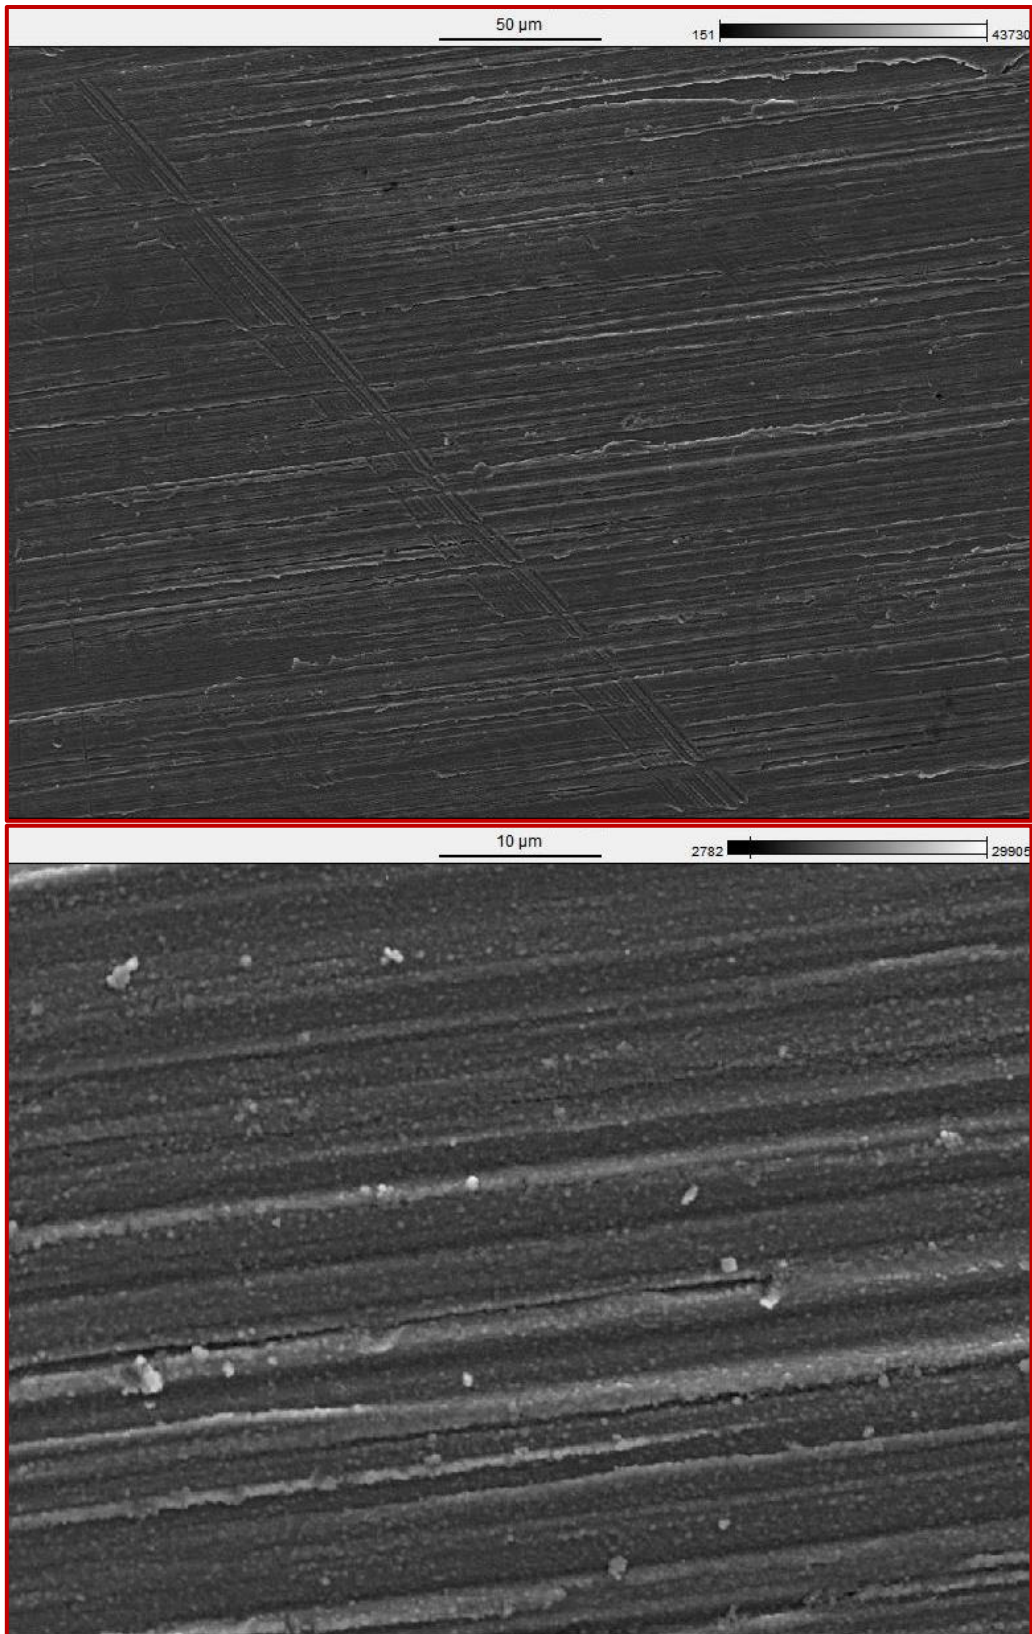
The surface of specimen n°23 is shown, at different magnitudes, in Figure 27. It appears substantially identical to the reference one (specimen n°31).

Figure 27: SEM images of specimen n° 23 surface (secondary electrons) at different magnitudes. Scale bar above the image.

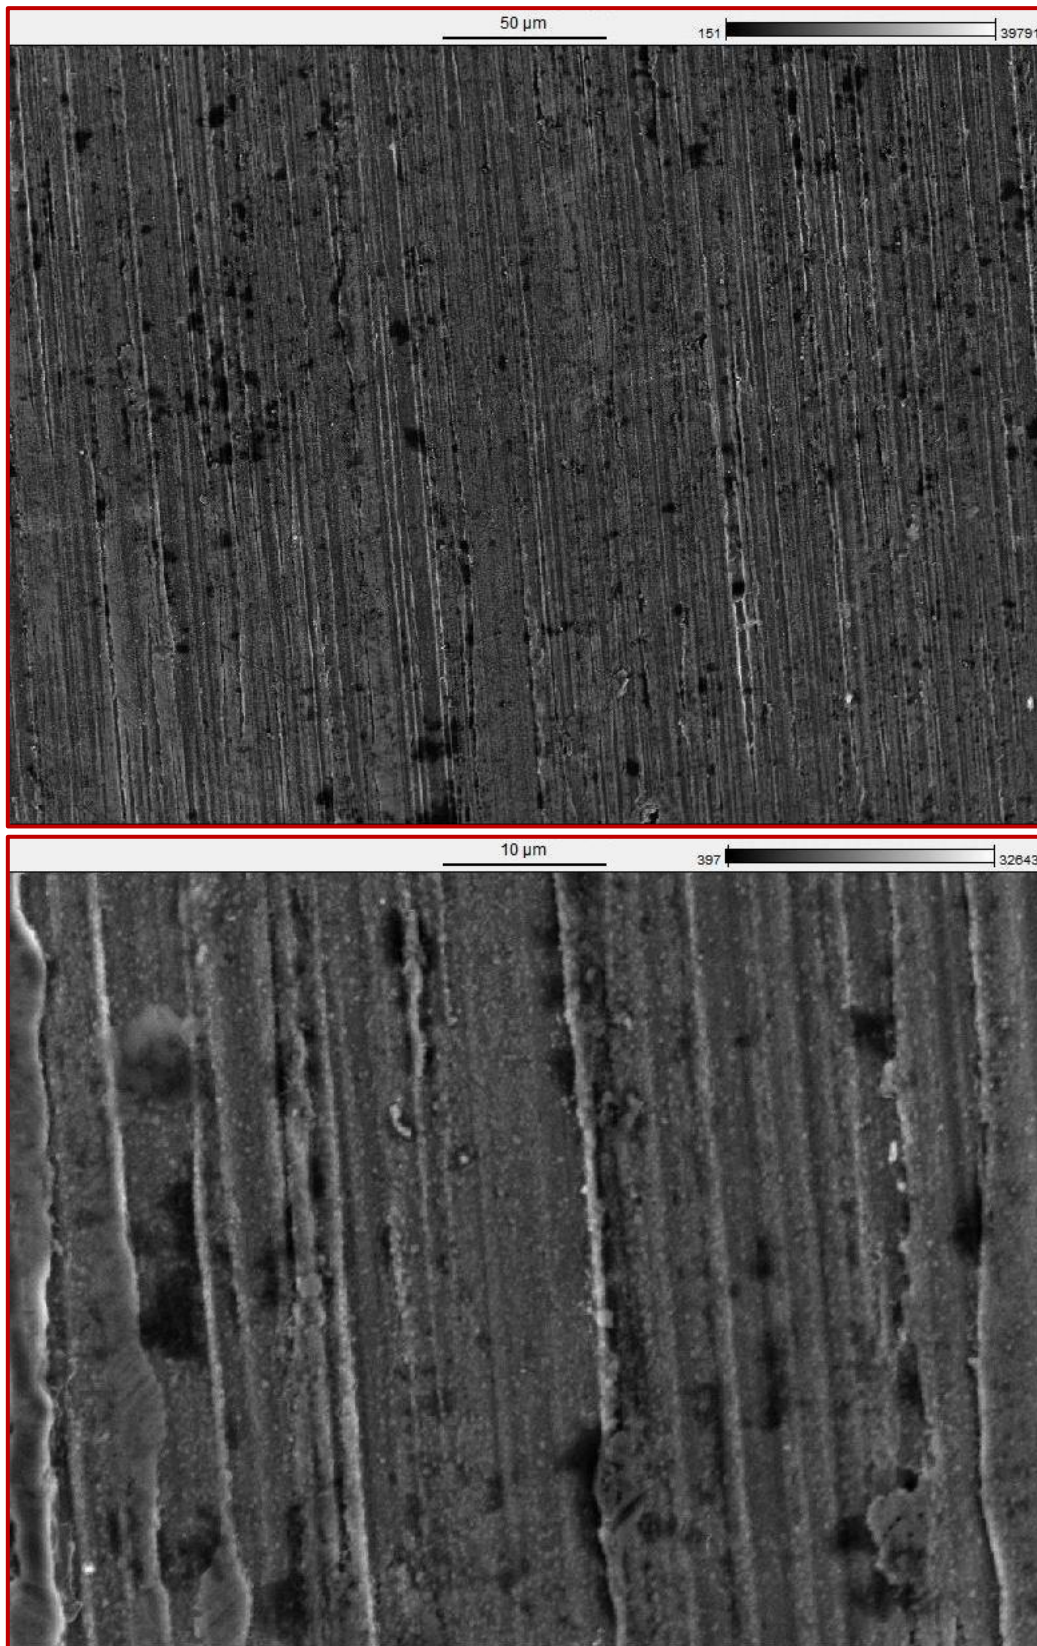
Figure 29 shows, at different magnitudes, the surface of specimen n°24. No substantial alteration of the morphology appears respect to the starting conditions (specimen n°31).

Figure 29: SEM images of specimen n° 24 surface (secondary electrons) at different magnitudes. Scale bar above the image.

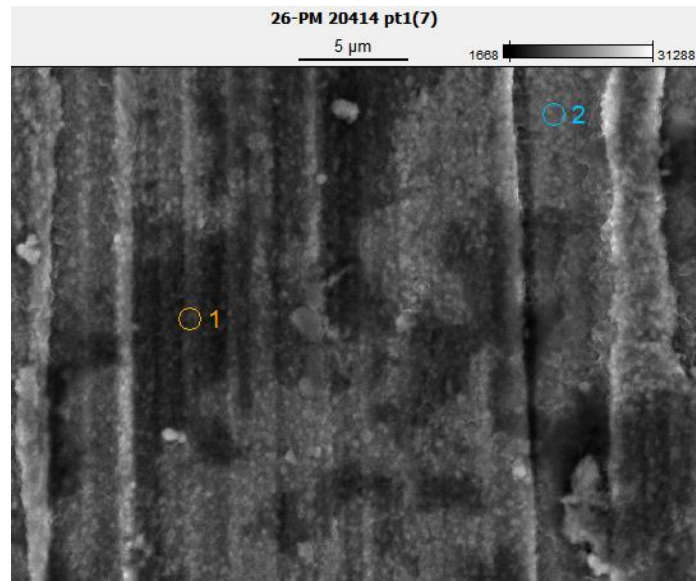
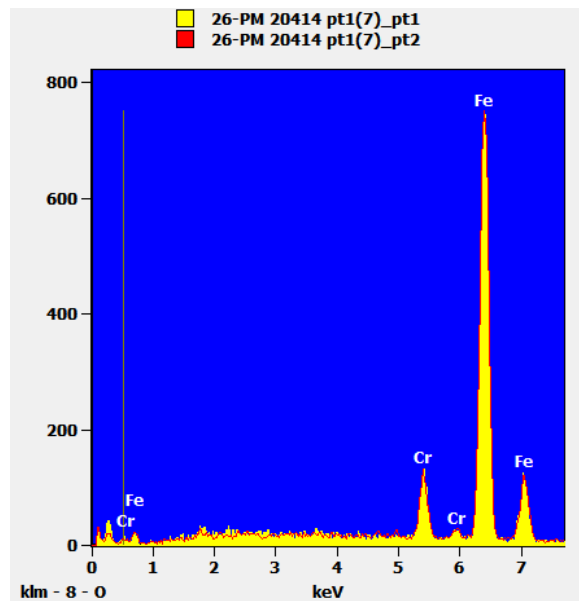
Figure 35: high magnitude image of specimen n°26 surface, highlighting a darker region ('1') and a 'regular' one ('2') (secondary electrons). Scale bar above the image.

Figure 36: EDS spectrum obtained in correspondence of position '1' and position '2' on the surface of specimen n°26; relative position is indicated in Figure 35.

Such an Oxygen increase in position '1' might be viewed a consequence of some oxidation process. This process could have occurred during the erosion-corrosion test (by the Oxygen solved in Lithium ?), but it is more likely to have occurred during the cleaning of the specimen, when it was kept for about 45' in boiling water. In any case, the entity of the phenomenon is very small.
