Ricerca di Sistema elettrico

Risultati relativi alla campagna sperimentale di medio termine sui fenomeni di erosione/corrosione da Litio liquido fluente nell'impianto Lifus 6

RISULTATI RELATIVI ALLA CAMPAGNA SPERIMENTALE DI MEDIO TERMINE SUI FENOMENI DI EROSIONE/CORROSIONE DA LITIO LIQUIDO FLUENTE NELL'IMPIANTO LIFUS 6

Settembre 2017

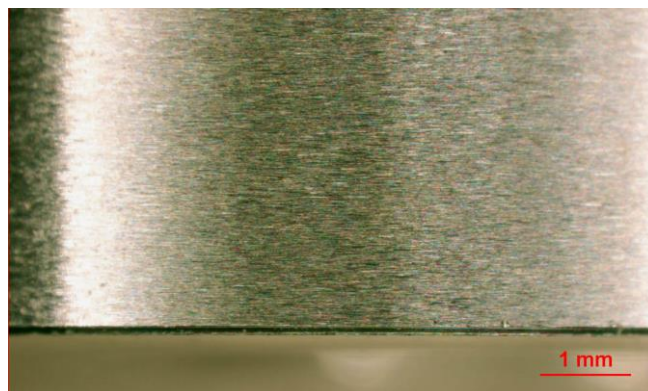
Figure 4: stereoscope image of a representative Eurofer 97 specimen: curved external surface, viewed from the top. The surface is in good shape.

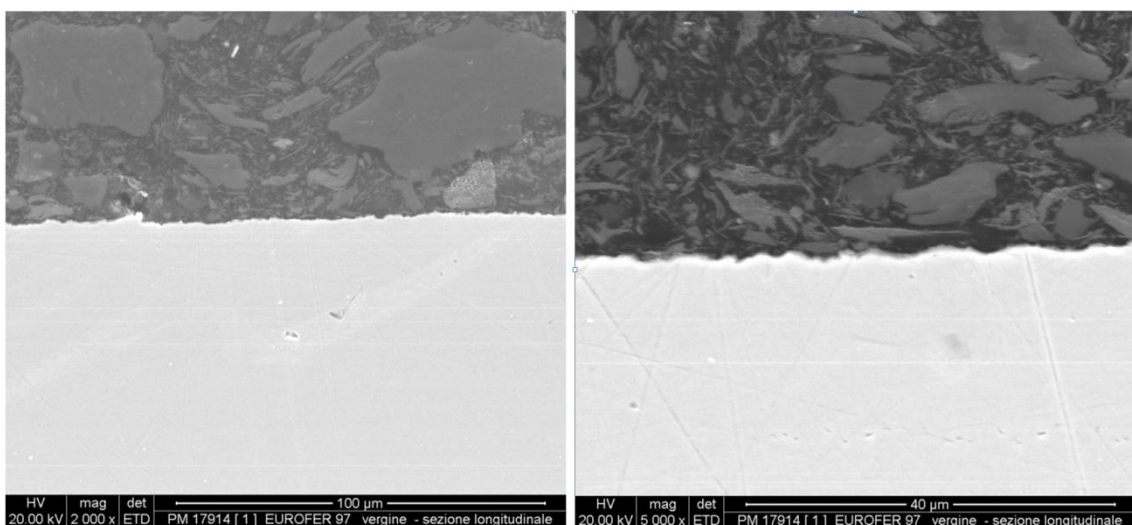
Figure 5: SEM images (secondary electrons) of a representative Eurofer 97 specimen: longitudinal sections. The surface is in good shape (dark region in the top half is due to graphite, where the specimen is mounted in).

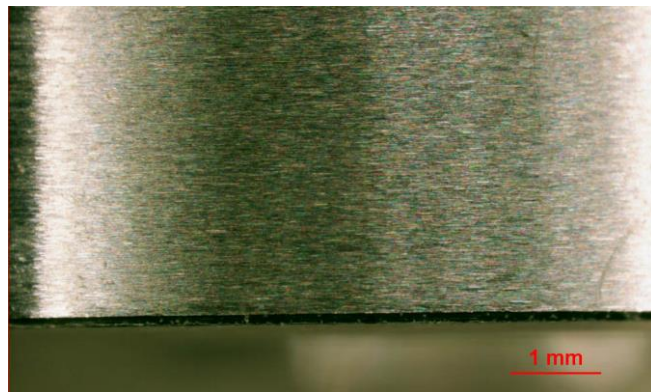
Figure 7: stereoscope image of a representative F82H specimen: curved external surface, viewed from the top. The surface is in good shape.

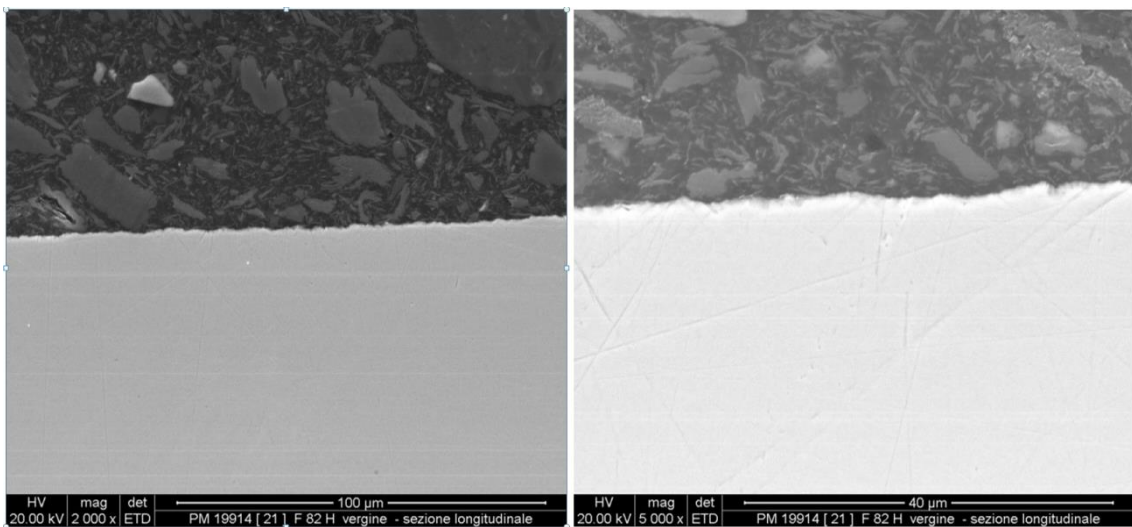
Figure 8: SEM images (secondary electrons) of a representative F82H specimen: longitudinal sections. The surface is in good shape (dark region in the top half is due to graphite, where the specimen is mounted in).

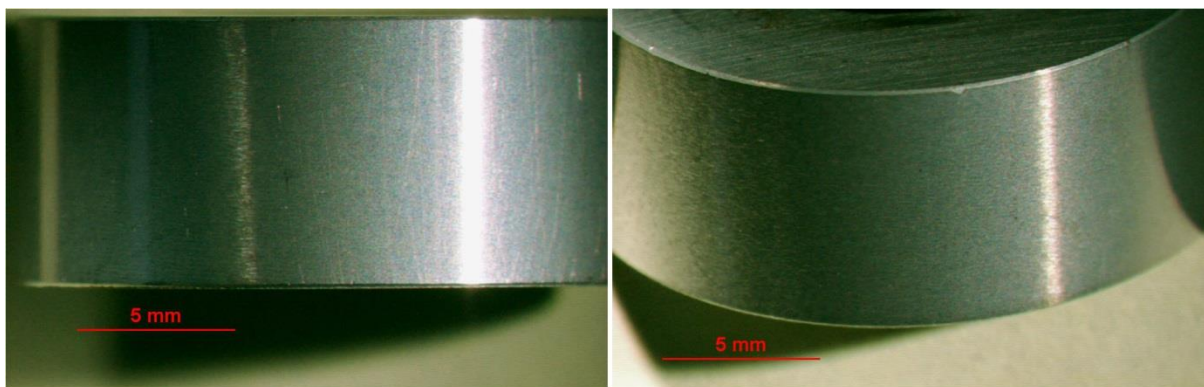
Figure 12: optical stereoscope inspection of the surface of tested specimen #12 (Eurofer 97, 2000 hours).

Figure 12 shows 2 different views of the external surface of specimen #12 (Eurofer 97, 2000 hours total exposure, exit of the Test Section) after the test. The surface is smooth and regular. Compared with the appearance of a fresh Eurofer 97 specimen (Fig. 4), no difference is evident, a part from (perhaps) some very light stripes going along the specimen height.

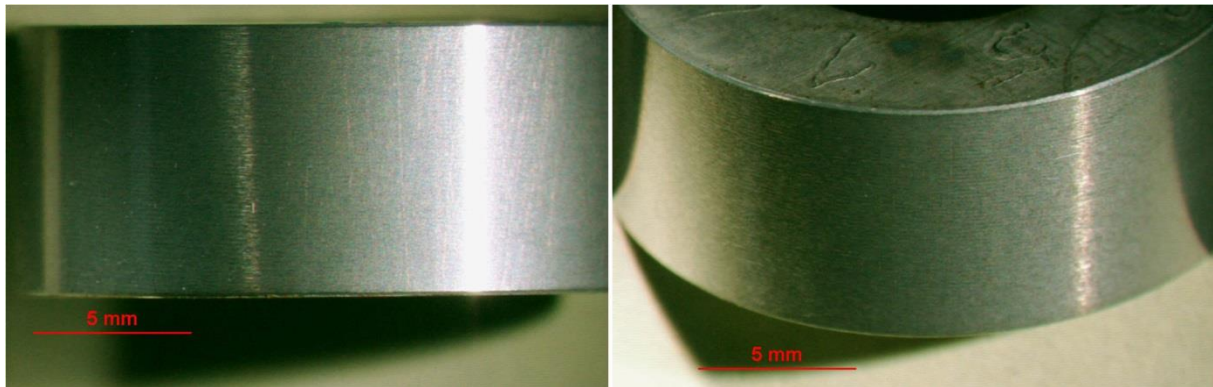
Figure 13: optical stereoscope inspection of the surface of tested specimen #7 (Eurofer 97, 4000 hours).

Figure 13 shows instead 2 different views of the external surface of specimen #7 (Eurofer 97 again, but 4000 hours total exposure, inner of the Test Section). The surface is smooth and regular; some very light stripes going along the specimen height can be noted again, which don’t appear, however, more pronounced than for the previous specimen.

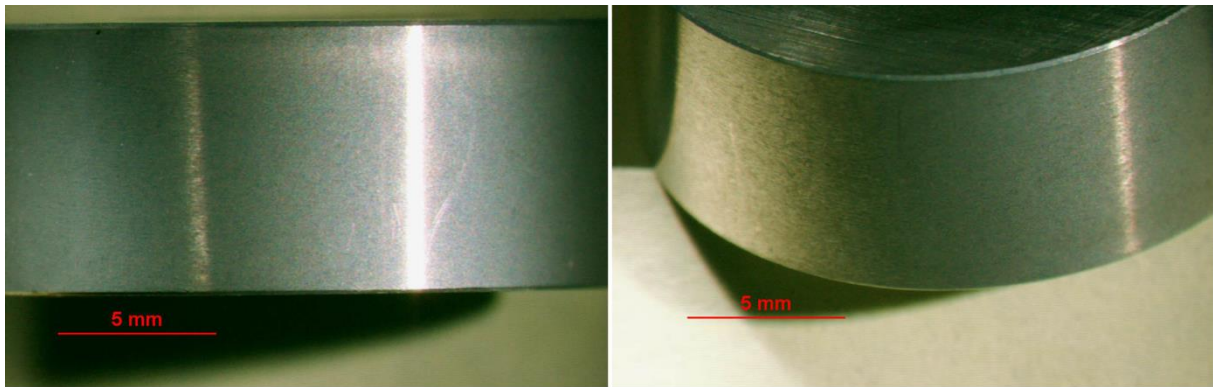
Figure 14: optical stereoscope inspection of the surface of tested specimen #34 (F82H, 2000 hours).

Figure 14 shows 2 different views of the external surface of specimen #34 (F82H, 2000 hours total exposure, entering of the Test Section) after the test. The surface is smooth and regular. Compared with the appearance of a fresh F82H specimen (Fig. 7), no difference is evident, nor even the light stripes seen in the previous specimens.

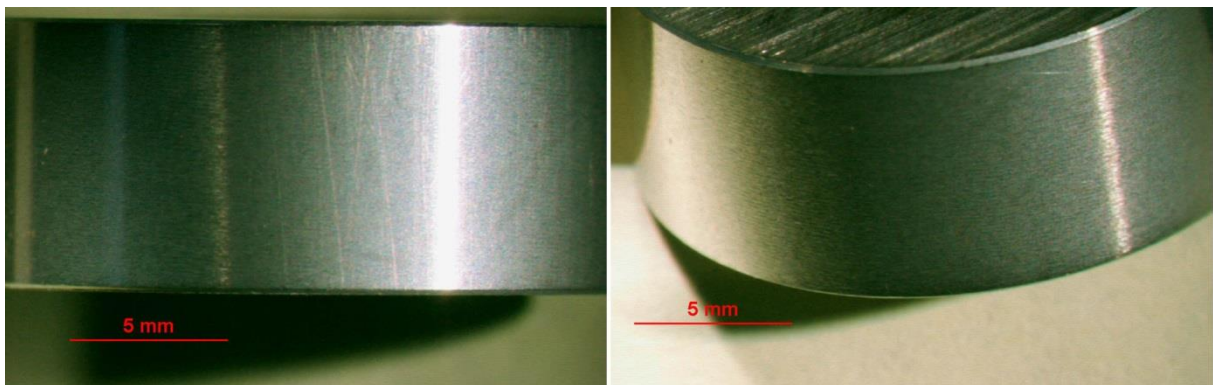
Figure 15: optical stereoscope inspection of the surface of tested specimen #28 (F82H, 4000 hours).

Figure 15 finally shows 2 different views of the external surface of specimen #28 (F82H again, but 4000 hours total exposure, inner of the Test Section). The surface is smooth and regular; some very light stripes going along the specimen height can be noted, a little more pronounced than in the two previous Eurofer 97 specimens.

On the whole, the appearance of the specimens after the test confirms the rather small damage provoked on them by the flowing Lithium. Some doubt remains about the nature of the light stripes visible on the left side of each of the previous figures, whether they result from just visual artifacts or they correspond to a real physical situation: in this case, they could indicate that the mass lost by the specimens is to some extent due also to an erosive effect exerted by the flow of Lithium, since a purely chemical dissolution would have been more isotropic on the specimen surface and would not have marked a specific attack direction.

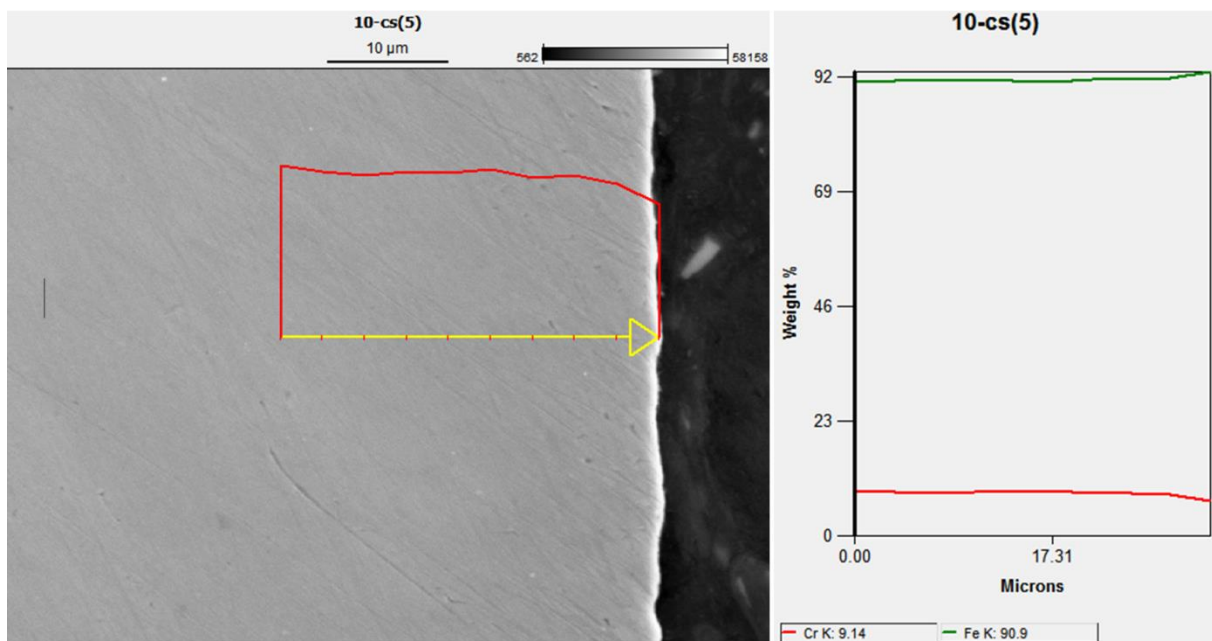
Figure 19: left: SEM image and Cr concentration profile (EDS) of specimen #10 section; right: Cr (red) and Fe (green) concentration profiles along the specimen section.

From the observation of Figure 19, it is possible to note that the internal specimen structure is in good condition, with only some sign due to the cut and preparation of the sample, but no erosion-corrosion damage: this is of course what expected, since specimen #10 is an unexposed specimen. The concentration profiles indicate a substantial constancy of values; the minimal value of Cr concentration at the highest value of x is not physically sure, because this measurement point was too close to the specimen border.

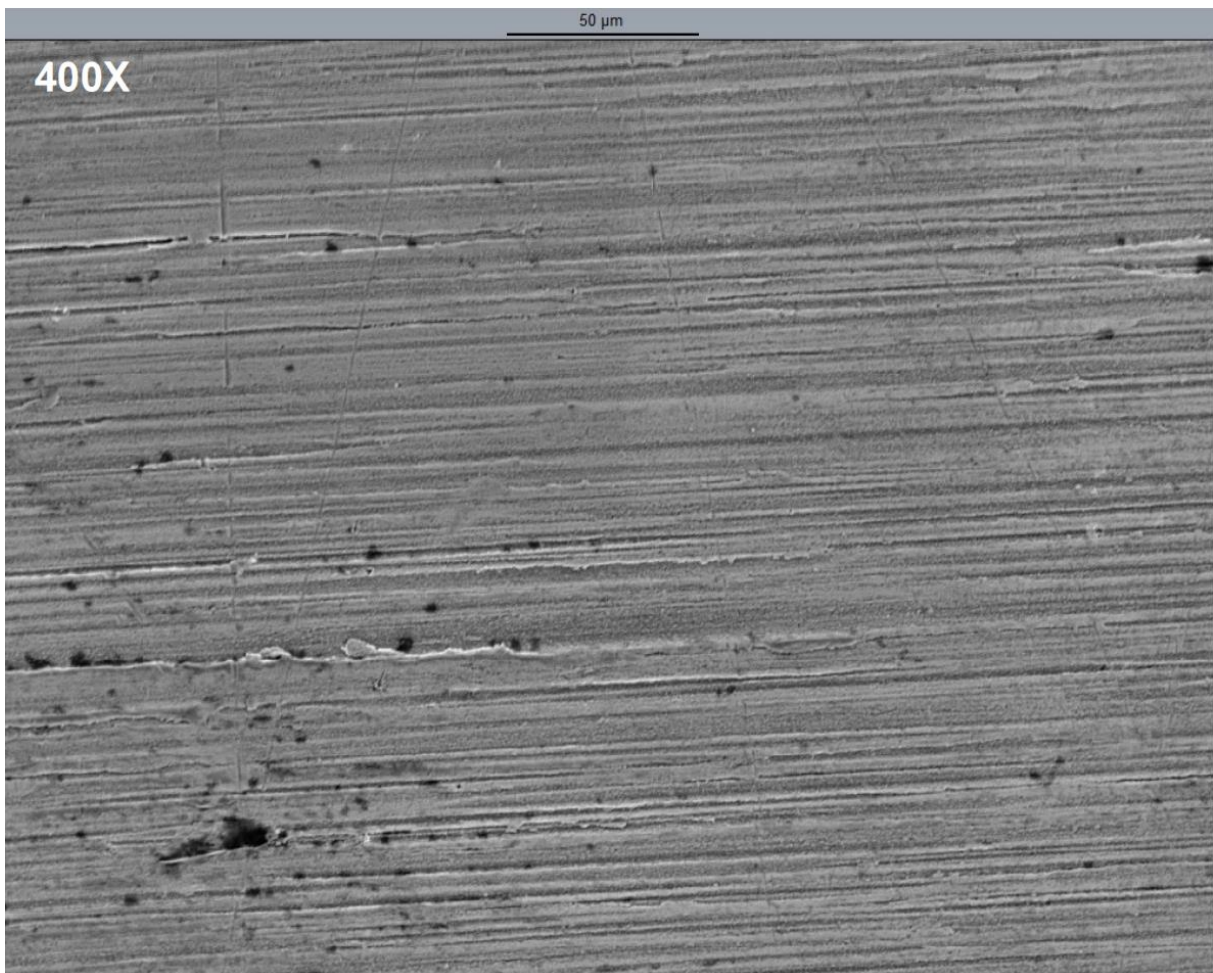
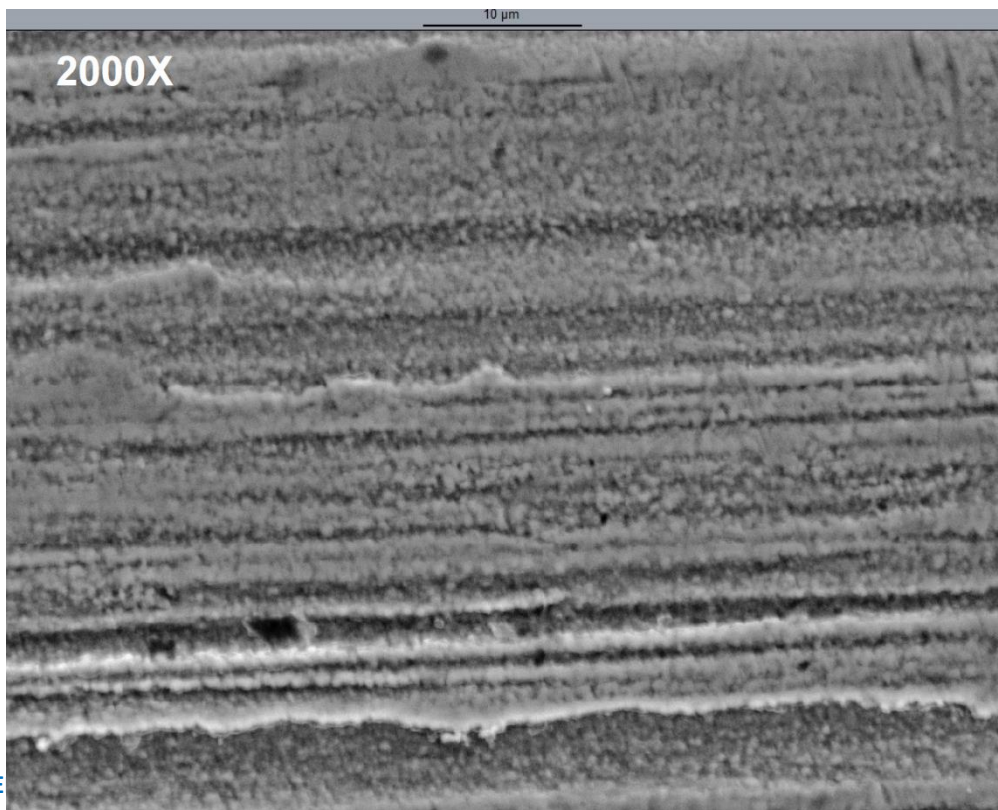
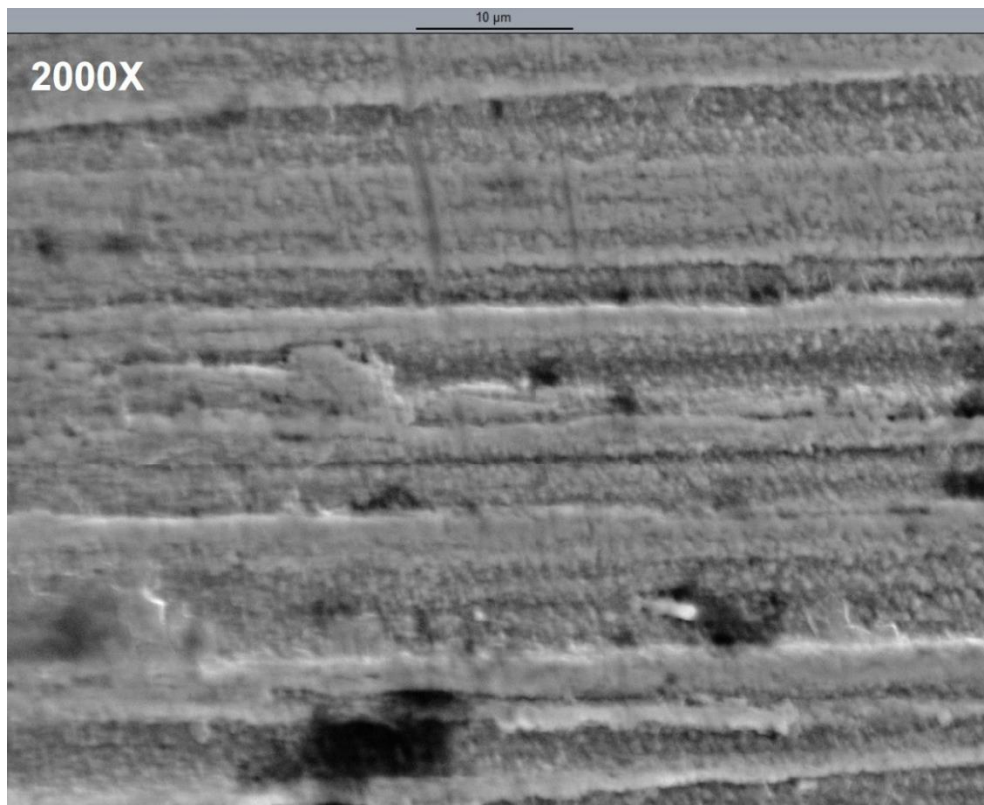
Figures 20 and 21 show, respectively at magnitude 400 and 2000X, a portion of the external surface of this specimen. Apart from the usual stripes produced during the mechanical manufacturing of the sample, no significant morphological alteration, ascribable to corrosion phenomena, is seen.

Figure 22 depicts instead, at magnitude 2000X, another different region of the external specimen surface. Also in this region, no corrosion item is detected.

By comparing Figures 21 and 22 with the bottom half of Figure 17 (observations made at the same magnitude) it appears anyway a more 'granulose' profile of the specimen #12 surface compared to the fresh one.

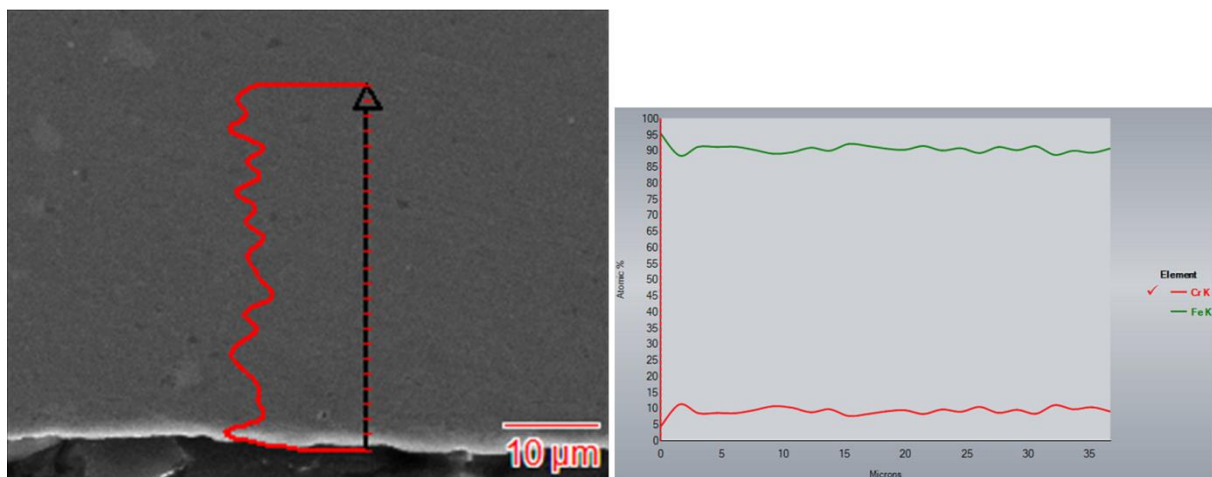
Figure 24: left: SEM image and Cr concentration profile (EDS) of specimen #12 section; right: Cr (red) and Fe (green) concentration profiles along the specimen section.

Figure 24 (left) shows instead a SEM image at 2000X of a representative cross section of specimen #12, together with the overlapped Chromium concentration vs depth profile, constructed by the EDS analysis of equidistant points (~ 1.5 μm spaced), in the arrow direction. On the right side of Figure 24 is instead reported a graph showing the profiles of both Chromium and Iron elements along the arrow direction, where y-axis is the atomic % concentration, while x-axis indicates the distance from the surface (the surface position is on the left boundary of the graph, in correspondance of x = 0).

From the observation of Figure 24 left, it is possible to note that the internal specimen structure is in good condition, with no morphological alteration or grain detachment. The concentration profiles on the right indicate a substantial constancy of values, with only small oscillations due to little random deviations from the theoretical alloy composition and/or to the analysis uncertainty (the starting 'red' value, on the left (Cr), must not be misleading; it is characterized by a value of ~ 5 , which is the lowest of all the Cr points, but it is associated to a measurement on the boundary of the sample, so it is not physically meaningful. The first real point is therefore the one of its right, which corresponds to a relative maximum, and from here on Cr concentrations are essentially constant).

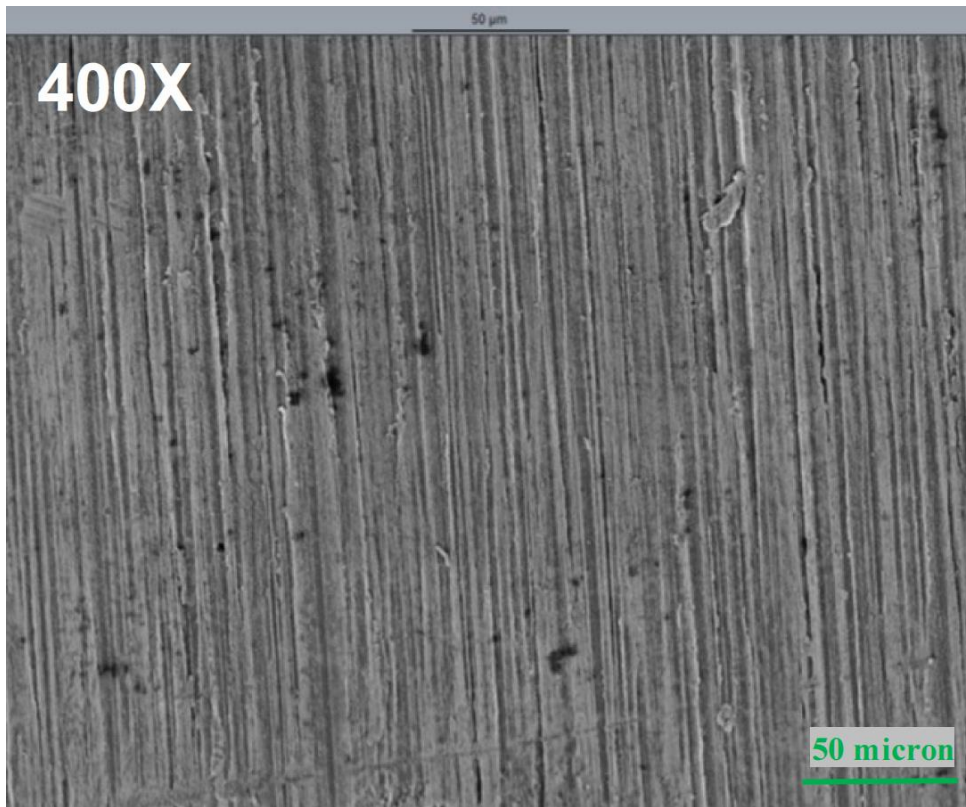
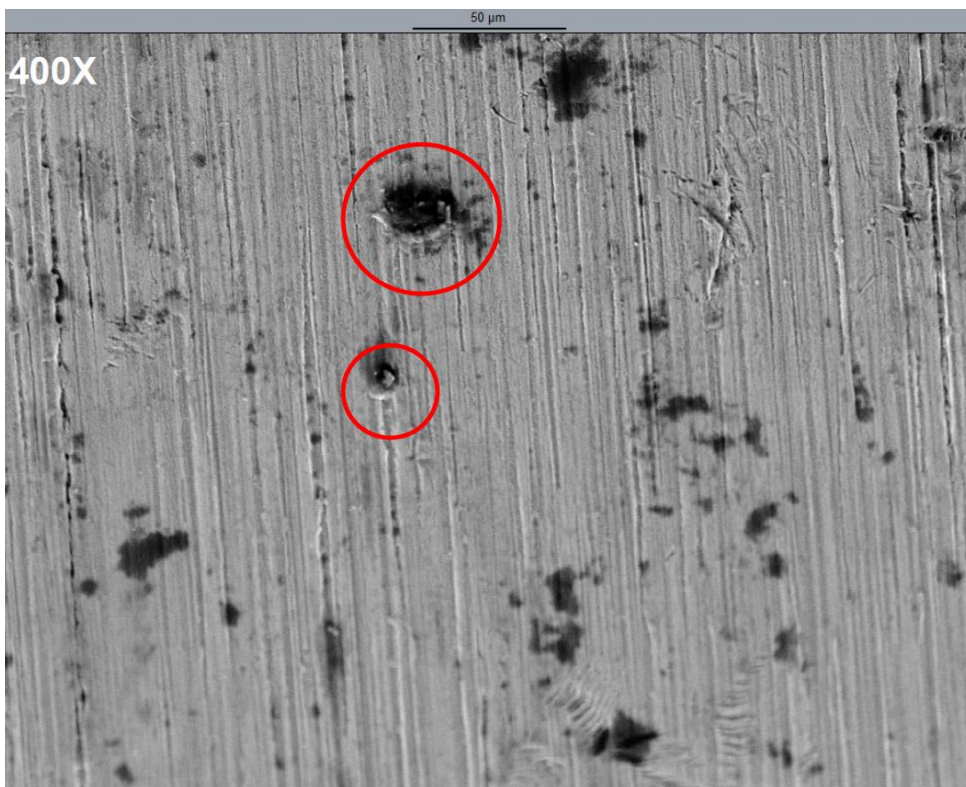
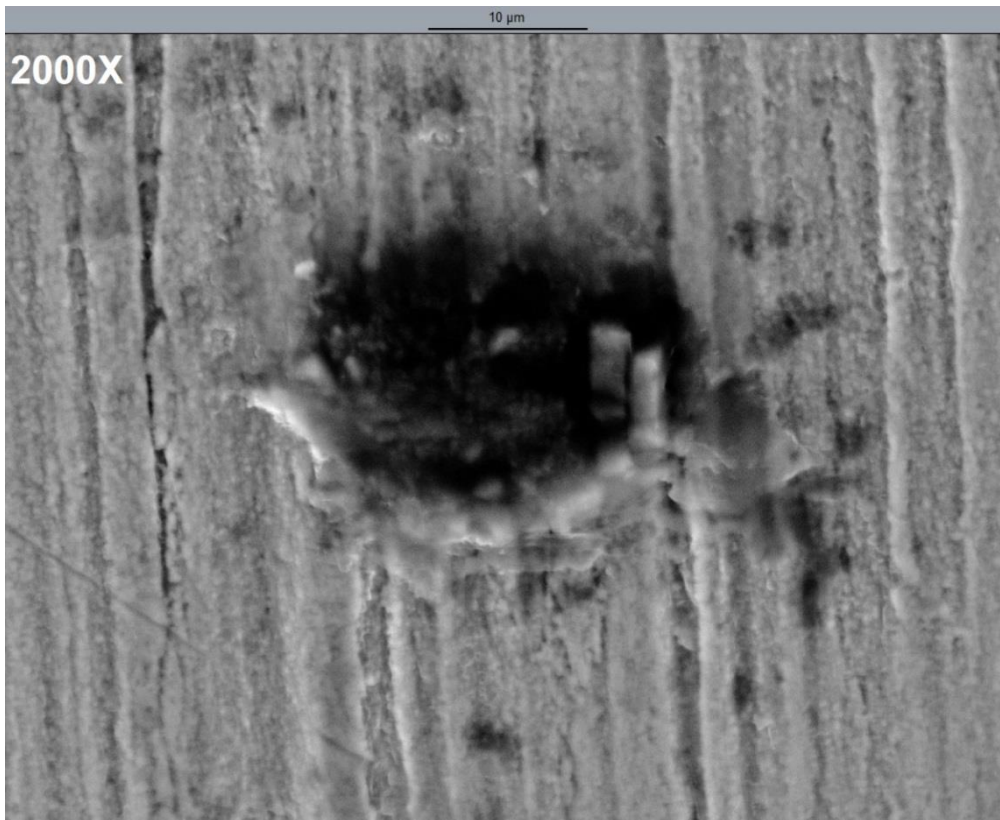
Figures 25 and 26 show, at magnitude 400X, 2 different regions of the external surface of this specimen. Region A (Figure 25) is characterized by the absence of degradative phenomena and is exemplifying of the general surface condition; region B (Figure 26) is instead characterized by the presence of some corrosion items (circled in red), which are anyway uncommon on the surface. When enlarging Figure 26 to Figure 27, it is easier to see that these surface anomalies are compatible with a small pitting phenomenon.

In all the shown figures it is possible also to note the presence of remains of organic substances, which originate, as for the other investigated specimens, the black spots in the secondary electrons observations.

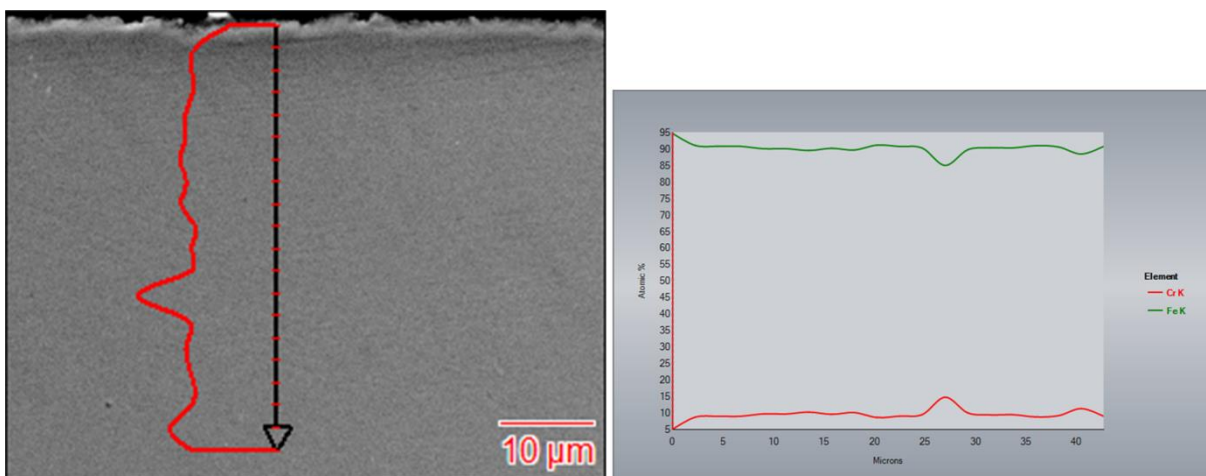
Figure 29: left: SEM image and Cr concentration profile (EDS) of specimen #13 section; right: Cr (red) and Fe (green) concentration profiles along the specimen section.

Figure 29 (left) shows a SEM image at 2000X of a representative cross section of specimen #13, together with the overlapped Chromium concentration vs depth profile, constructed by the EDS analysis of equidistant points (~ 2.2 μm spaced), in the arrow direction. On the right side of Figure 29 is instead reported a graph showing the profiles of both Chromium and Iron elements along the arrow direction, where y-axis is the atomic % concentration, while x-axis indicates the distance from the surface (the surface position is on the left boundary of the graph, in correspondence of x = 0). From the observation of Figure 29 left, it is possible to note that the internal specimen structure is in good condition, with no morphological alteration or grain detachment. The concentration profiles on the right indicate no increasing or decreasing trend of values moving inside the specimen; the starting Cr value, on the left (~ 5), must not be misleading, because it is associated to a measurement on the boundary of the sample, so it is not physically meaningful: the first real point is therefore the one of its right. A part from small values fluctuations, a peak in Cr concentration is seen around 27 μm below the surface. This peak describes a real physical situation, maybe corresponding to a local accumulation of Cr in the form of Carbide; such a kind of compound can be present in the specimen also before the test (in the starting steel composition), therefore it is not indicative of a structure alteration produced by the exposure to flowing Lithium.

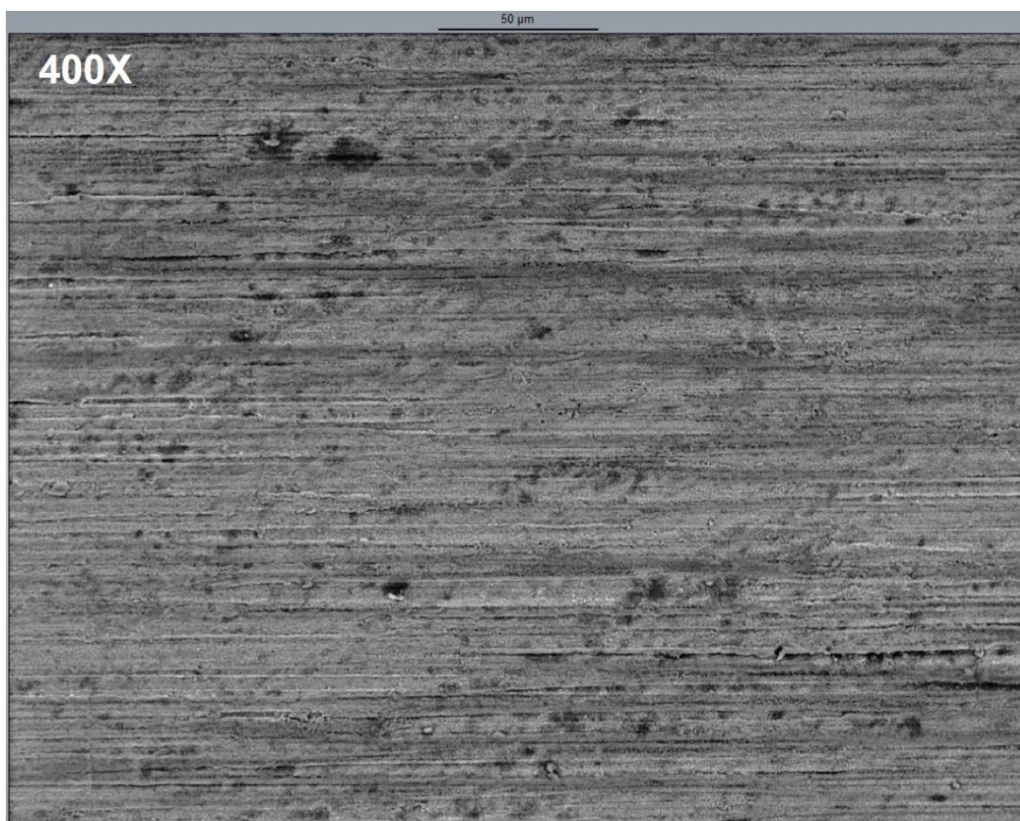
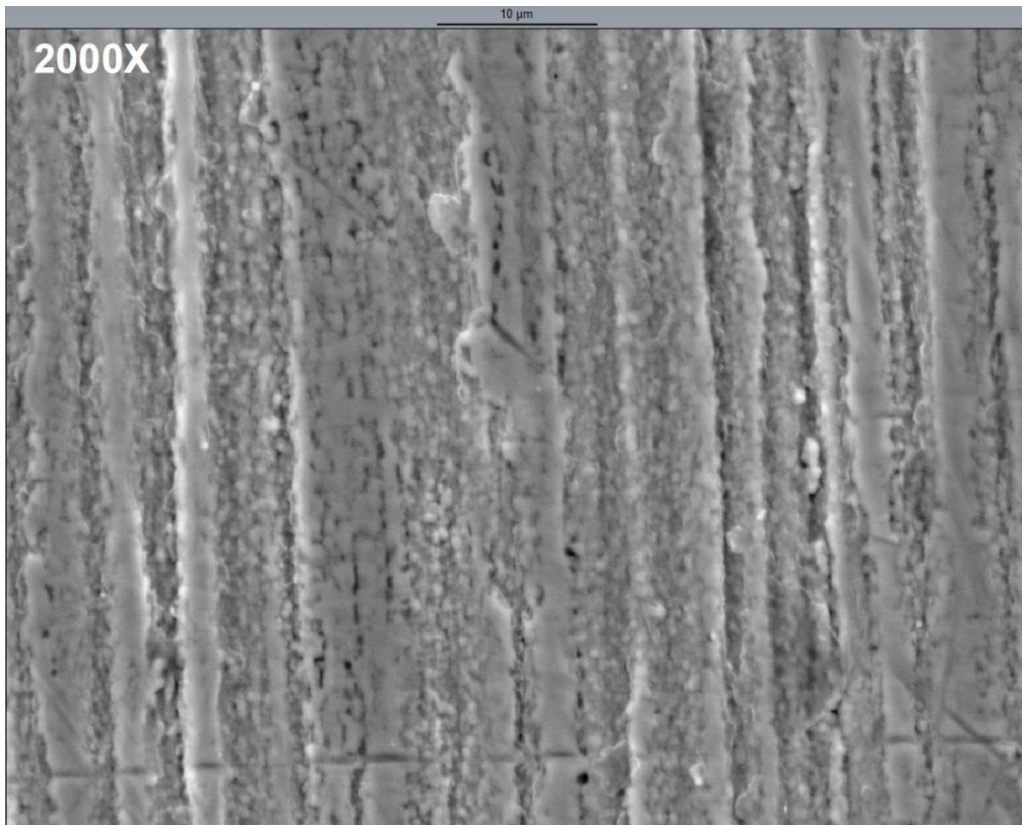
Figures 30 and 31 show, respectively at magnitude 400 and 2000X, 2 portions of the external surface of this specimen. Apart from the usual stripes produced during the mechanical manufacturing of the sample, no significant morphological alteration, ascribable to corrosion phenomena, is seen. The round black spots, which are seen here as well as in any other investigated specimen, are not due to degradative phenomena of the surface but to external organic substances stuck on the surface. By comparing Figures 31 with the bottom half of Figure 17 (observations made at the same magnitude) it appears anyway a more 'granulose' profile of the specimen #7 surface compared to the fresh one.

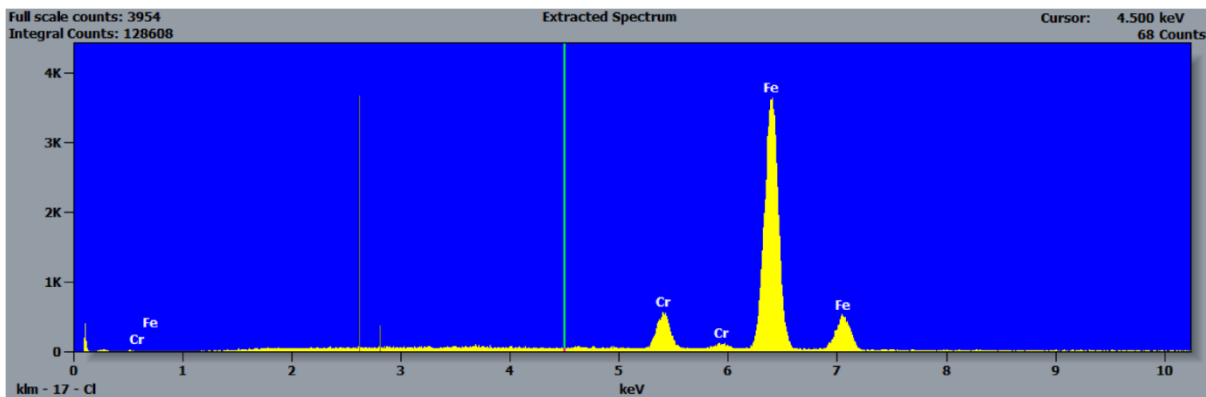
Figure 32: EDS spectrum obtained at specimen #7 surface

Figure 32 reports instead the average EDS spectrum of a large surface region; Table 8 summarizes the values of the related compositional analysis. By looking at Figure 32, the zeroing of Mn and W is evident. Moreover, by comparing Table 8 with Table 5, the Chromium depletion is observed (-1.2% by weight); Iron content is instead a bit increase, so to compensate for that diminution.

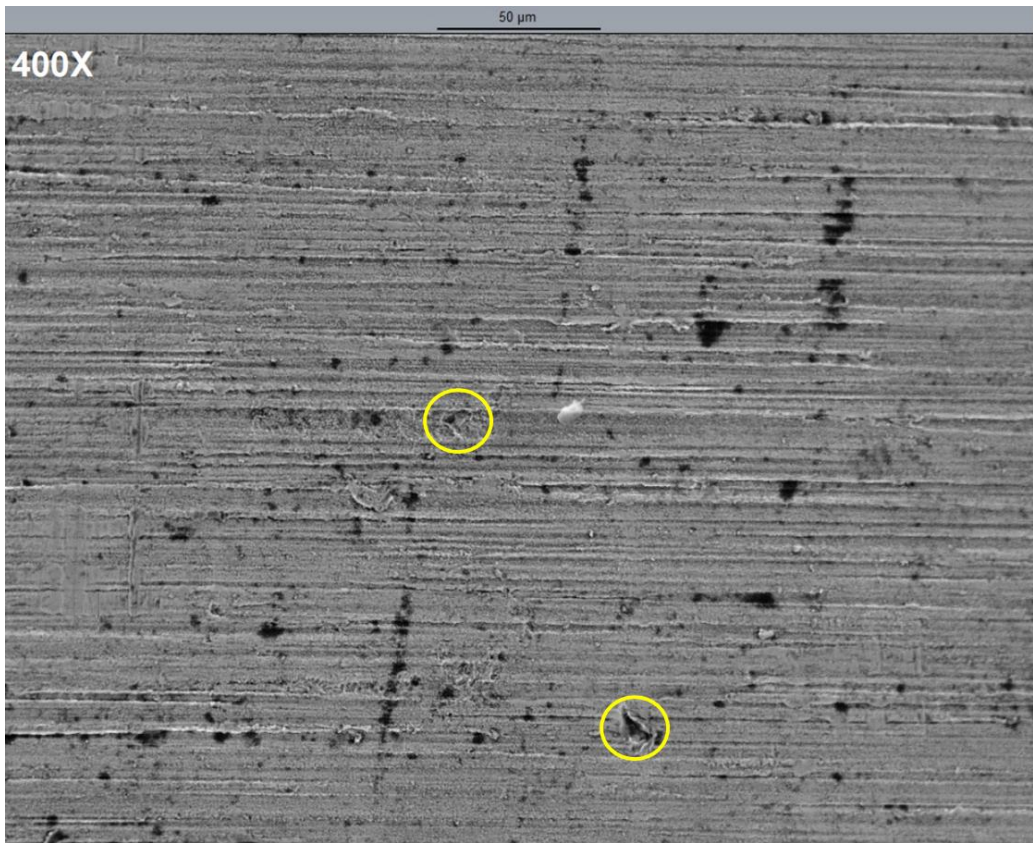
Figure 34: SEM image of specimen #8 surface (secondary electrons) at magnitude 400 X. Scale bar above the image.

Figure 34 shows, at magnitude 400X, a portion of the external surface of this specimen. The surface presents the usual features already observed in the other investigated specimens, including also the fresh Eurofer 97 (specimen #10): stripes produced during the manufacturing and black spots due to stuck organic substances. No corrosion item is clearly seen, a part, perhaps, the two small anomalies circled in yellow, which appears as shallow cavities.

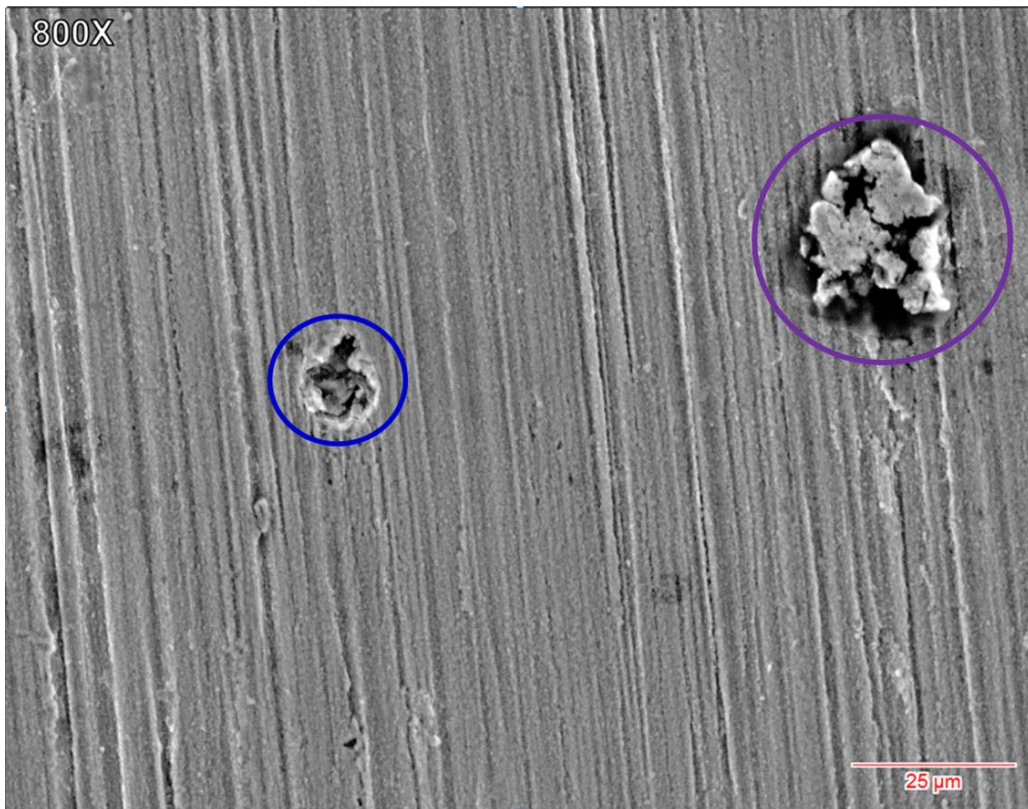
Figure 47: SEM image of specimen #34 surface (secondary electrons) at magnitude 800X, highlighting two surface anomalies. Scale bar above the image.

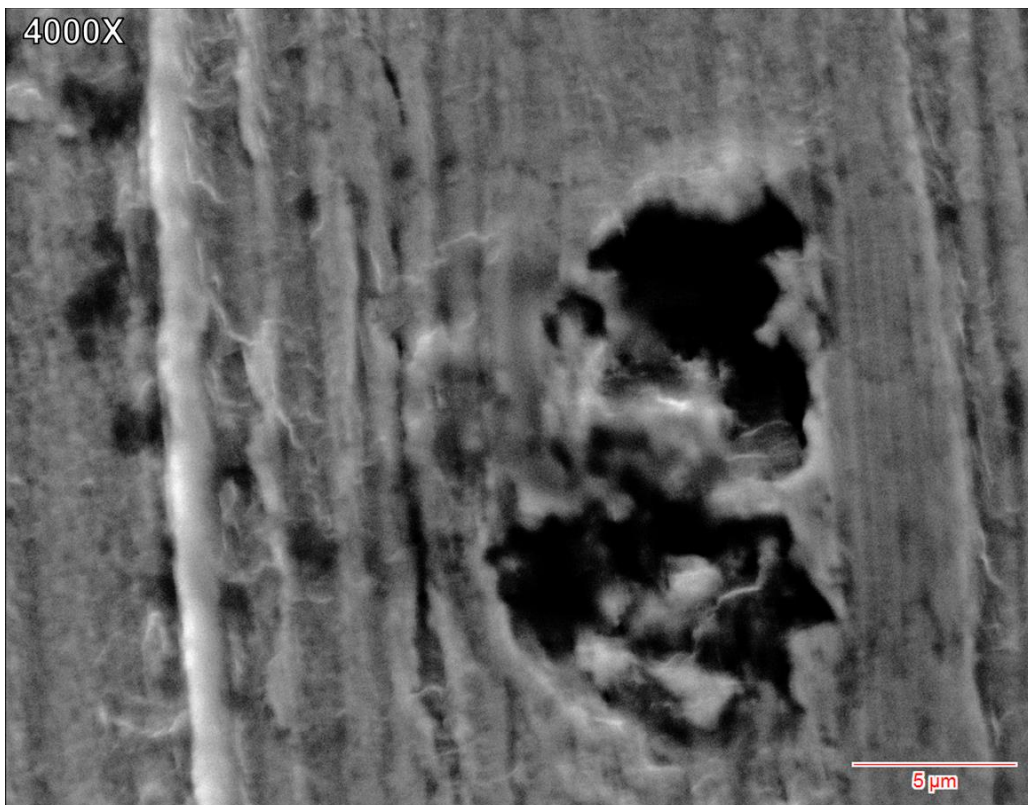
Figure 48: high magnitude (4000X) SEM image of specimen #34 surface (secondary electrons), focused on a riddled surface region. Scale bar above the image.

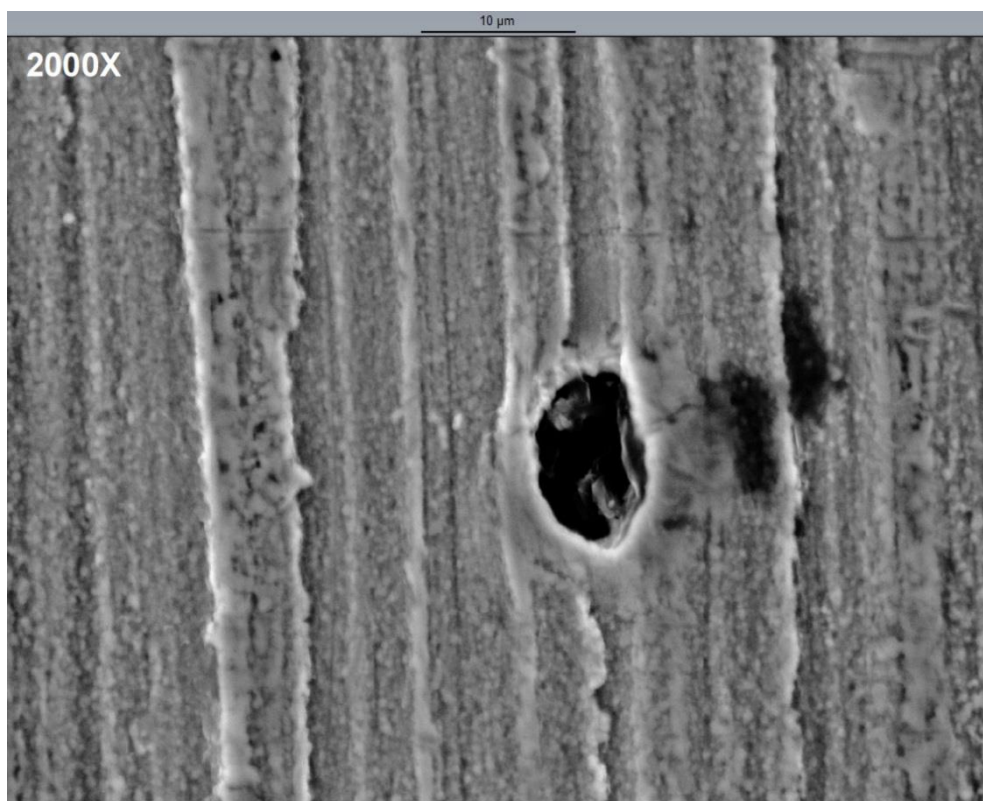
Figure 52: SEM image of specimen #28 surface (secondary electrons) at magnitude 2000X (enlargement of Figure 51 centered on the corrosion item). Scale bar above the image.
