RISULTATI DELLA CAMPAGNA SPERIMENTALE SULL'IMPIANTO ELTL DI OARAI PER LA RILEVAZIONE DEI FENOMENI DI CAVITAZIONE

A. Aiello, G. Micciché, A. Tincani (ENEA)

Settembre 2014

Report Ricerca di Sistema Elettrico

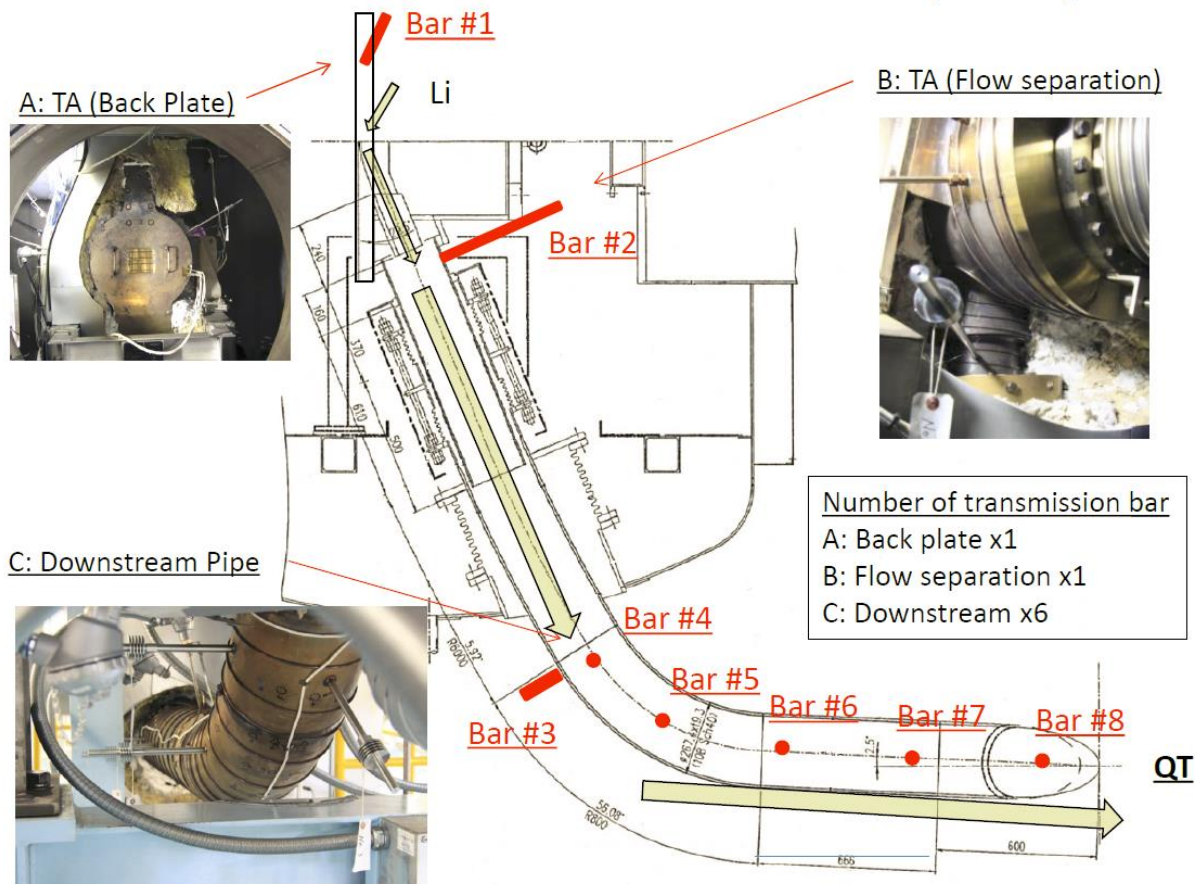
Fig. 1 Positions of CASBA installation.

- The first Casba was already installed at the inlet of the TA and will be kept in the this position;
- The second Casba was installed on the outlet channel at the beginning of the elbow, where it was expected the lithium flow will impact on the tube

Positions of the Casba system in the second campaign are related to Bar#1 and Bar# 4 as illustrated in the Fig. 1

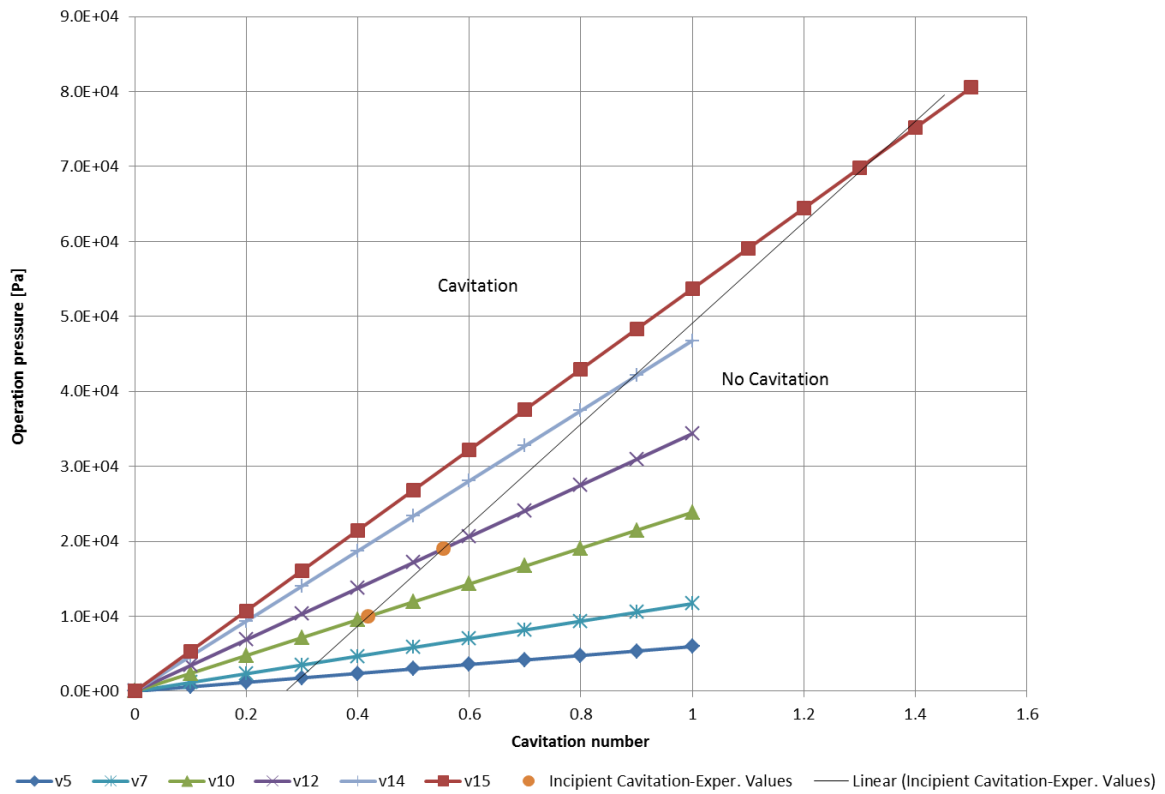
Fig. 2 Operation pressures vs the cavitation numbers at the nozzle exit

In the experimental data obtained in the former cavitation test campaign in 2012, critical values of operation pressures and jet velocities which shown an incipient cavitation have been identified. In the fig. 2 the operation pressures vs the cavitation numbers at the nozzle exit for different jet velocities are displayed. Moreover the experimental values of operation pressure and jet velocity that shown an incipient cavitation are displayed. The interpolation curve of the experimental incipient cavitation points could be used to evaluate the incipient cavitation conditions at different velocities. Different operation conditions for an incipient cavitation have been evaluated as in Tab. 1 and 2.

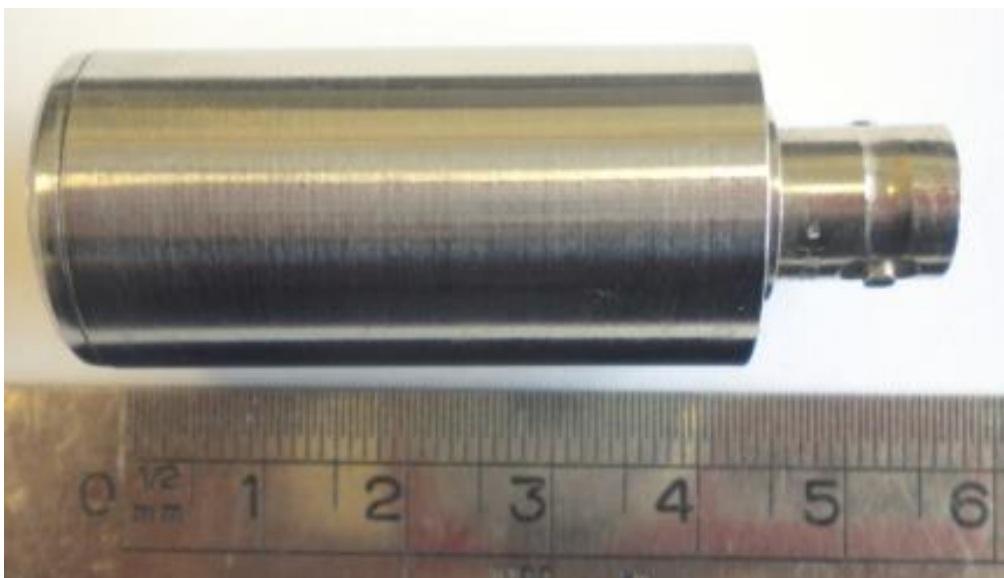
Fig. 3 CASBA sensor

- 1) Two CASBA sensors: one installed on the target assembly (inlet side) and another one on the inlet of the electromagnetic pump;
- 2) Two CASBA signal preamplifiers;
- 3) One power supply and signal splitter
- 4) One signal booster.

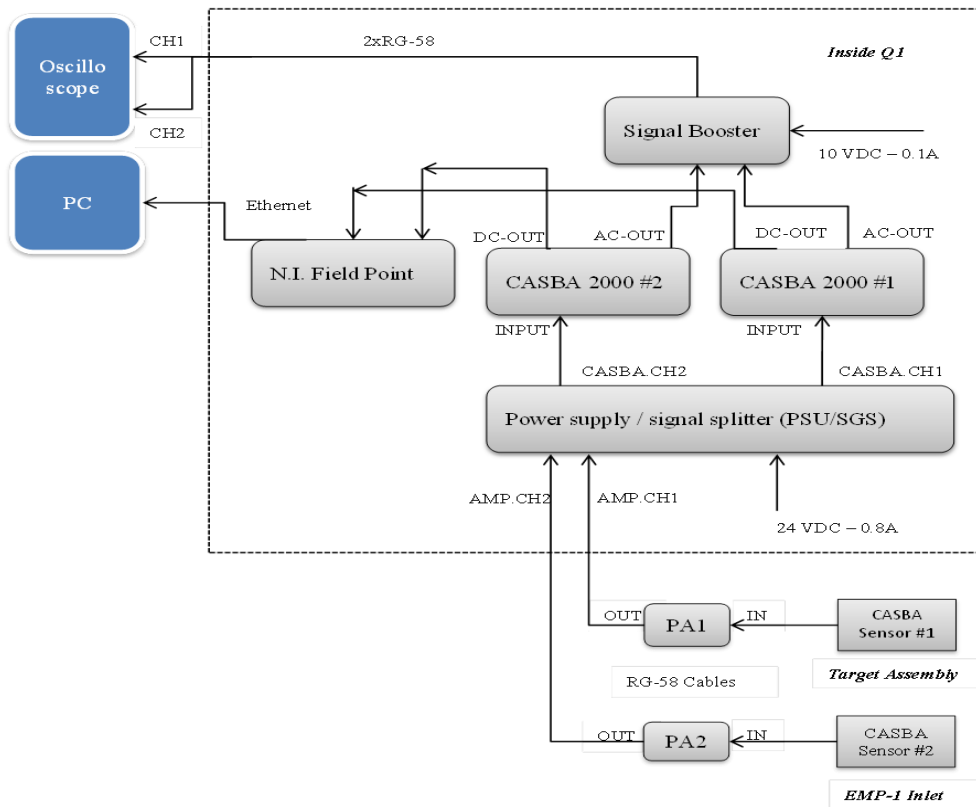
Fig. 7 Logic scheme (blocks diagram) of the measurement system for the cavitation detection

The final scheme of the implemented measurement system is shown in Fig. 7.

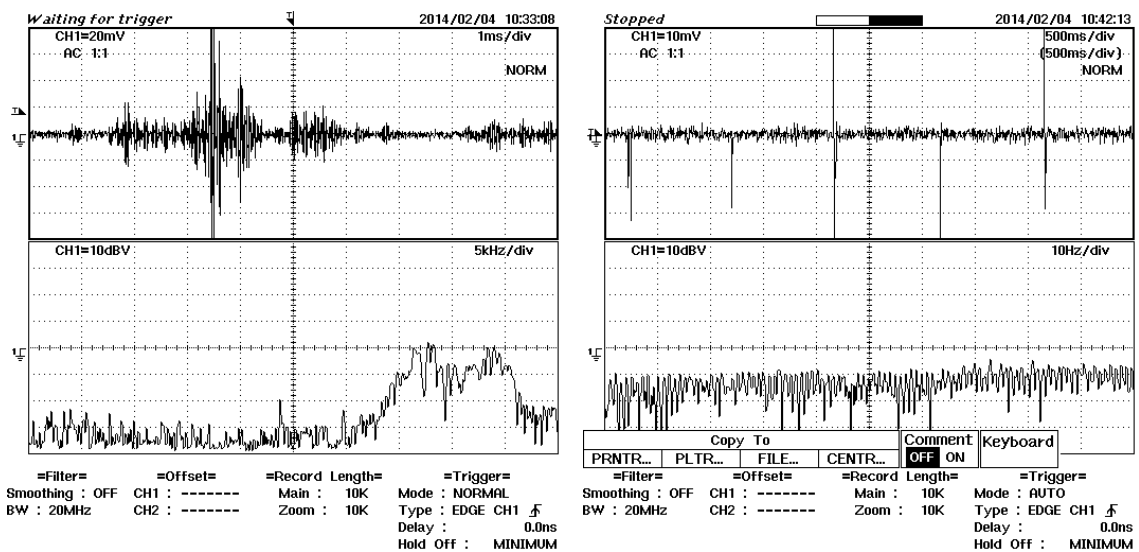
Fig. 8 Single ping / Multiple ping

The two CASBA sensors have been tested – after installation – using external mechanical excitation produced hammering on the transmission bar. In fig. 8 the signals coming from the CASBA (single and multiple excitation) and displayed on the screen of the oscilloscope are shown.

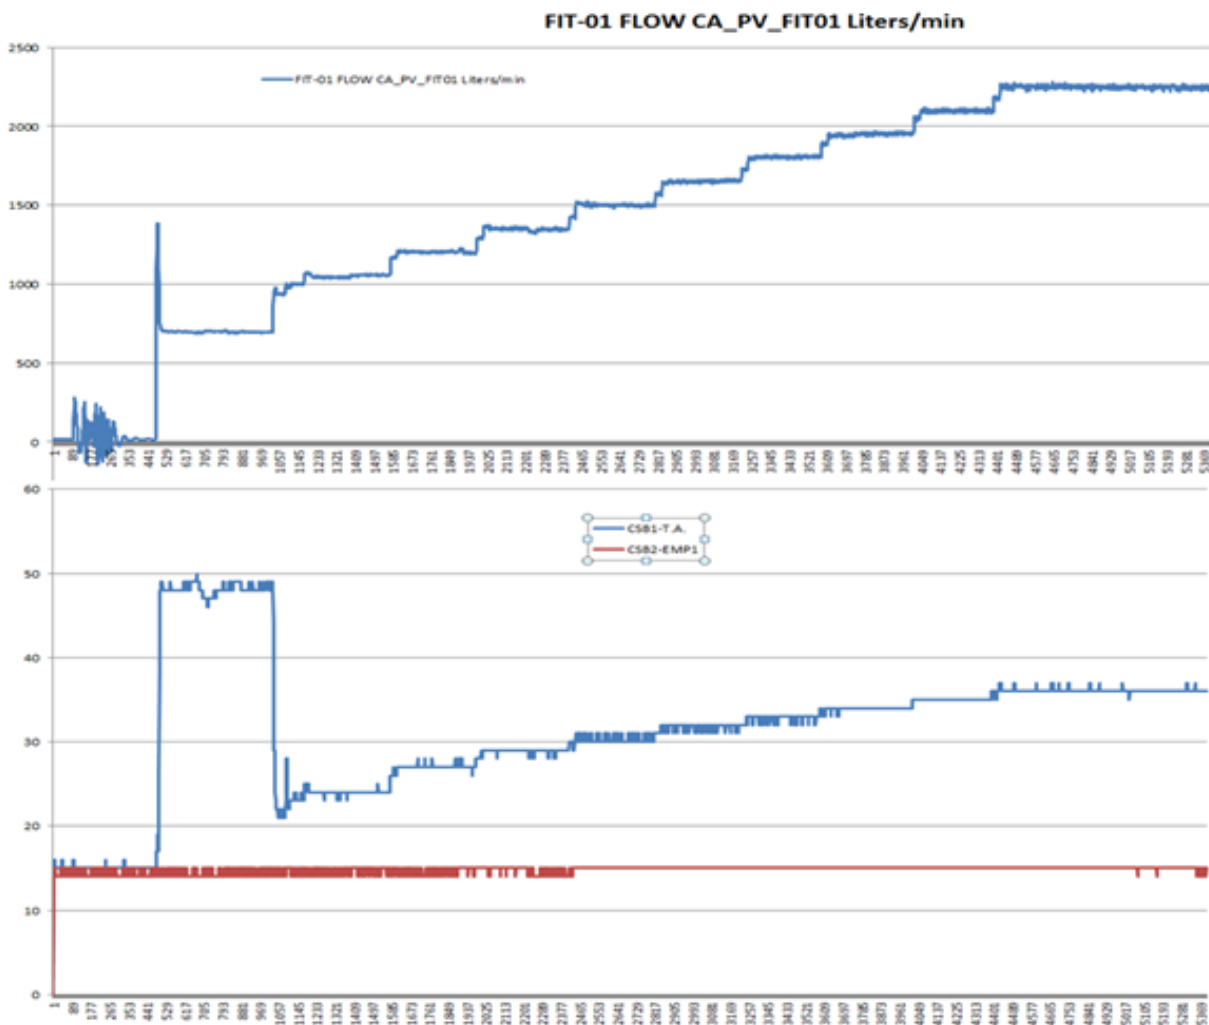
Fig. 9 Lithium flow (l/min)/ CASBA readings (db) during ramp up

The top graph in Fig. 9 shows the lithium flow (liters/minute). The FIT-01 electromagnetic flow meter is installed after the EMP-1 outlet; the reading of the flow meter is not reliable below 500 l/min. The bottom graph shows the two CASBA readings.

At low flow regime (below 750 l/min) the flow is unstable. This instability generates a lot of plant noise (CASBA#1 TA, up to 50 dB); increasing the flow, the instability disappears and the plant noise drop to normal values (between 25 and 35 dB).

CASBA#2 does not register any significant signal.

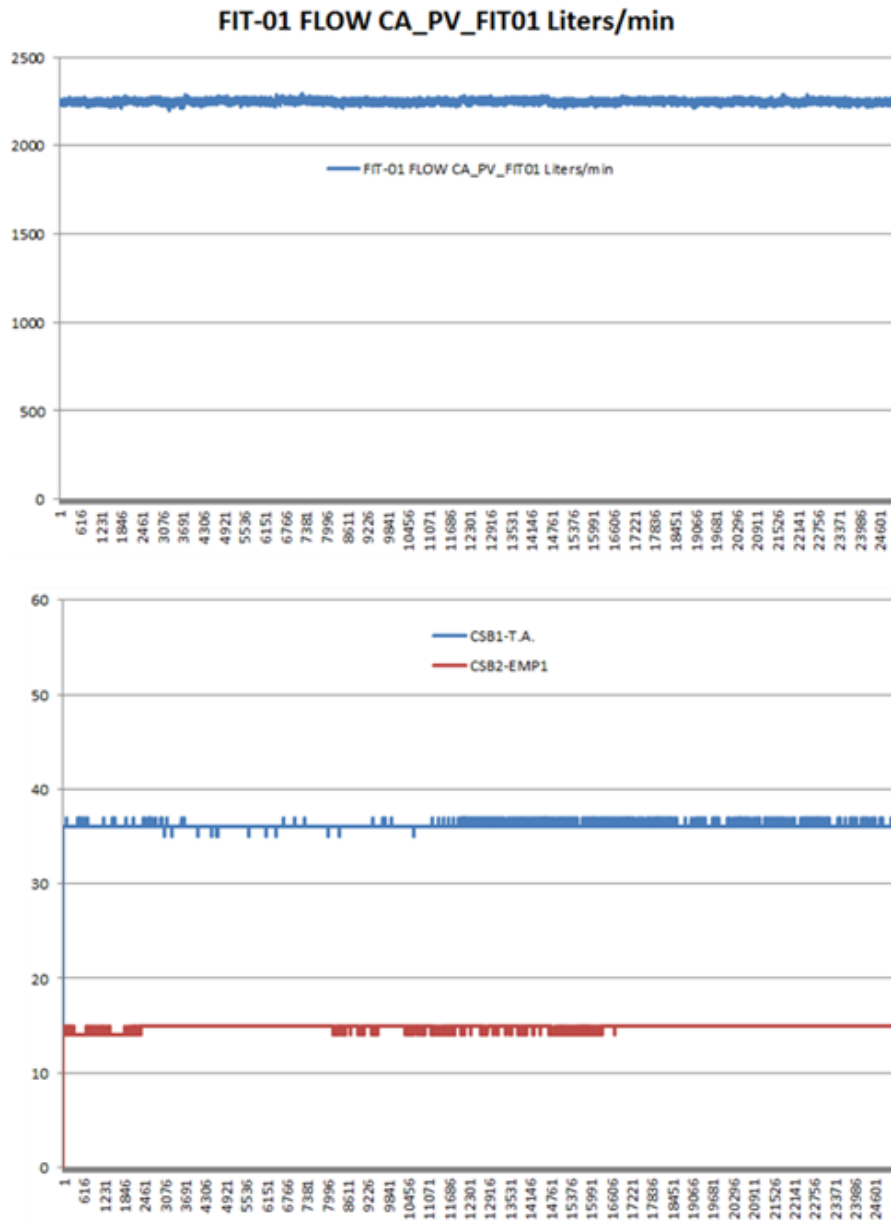
Fig. 10 Lithium flow (l/min)/ CASBA readings (db) –during steady state regime

Top graph in Fig. 10 shows the lithium flow (liters/minute). The flow is constant.

The bottom graph shows the two CASBA readings.

Both readings are constant, oscillating only few decibel and no cavitation is detected.

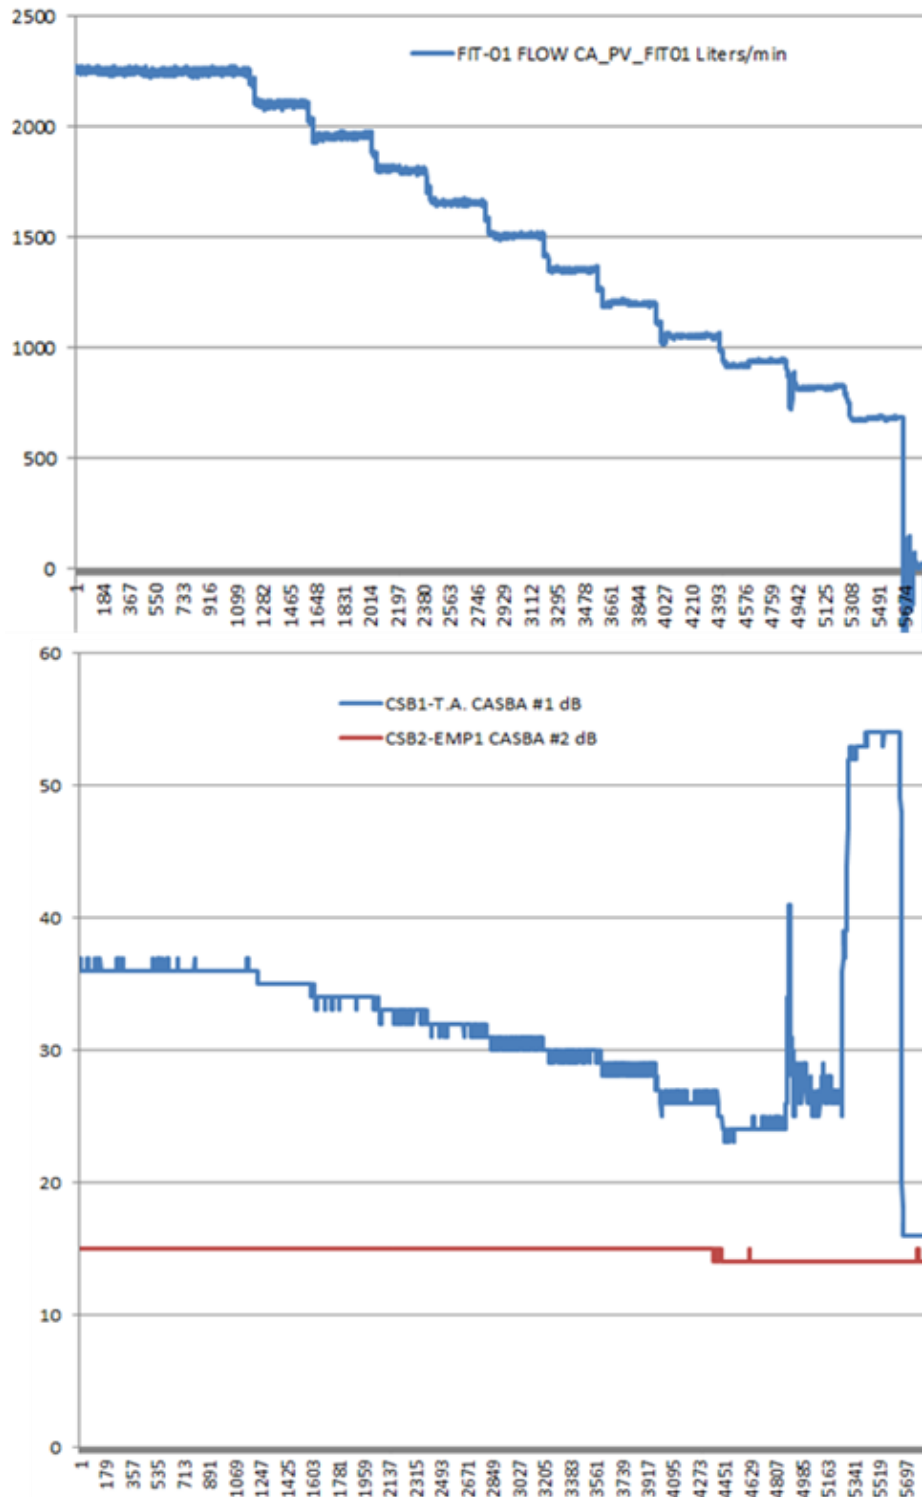
Fig. 11 Lithium flow (l/min)/ CASBA readings (db) –during ramp down

Top graph shows the lithium flow (liters/minute). The reading of the flow meter is not reliable below 500 l/min.

The bottom graph shows the readings of the two CASBA sensor.

CASBA#1(TA) shows transient and steady instabilities at low flow regimes as previously registered during the ramp-up phase while also in this case CASBA#2 (EMP-1) shows a very quiet reading, constant at all regimes and no cavitation have been detected.

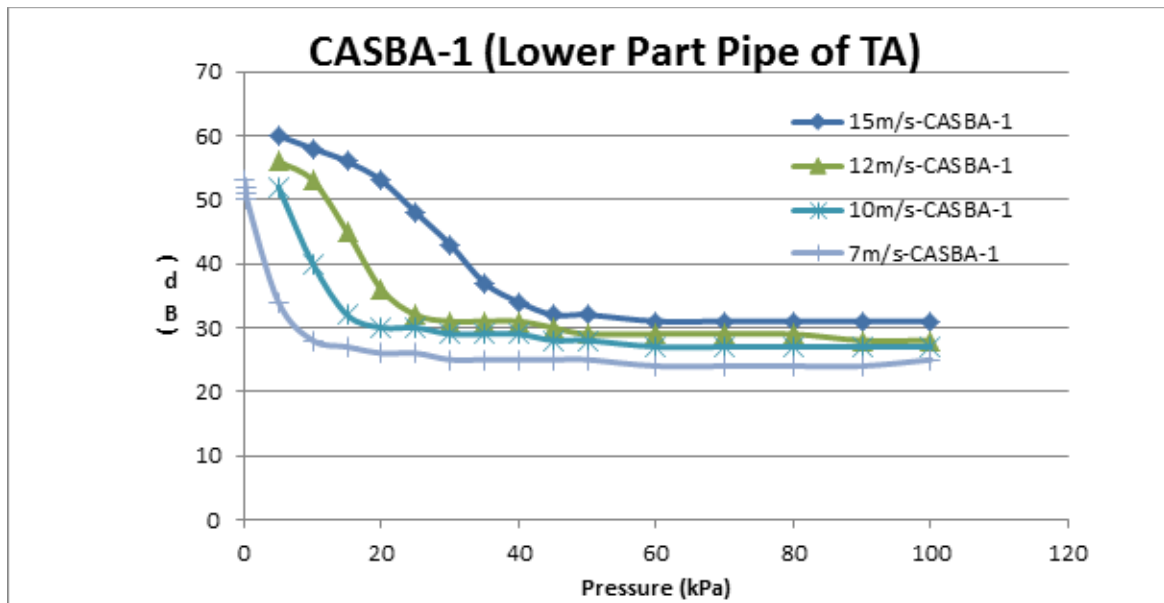
Fig. 12 Signal detected by the CASBA 1 sensor

The test procedure agreed with the personnel in charge to the ELTL loop of JAEA is in the next Tab. 2. In this table the test matrix together the preliminary results obtained are reported. In Figs. 12 and 13 graphs of the data obtained for the CASBA on the inlet and outlet channels of the TA are shown. The first conclusion that could be said is that almost the results obtained in the previous test campaign in the inlet of the TA (nozzle) are confirmed: no cavitation occurred.

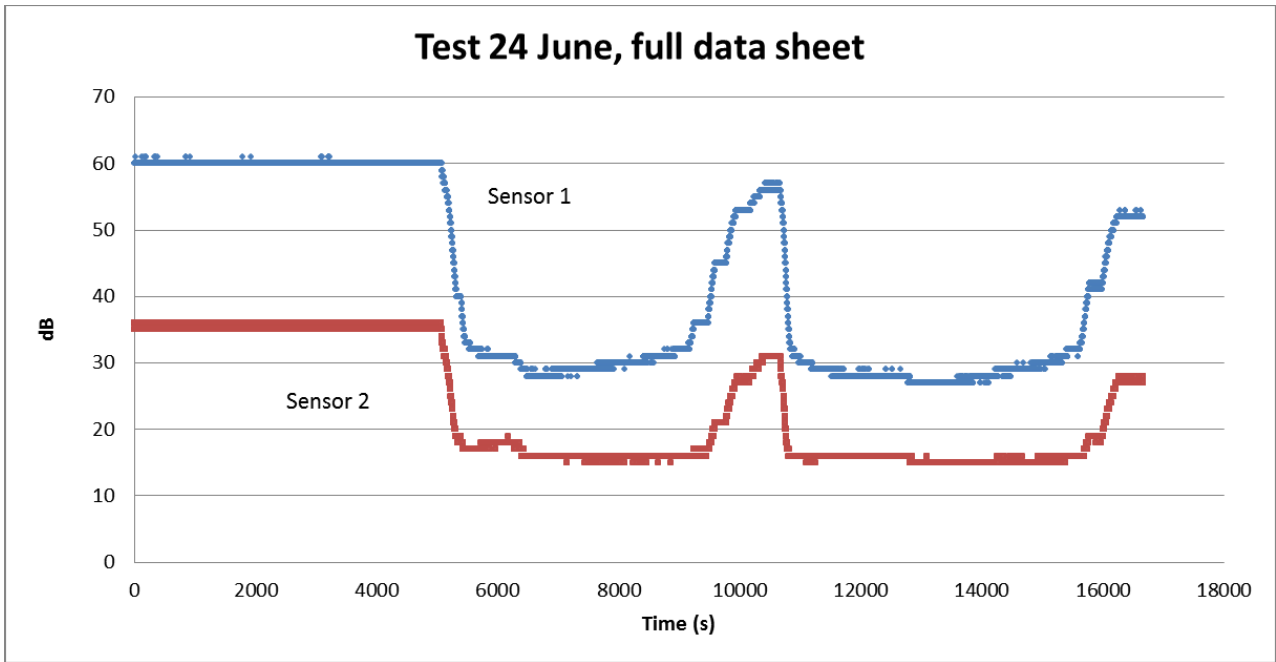
Figure 14: Full data sheet of the experiment

In the figures 14 and 15 the full data set is presented.

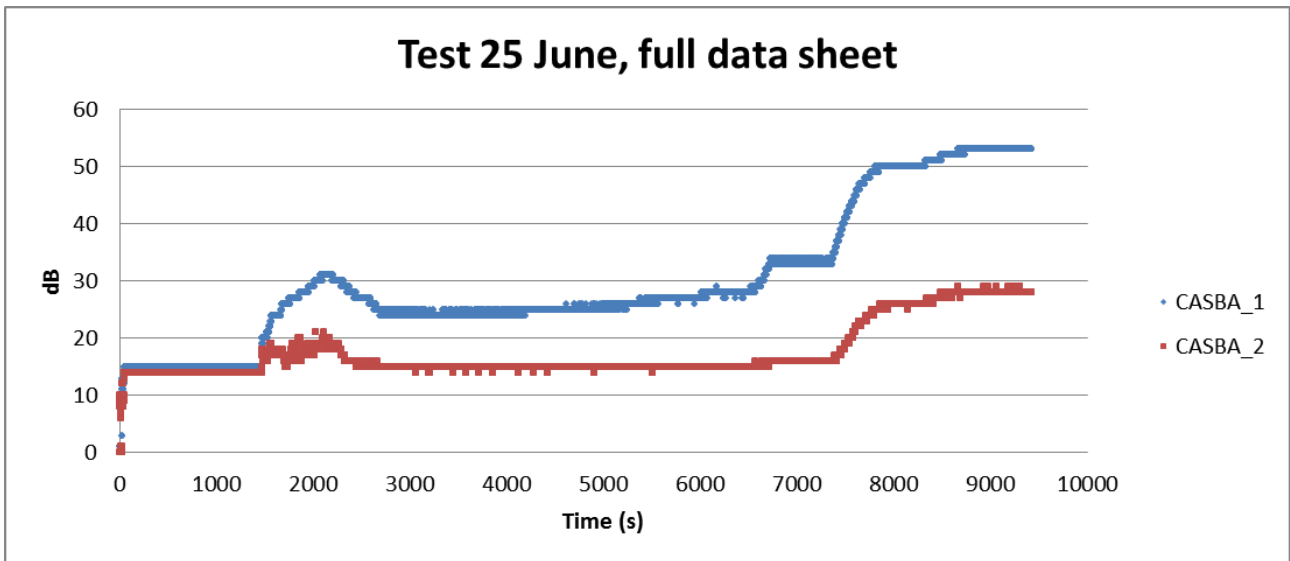
Figure 15: Full data sheet of the experiment

Comparing the operational data in tab. 3 with the curve in fig. 15, while the difference between sensors signal is more or less constant, even at 7m/s, decreasing the pressure below 10000 Pa this difference sudden increases. It should be said that this 'divergence' of sensor 2 is due to cavitation. Also in this case the operational conditions in which this phenomenon occurs are very far from the usual operational parameters of the loop.
