Risultati relativi alle campagne sperimentali di breve e medio termine sui fenomeni di erosione/corrosione da litio liquido fluente nell'impianto Lifus 6

P.Favuzza, M.Cuzzani, G. Fasano

Settembre 2016

Progetto: B.3.2 – Attività di Fisica della Fusione Complementari a ITER

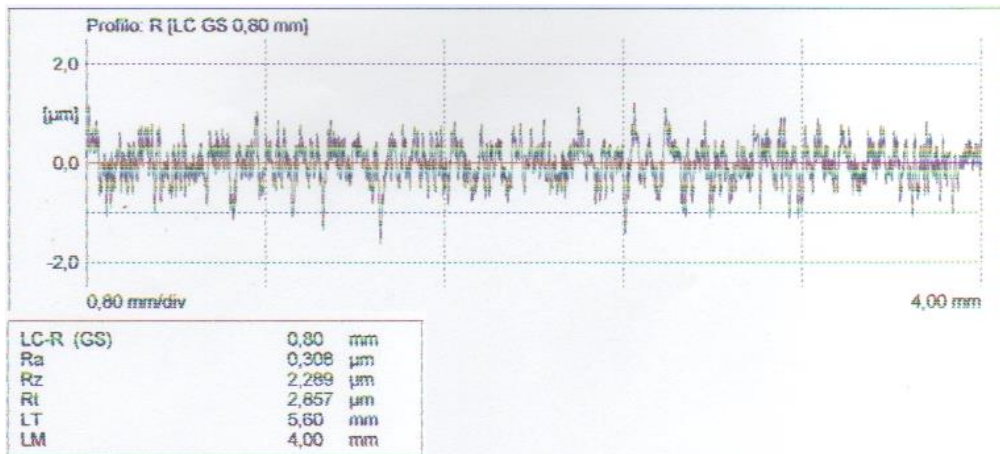
Figure 3: roughness profile of the external surface of a representative Eurofer 97 specimen. It complies with value in Table 1

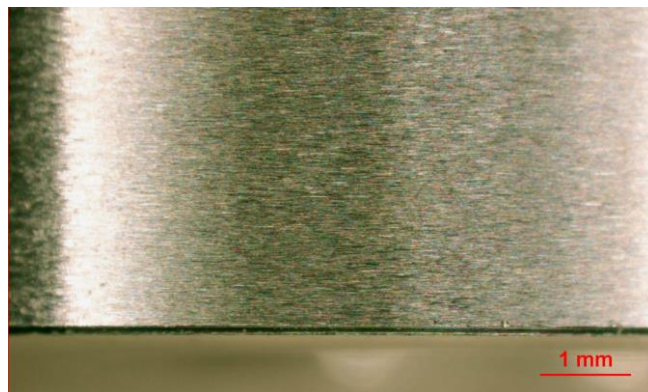
Figure 4: stereoscope image of a representative Eurofer 97 specimen: curved external surface, viewed from the top. The surface is in good shape.

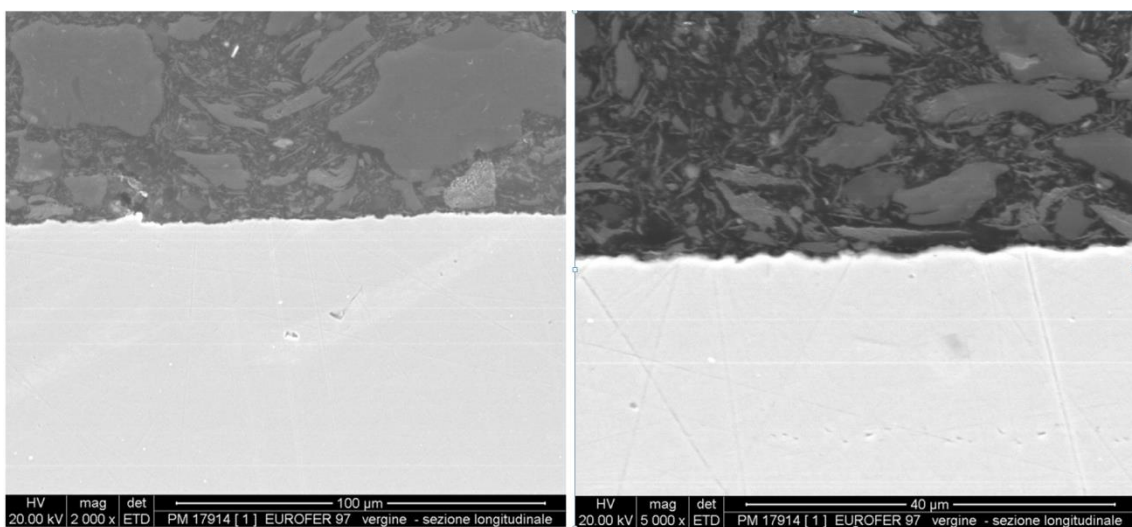
Figure 5: SEM images (secondary electrons) of a representative Eurofer 97 specimen: longitudinal sections. The surface is in good shape (dark region in the top half is due to graphite, where the specimen is mounted in).

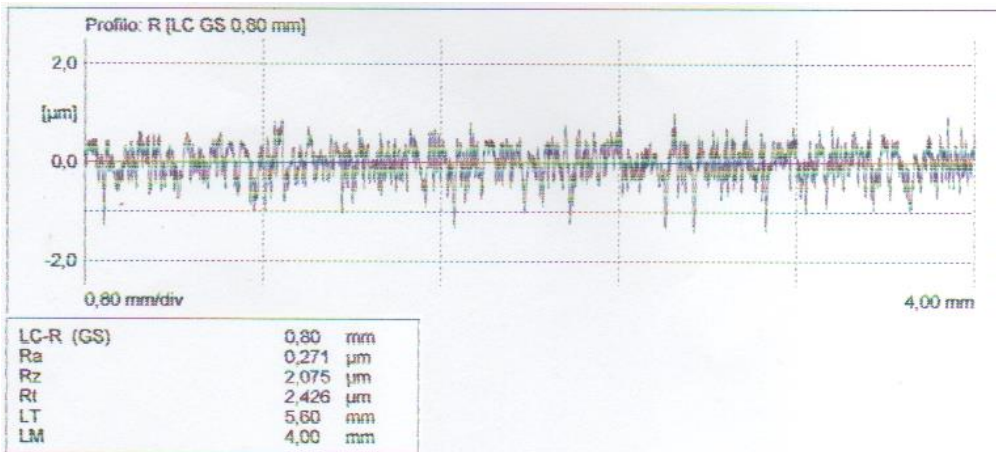
Figure 6: roughness profile of the external surface of a representative F82H specimen. It complies with the value in Table 1

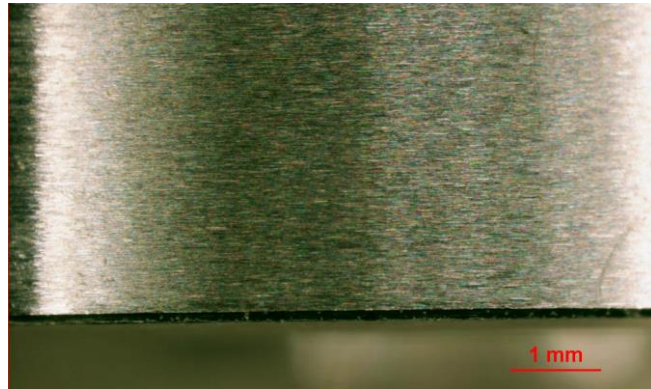
Figure 7: stereoscope image of a representative F82H specimen: curved external surface, viewed from the top. The surface is in good shape.

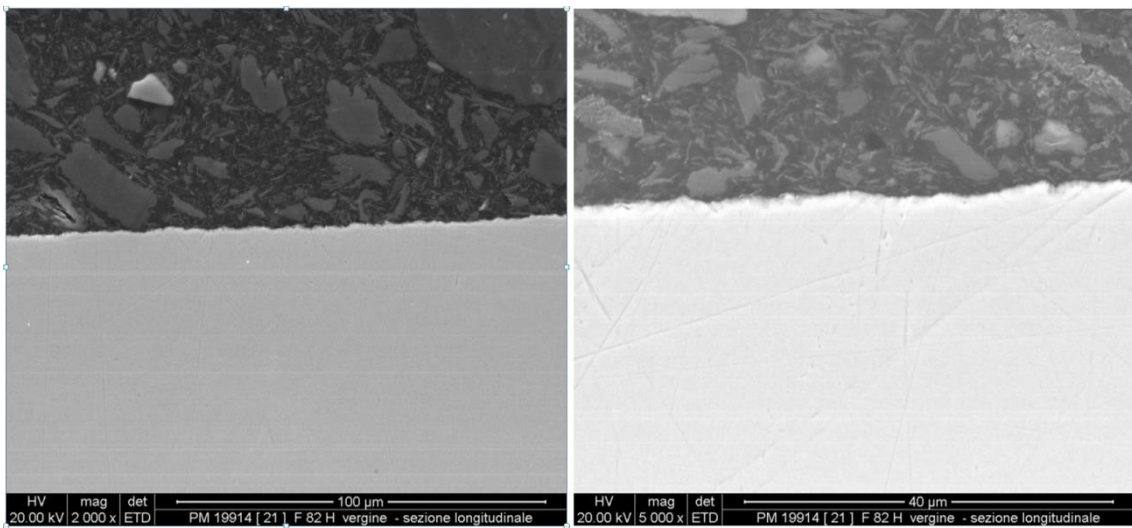
Figure 8: SEM images (secondary electrons) of a representative Eurofer 97 specimen: longitudinal sections. The surface is in good shape (dark region in the top half is due to graphite, where the specimen is mounted in).

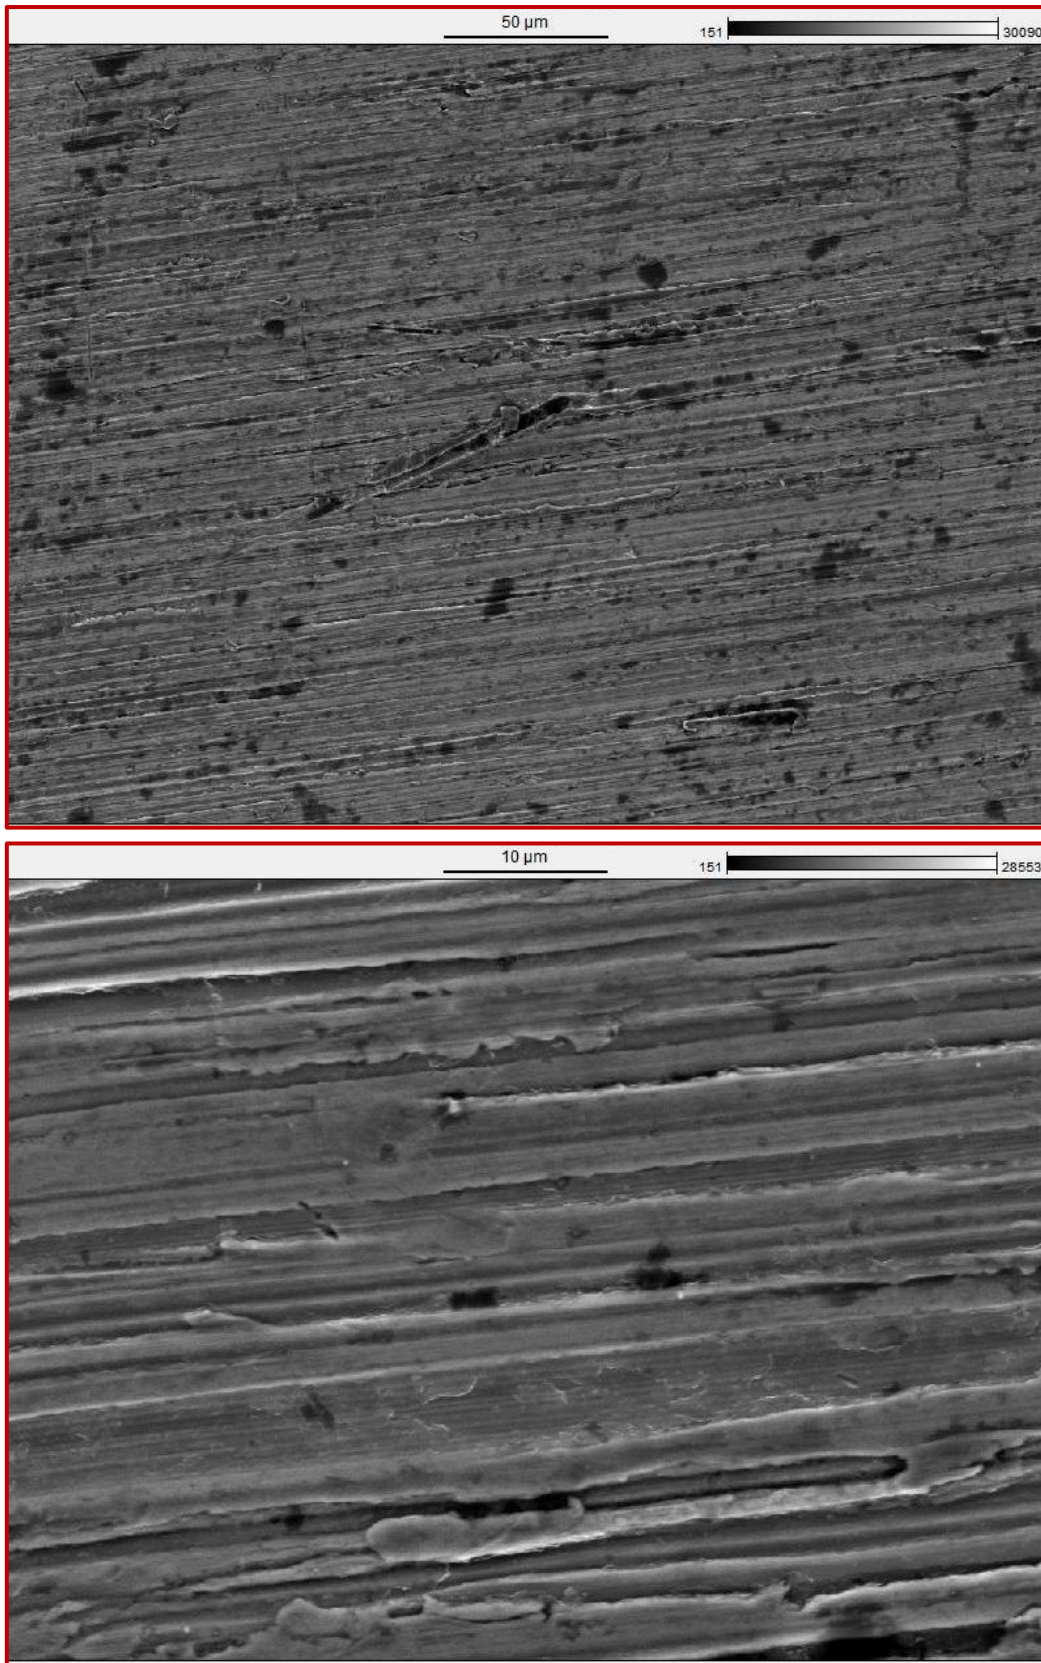
Figure 13: SEM images of specimen n°10 surface (secondary electrons) at different magnitudes. Scale bar above the image.

Figure 13 shows, at different magnitudes (400x and 2000x), the surface of a representative region of this specimen: the scrapes of the mechanical manufacturing are clearly visible.

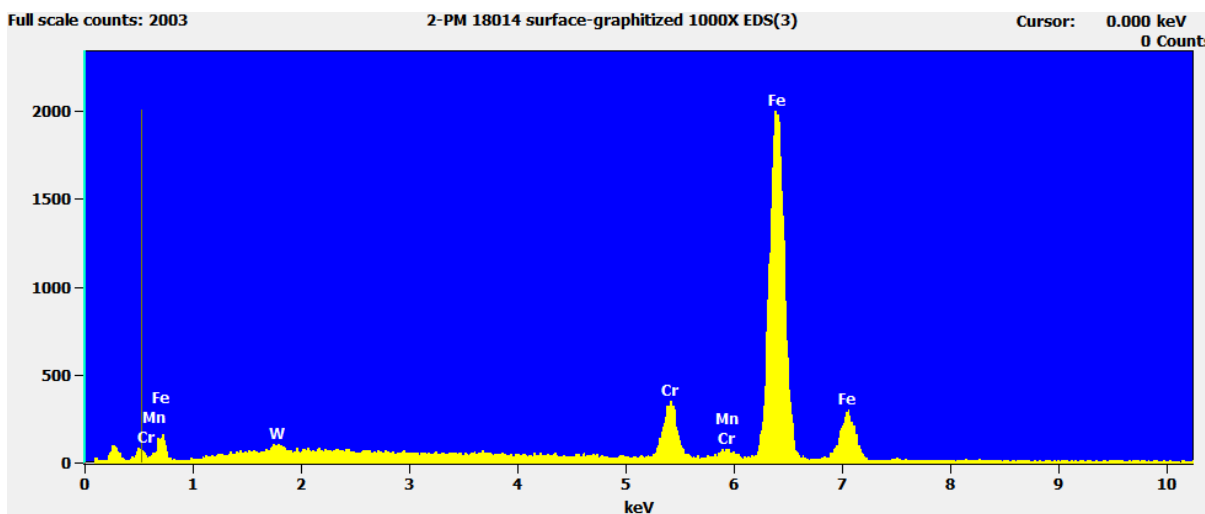
Figure 16: EDS spectrum obtained at specimen n°2 surface

Figure 16 reports instead the EDS spectrum of specimen n° 2 surface; Table 7 summarizes the values of the related semiquantitative analysis (average composition of the investigated area). A small reduction of Cr and W, respect to the unexposed specimen, appears.

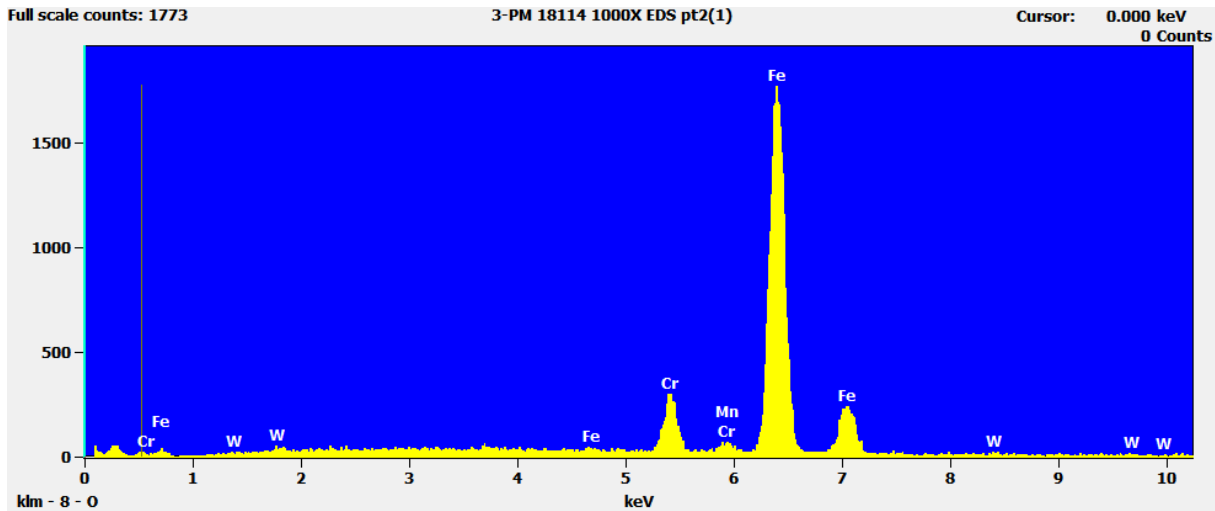
Figure 18: EDS spectrum obtained at specimen n°3 surface

Figure 18 reports instead the EDS spectrum of specimen n° 3 surface; Table 8 summarizes the values of the related semiquantitative analysis (average composition of the investigated area). A small decrease of Cr concentration, respect to the unexposed specimen, is visible again.

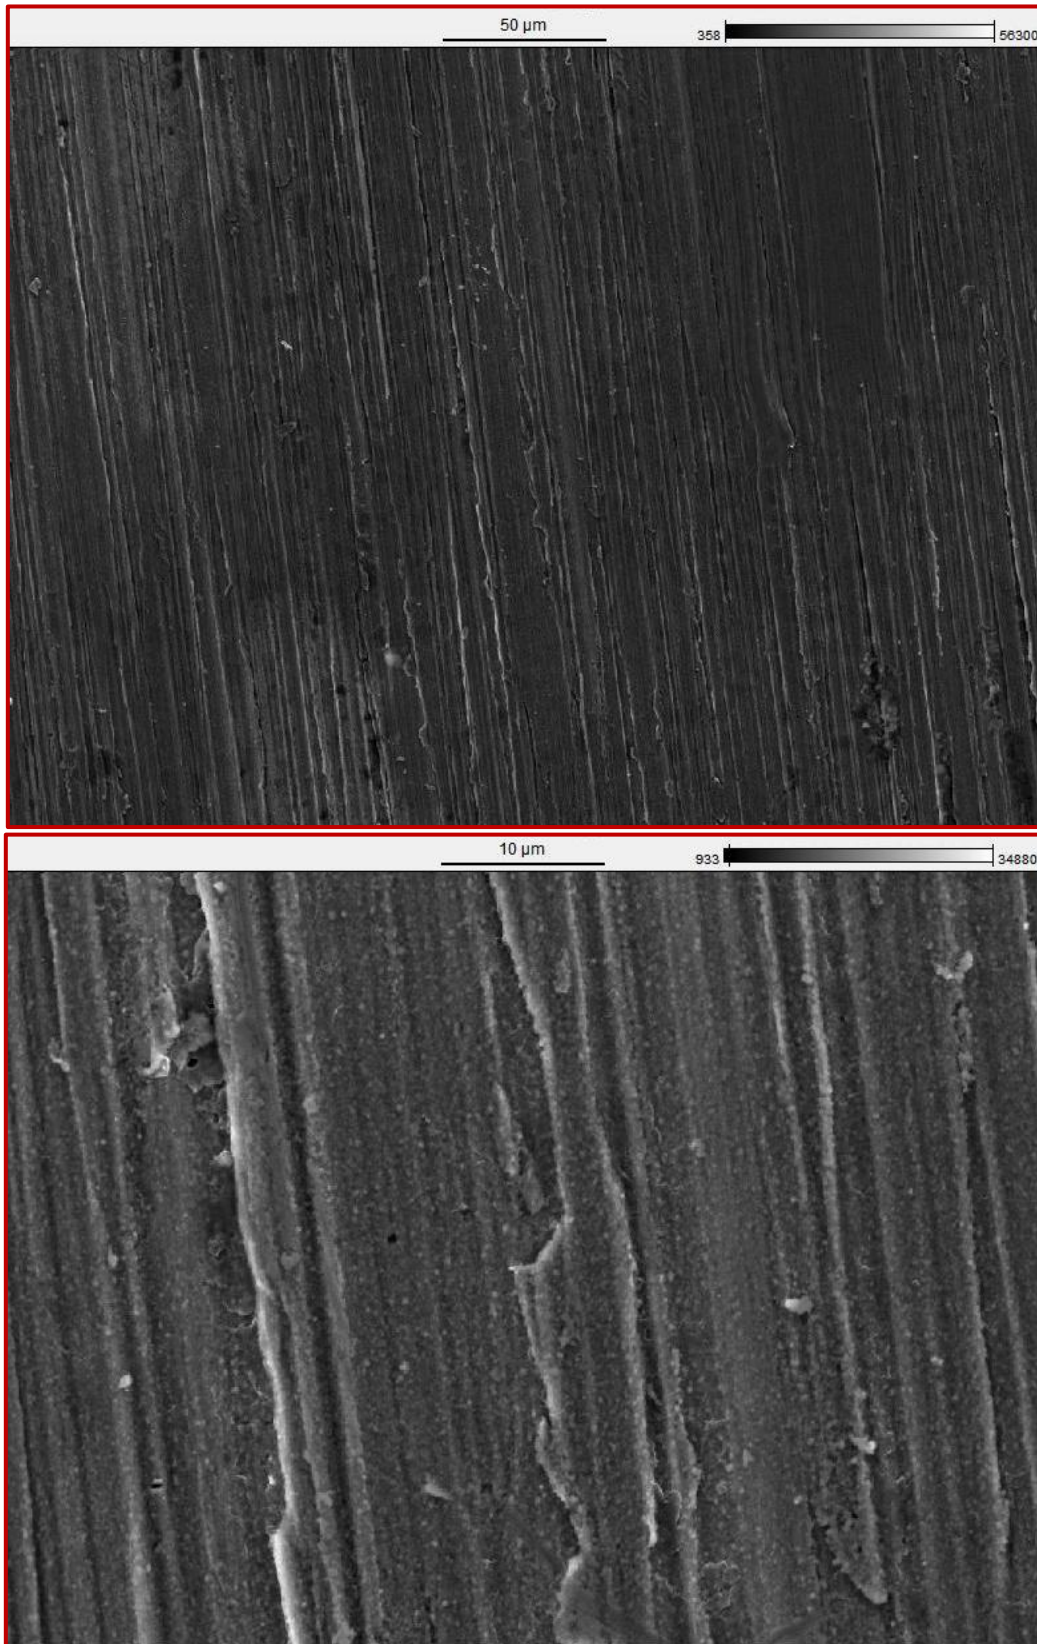
Figure 19: SEM images of specimen n°4 surface (secondary electrons) at different magnitudes. Scale bar above the image.

The same considerations made for specimen n°2 and n°3 hold also for specimen n°4.

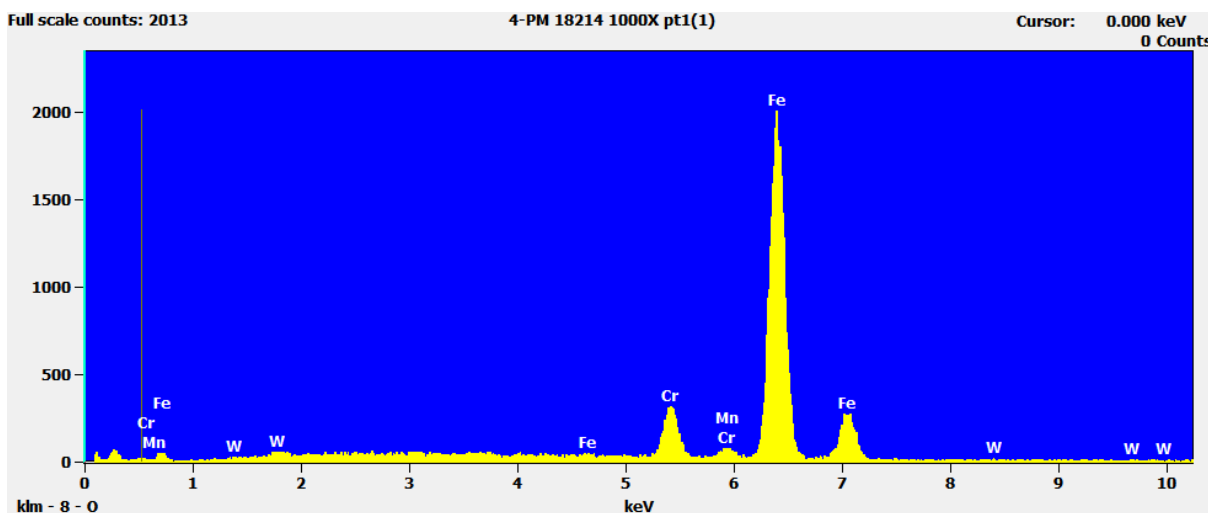
Figure 20: EDS spectrum obtained at specimen n°4 surface

Figure 20 reports the EDS spectrum of specimen n° 4 surface; Table 9 summarizes the values of the related semiquantitative analysis (average composition of the investigated area). Also in this case there seems to be a minimal diminution of Cr concentration at the surface, respect to the unexposed specimen.

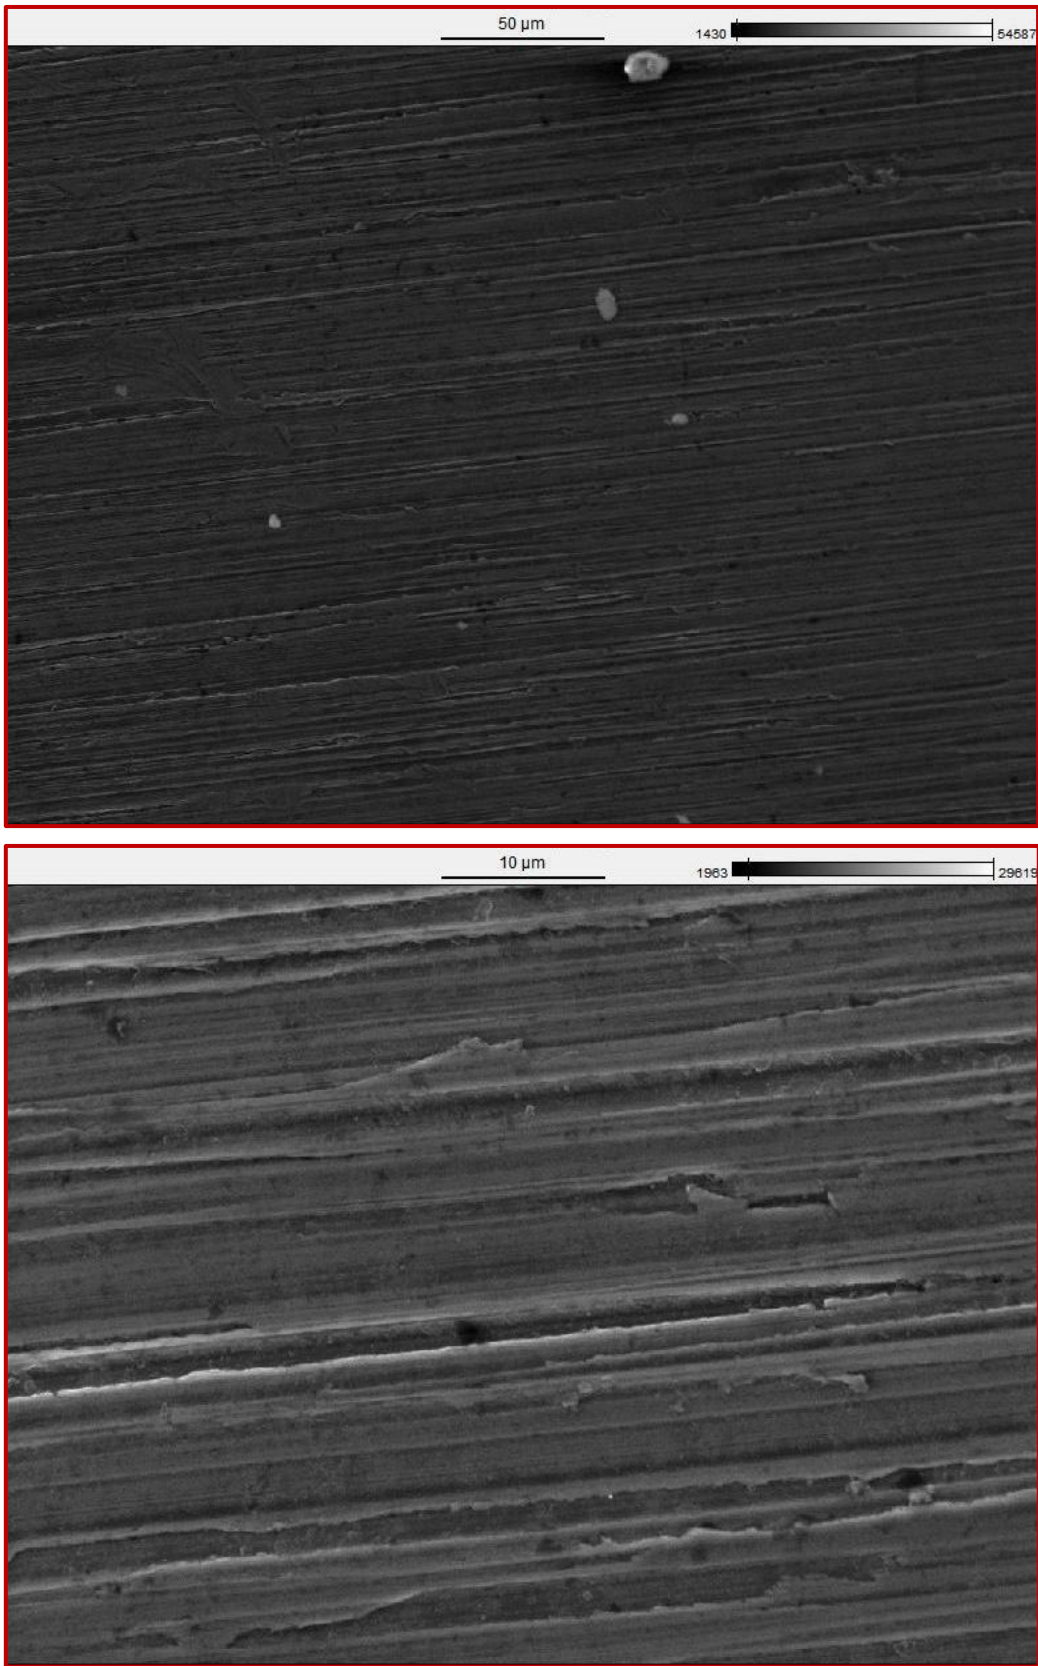
Figure 23: SEM images of specimen n° 31 surface (secondary electrons) at different magnitudes. Scale bar above the image.

Figure 23 shows, at different magnitudes, the surface of a representative region of this specimen. As already observed for the Eurofer 97 specimens, also here the sample surface is characterized by the presence of signs due to the mechanical manufacturing, while surface alterations due to erosion-corrosion by Lithium are (of course) absent.

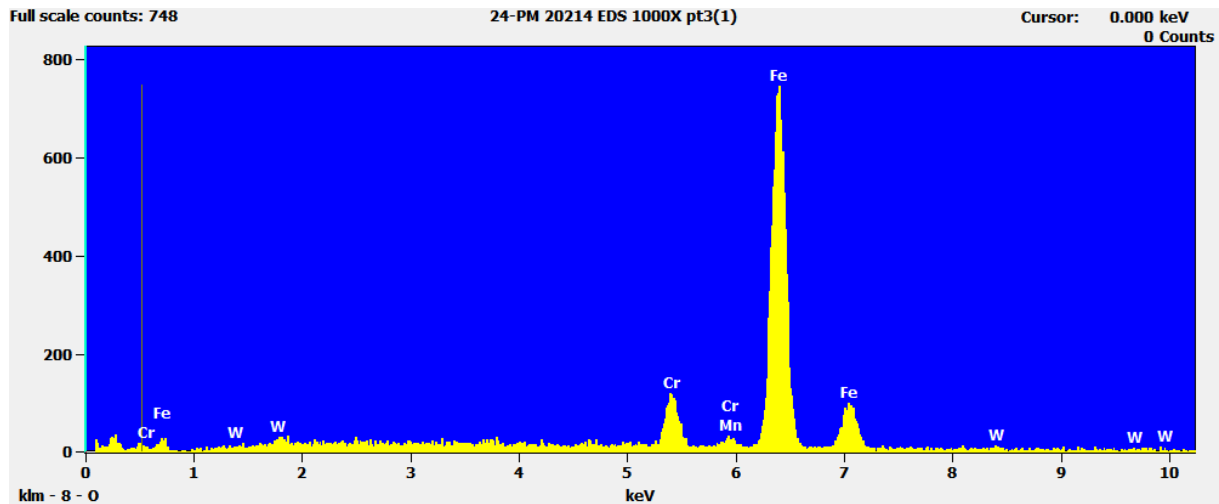
Figure 30: EDS spectrum obtained at specimen n°24 surface

Comparing the above values with the ones in Table 11, a small decrease of Cr concentration can be noted.

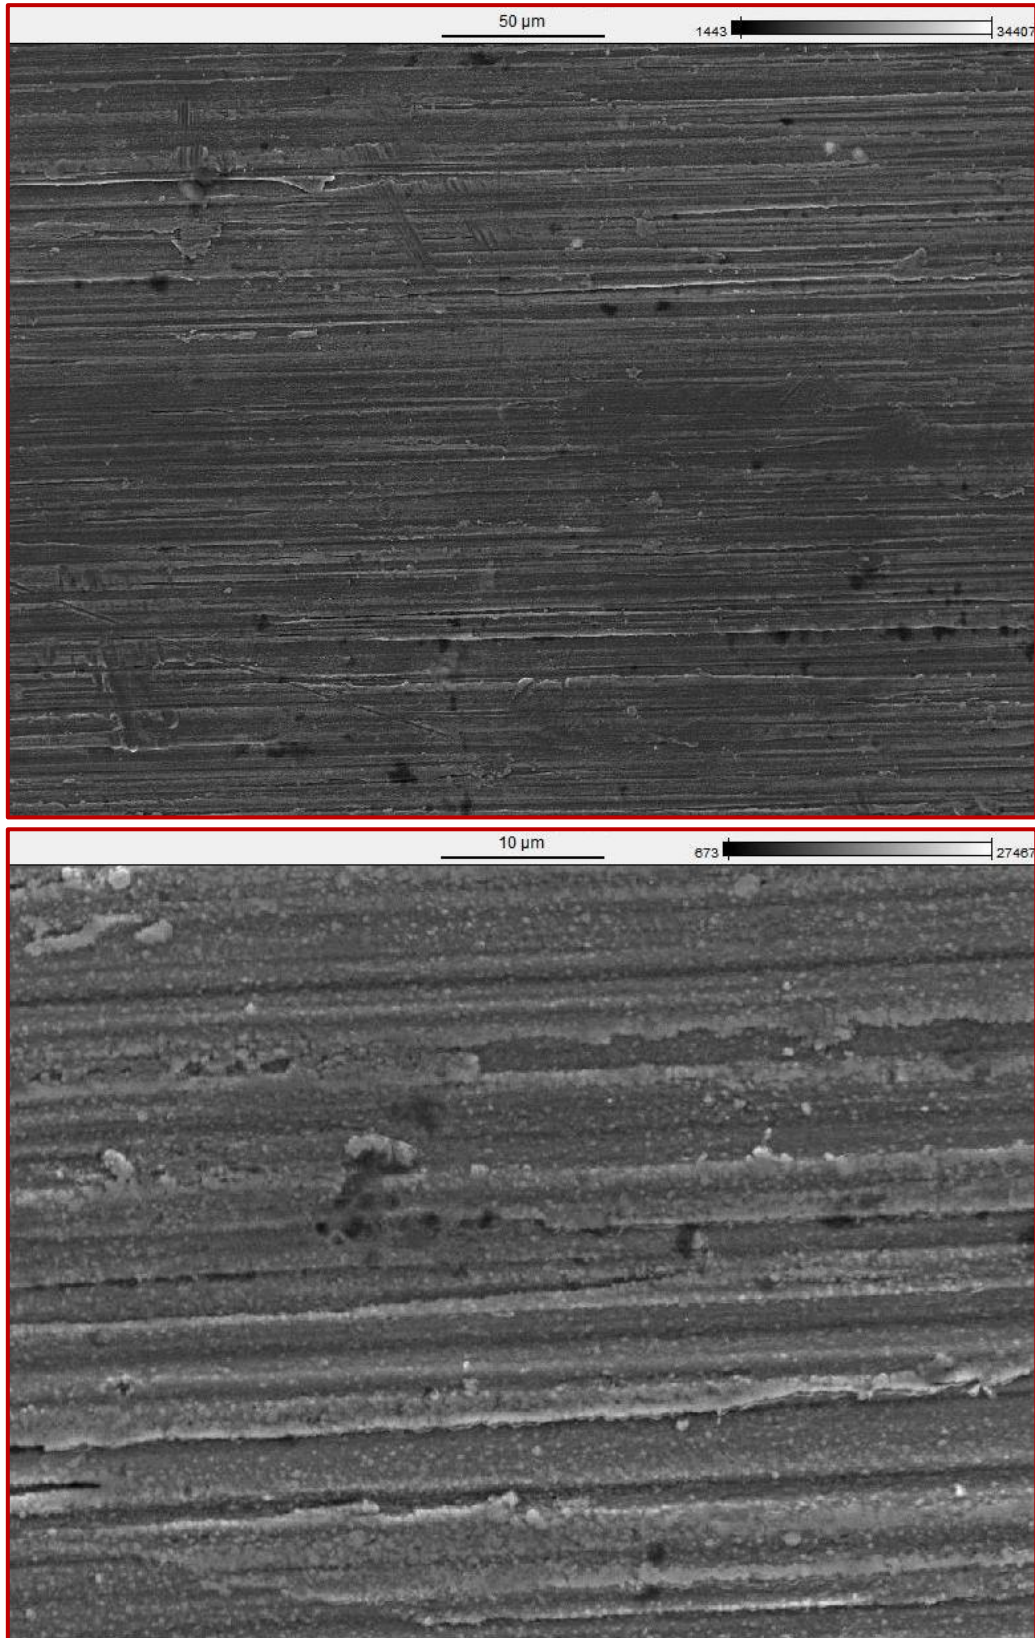
Figure 31: SEM images of specimen n° 25 surface (secondary electrons) at different magnitudes. Scale bar above the image.

Figure 31 shows, at different magnitudes, the surface of specimen n°25. No substantial alteration of the morphology appears respect to the unexposed specimen (n°31).

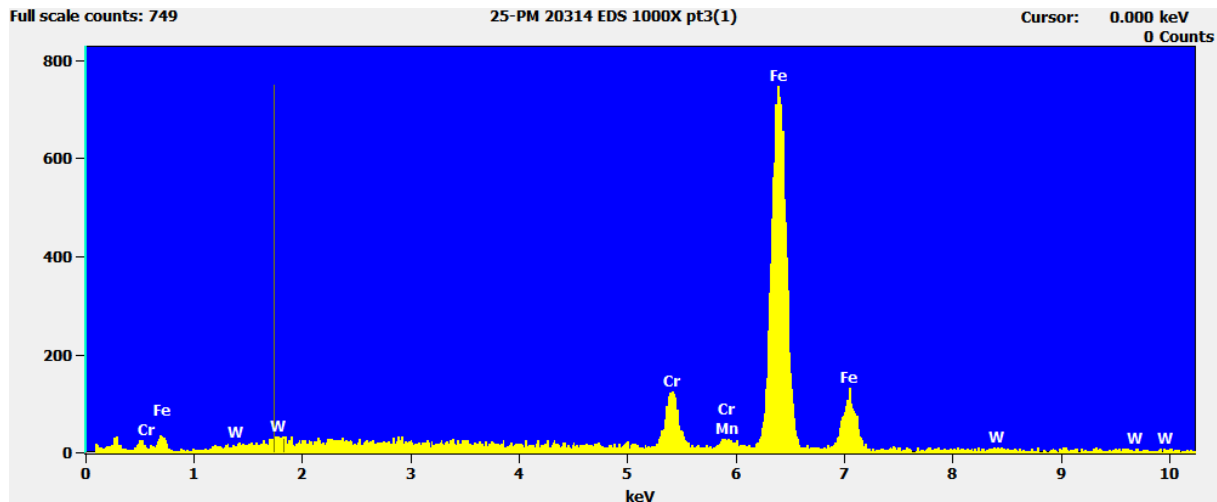
Figure 32: EDS spectrum obtained at specimen n°25 surface

Comparing the above values with the ones in Table 11, a small decrease of Cr and W concentration can be noted.

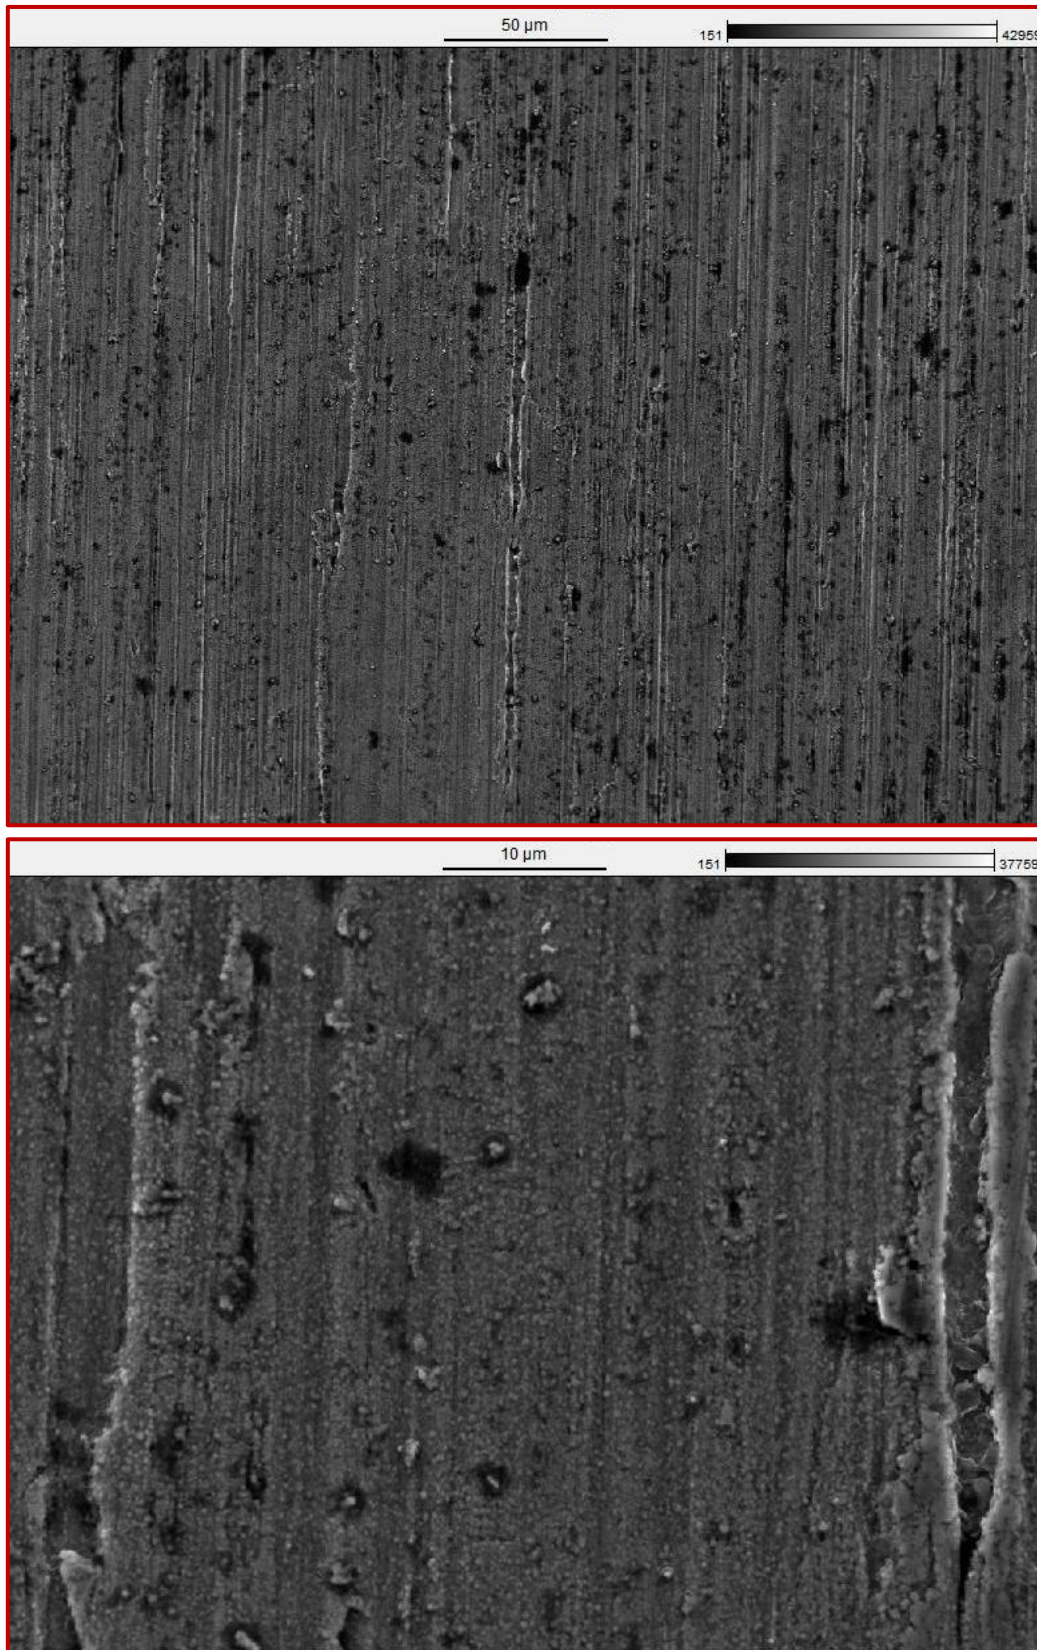
Figure 33: SEM images of specimen n° 26 surface (secondary electrons) at different magnitudes. Scale bar above the image.

Looking at Figure 33, we don't note morphological alterations of the surface respect to the unexposed one (specimen n°31). Anyway, many small black spots can be seen. In order to better investigate the nature of this black spots, two additional EDS spectrum were performed, the first investigating the position indicated by '1' (dark region) in Figure 35 (higher magnitude image of surface specimen), the second investigating the position indicated by '2' (surface matrix), to compare the concentrations of the elements in the two different locations.

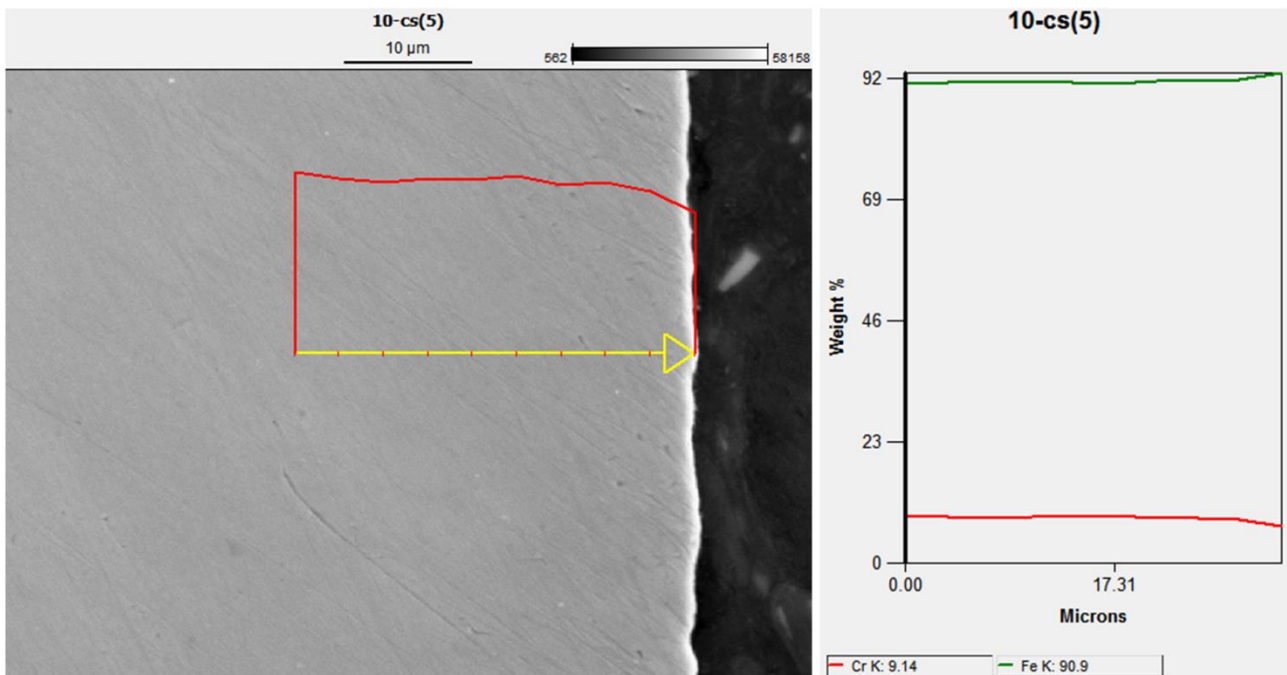
Figure 37: left: SEM image and Cr concentration profile (EDS) of specimen n°10 cross section; right: Cr (red) and Fe (green) concentration profiles along the specimen section.

From the observation of the Figure, it is possible to note that the internal specimen structure is in good condition, with only some sign due to the cut and preparation of the sample, but no erosion-corrosion damage: this is of course what expected, since specimen n° 10 is an unexposed specimen. The concentration profiles indicate a substantial constancy of values, with perhaps only a minimal decrease of Cr concentration in the first microns below the surface.

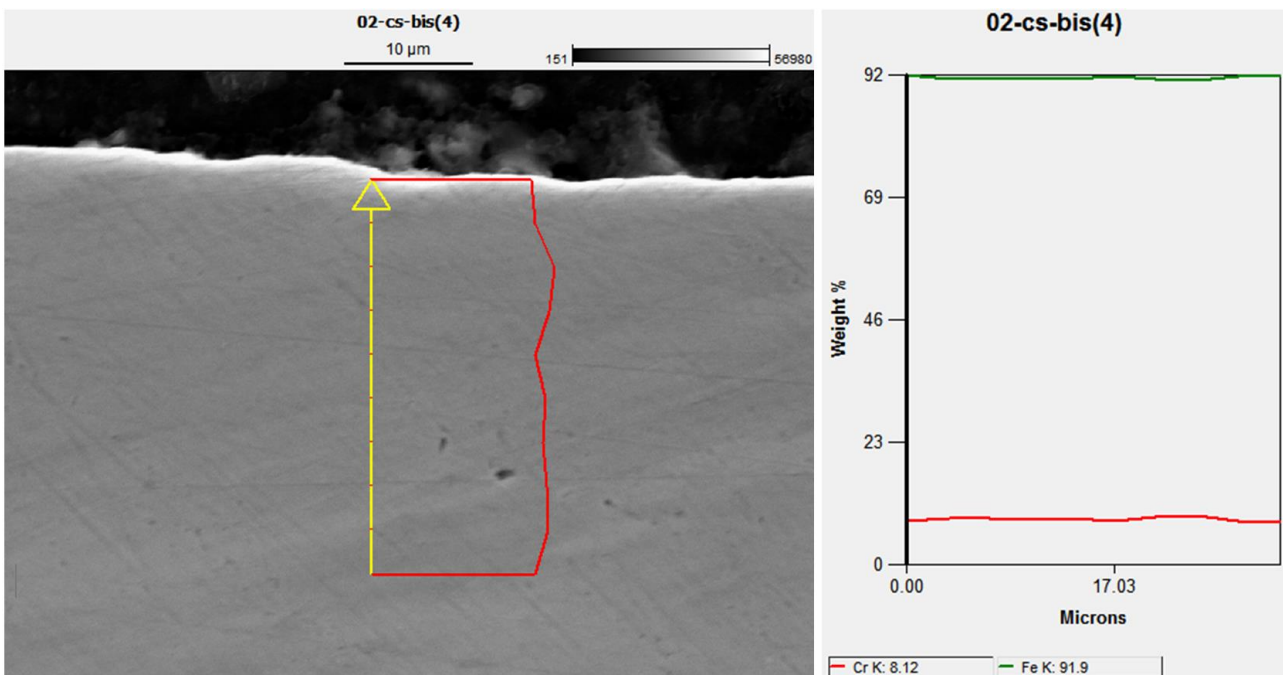
Let's consider now the Eurofer 97 specimens tested in Lifus 6 plant. Figure 38 shows on the left a SEM representative image of specimen n° 2 section, with the red Chromium concentration profile overlapped, as determined by the EDS analysis; on the right side is instead reported a graph showing the profiles of both Chromium and Iron elements. The graph meaning and details are the same already described for Figure 37. A part from the signs due to the cut and preparation of the sample, no erosion-corrosion damage is shown by the SEM image: the appearance of the specimens section is quite similar to the one in Figure 37. For what concerns the concentration profiles, they are rather flat (small oscillations can be related to uncertainty in the EDS analysis result), even if in the case of Cr the concentration values seem to be slightly smaller than in specimen n° 10.

Figure 38: left: SEM image and Cr concentration profile (EDS) of specimen n°2 cross section; right: Cr (red) and Fe (green) concentration profiles along the specimen section.

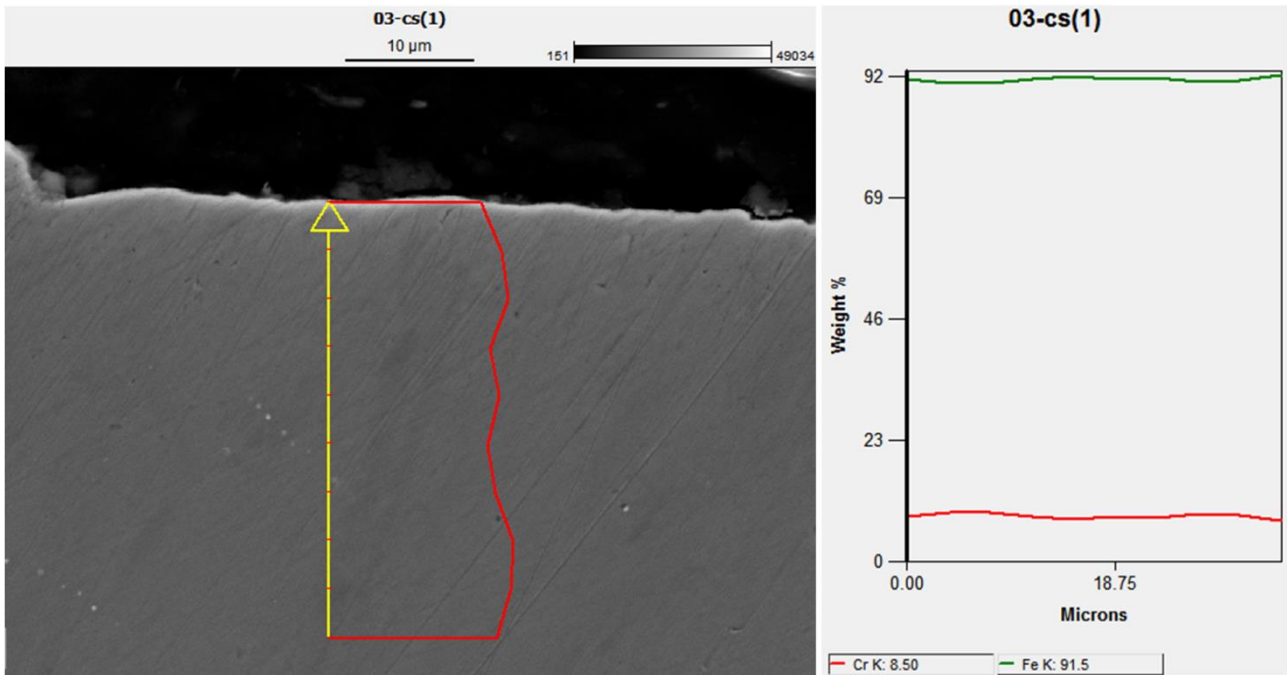
Figure 39 shows on the left a SEM representative image of specimen n° 3 section, with the red Chromium concentration profile overlapped, as determined by the EDS analysis; on the right side is instead reported a graph showing the profiles of both Chromium and Iron elements. The graph meaning and details are the same already described for Figure 37. No internal morphological damage is evident; the concentration profiles are rather flat, a part from some small oscillations due to the uncertainty in the EDS analysis result.

Figure 39: left: SEM image and Cr concentration profile (EDS) of specimen n°3 cross section; right: Cr (red) and Fe (green) concentration profiles along the specimen section.

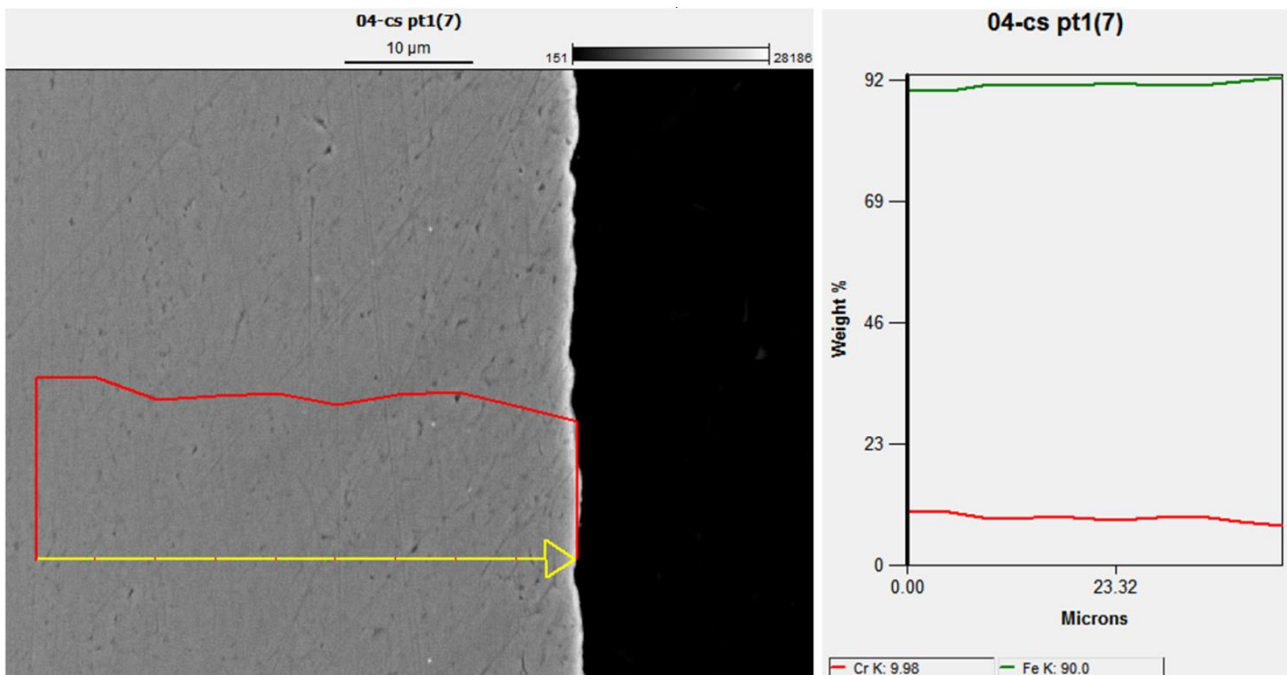
Figure 40 shows on the left a SEM representative image of specimen n° 4 section, with the red Chromium concentration profile overlapped, as determined by the EDS analysis; on the right side is instead reported a graph showing the profiles of both Chromium and Iron elements. The graph meaning and details are the same already described for Figure 37. No internal morphological damage is evident; the concentration profiles are rather flat, with perhaps a minimal Cr concentration decrease in the first microns below the surface; small fluctuations are anyway due to the uncertainty in the EDS analysis result.

Figure 40: left: SEM image and Cr concentration profile (EDS) of specimen n°4 cross section; right: Cr (red) and Fe (green) concentration profiles along the specimen section.

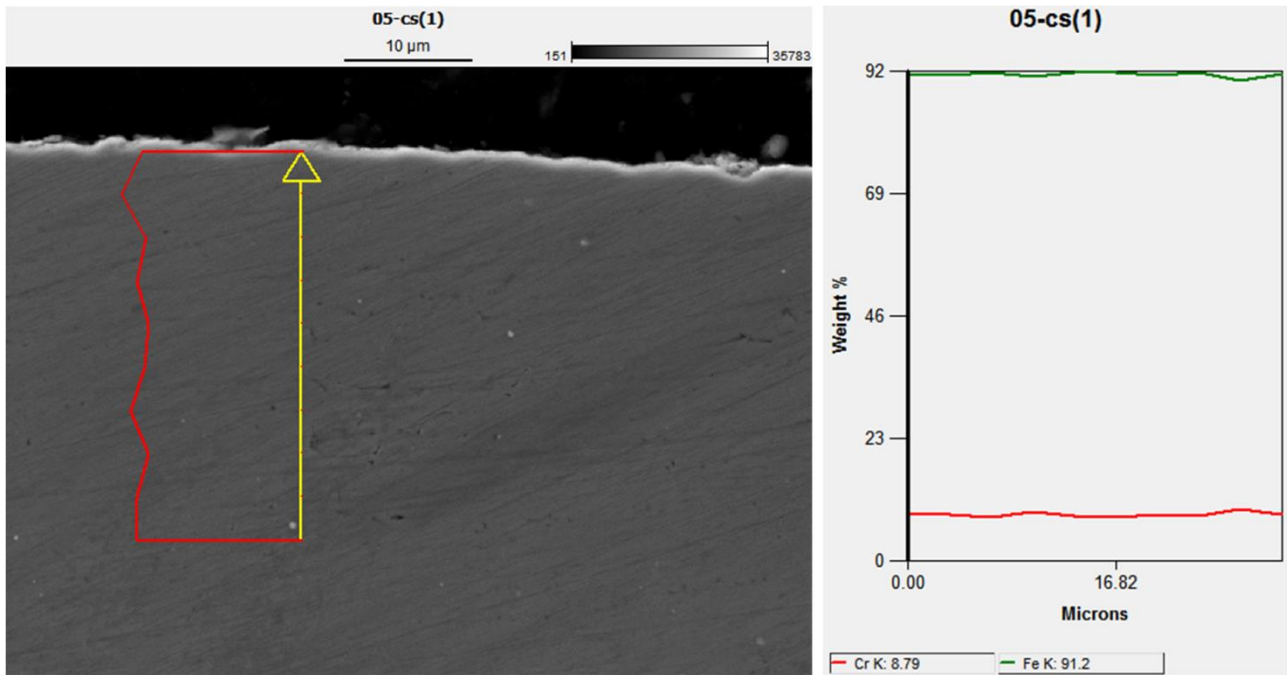
Finally, Figure 41 shows on the left a SEM representative image of specimen n° 5 section, with the red Chromium concentration profile overlapped, as determined by the EDS analysis; on the right side is instead reported a graph showing the profiles of both Chromium and Iron elements. The graph meaning and details are the same already described for Figure 37. No internal morphological damage is evident; the concentration profiles are rather flat, with small fluctuations due to the uncertainty in the EDS analysis result.

Figure 41: left: SEM image and Cr concentration profile (EDS) of specimen n°5 cross section; right: Cr (red) and Fe (green) concentration profiles along the specimen section.

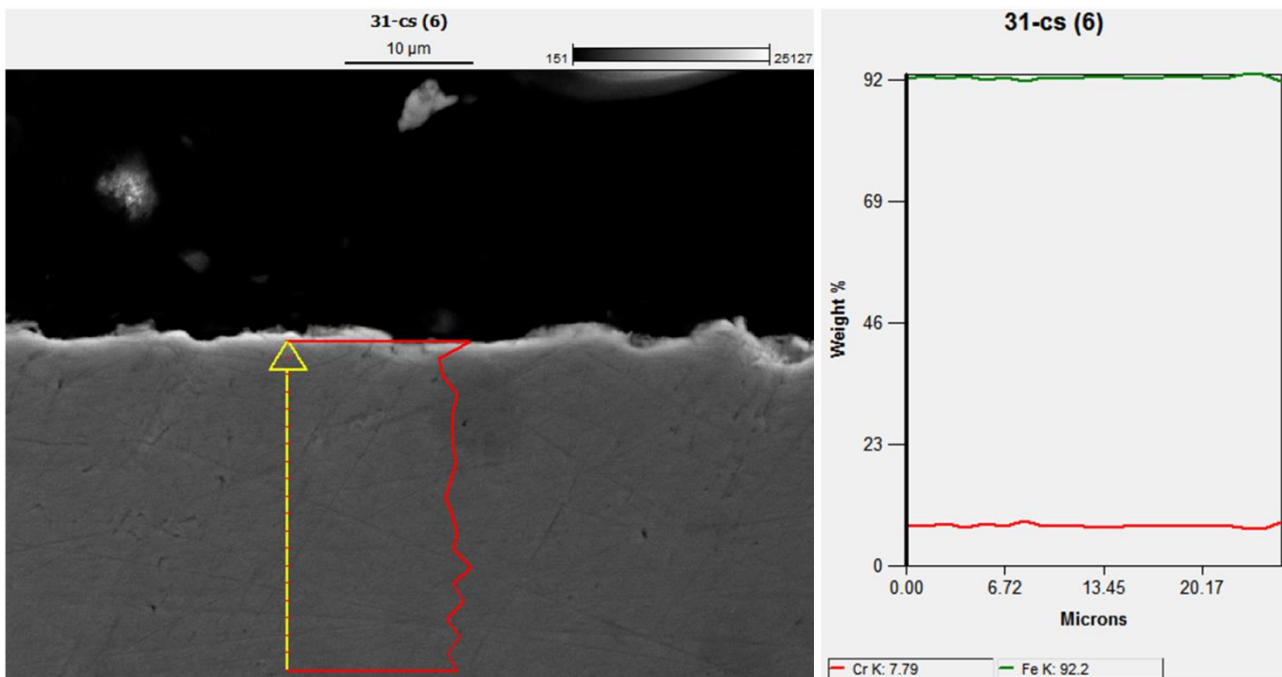
Figure 42 shows on the left a SEM representative image of specimen n° 31 section, with the red Chromium concentration profile overlapped, as determined by the EDS analysis; on the right side is instead reported a graph showing the profiles of both Chromium and Iron elements. The graph meaning and details are the same already described for Figure 37.

From the observation of the Figure, it is possible to note that the internal specimen structure is in good condition, with only some sign due to the cut and preparation of the sample, but no erosion-corrosion damage: this is of course what expected, since specimen n° 31 is an unexposed specimen. The concentration profiles indicate a substantial constancy of values, with minimal fluctuations due to the uncertainty in the EDS analysis result.

Figure 42: left: SEM image and Cr concentration profile (EDS) of specimen n° 31 cross section; right: Cr (red) and Fe (green) concentration profiles along the specimen section.

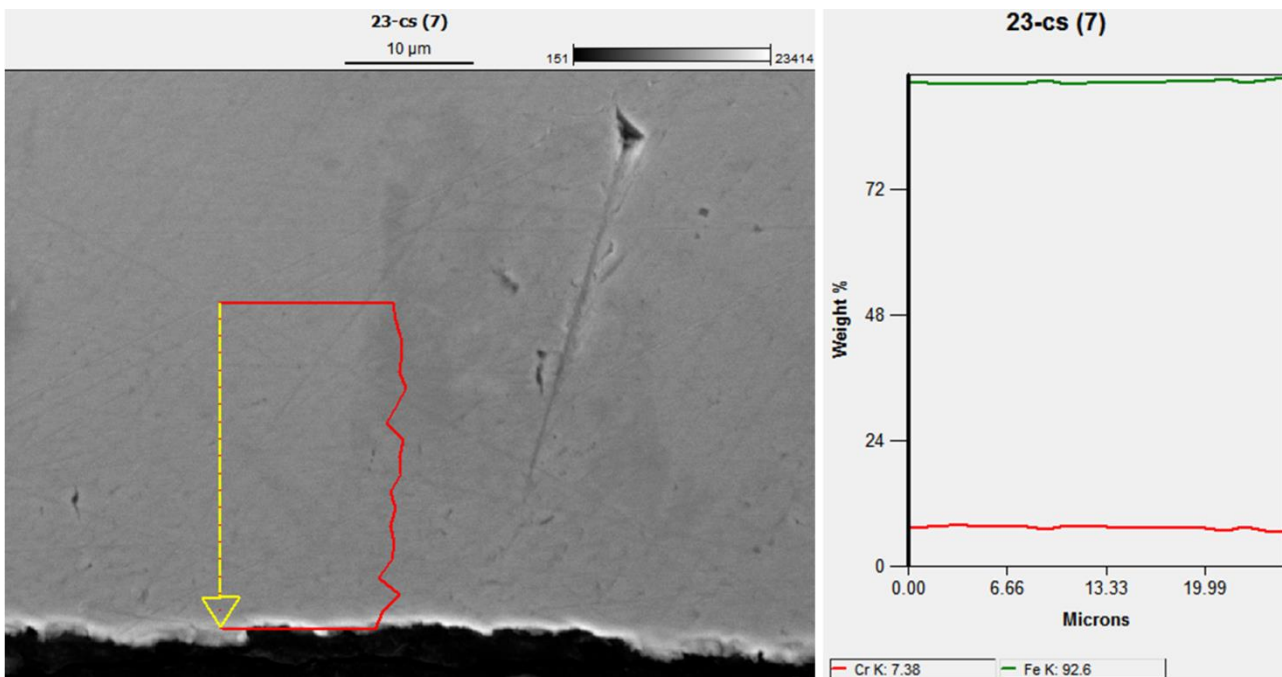
Figure 43 shows on the left a SEM representative image of specimen n° 23 section, with the red Chromium concentration profile overlapped, as determined by the EDS analysis; on the right side is instead reported a graph showing the profiles of both Chromium and Iron elements. The graph meaning and details are the same already described for Figure 37. No internal morphological damage is evident; the concentration profiles are rather flat, with small oscillations due to the uncertainty in the EDS analysis result.

Figure 43: left: SEM image and Cr concentration profile (EDS) of specimen n° 23 cross section; right: Cr (red) and Fe (green) concentration profiles along the specimen section.
