Risultati relativi alle campagne sperimentali di breve e medio termine sui fenomeni di erosione/corrosione da litio liquido fluente nell'impianto Lifus 6

P.Favuzza, M.Cuzzani, G. Fasano

Settembre 2016

Progetto: B.3.2 – Attività di Fisica della Fusione Complementari a ITER

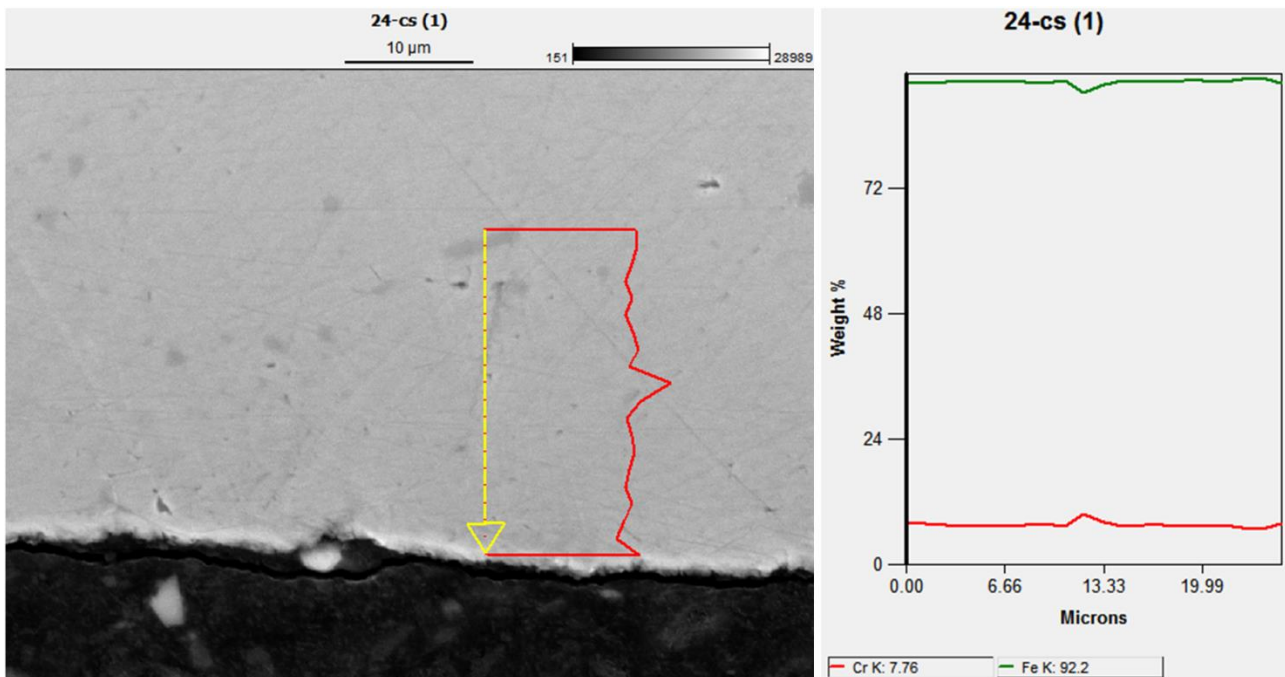
Figure 44 shows on the left a SEM representative image of specimen n° 24 section, with the red Chromium concentration profile overlapped, as determined by the EDS analysis; on the right side is instead reported a graph showing the profiles of both Chromium and Iron elements. The graph meaning and details are the same already described for Figure 37. No internal morphological damage is evident; the concentration profiles are rather flat, with only a small positive peak in Cr concentration at about half path, due to the uncertainty in the EDS analysis result or to a local concentration which is higher by chance. A corresponding peak is visible also in the Fe profile, this time negative, since the sum of the two concentration values is fixed to be always 100%. In any case, no real increasing/decreasing trend appears moving along the direction of the yellow arrow.

Figure 44: left: SEM image and Cr concentration profile (EDS) of specimen n° 24 cross section; right: Cr (red) and Fe (green) concentration profiles along the specimen section.

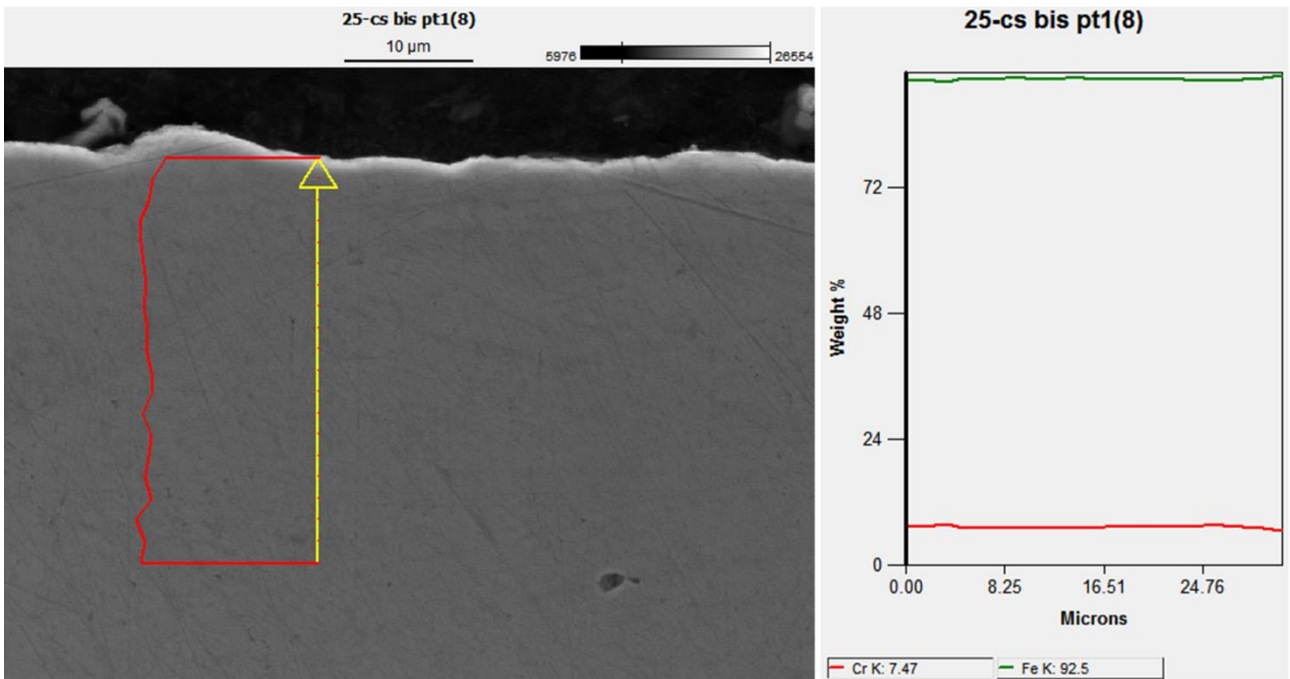
Figure 45 shows on the left a SEM representative image of specimen n° 25 section, with the red Chromium concentration profile overlapped, as determined by the EDS analysis; on the right side is instead reported a graph showing the profiles of both Chromium and Iron elements. The graph meaning and details are the same already described for Figure 37. No internal morphological damage is evident; the concentration profiles are rather flat, with minimal oscillations due to the uncertainty in the EDS analysis result.

Figure 45: left: SEM image and Cr concentration profile (EDS) of specimen n° 25 cross section; right: Cr (red) and Fe (green) concentration profiles along the specimen section.

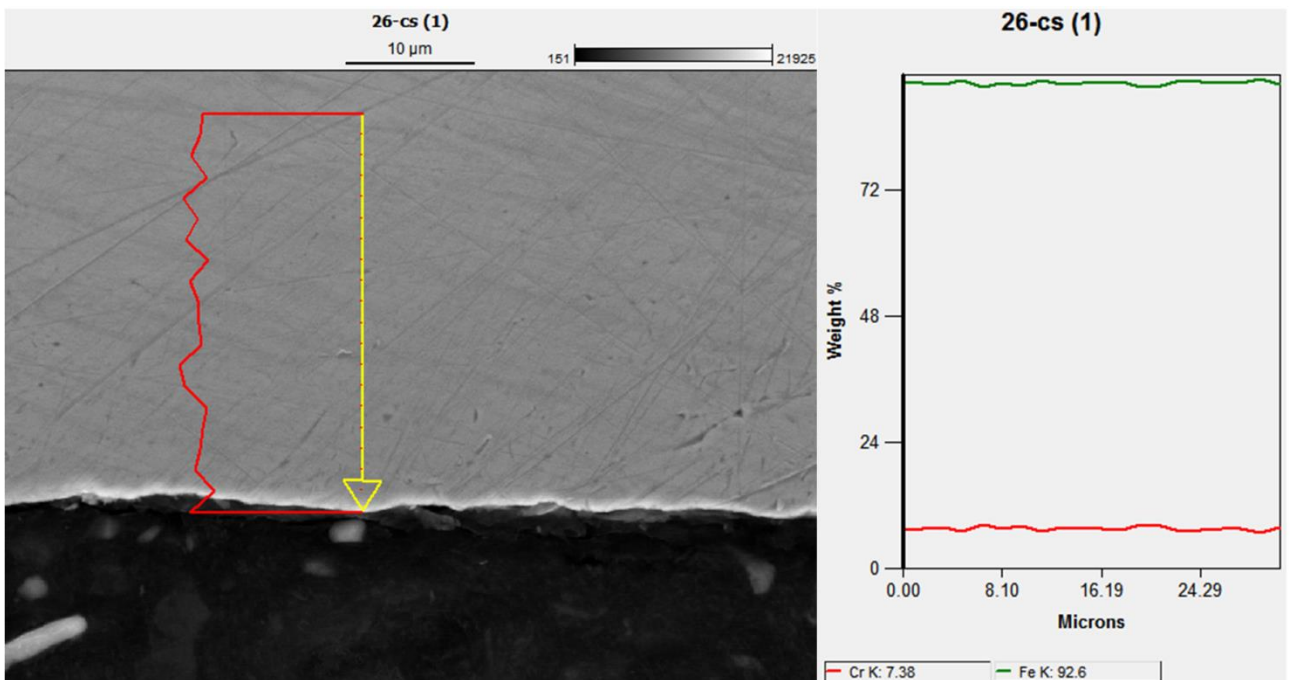
Finally, Figure 46 shows on the left a SEM representative image of specimen n° 26 section, with the red Chromium concentration profile overlapped, as determined by the EDS analysis; on the right side is instead reported a graph showing the profiles of both Chromium and Iron elements. The graph meaning and details are the same already described for Figure 37. Apart from the signs produced during the cut and the preparation of the sample, no internal morphological damage is evident; the concentration profiles are rather flat, with small oscillations due to the uncertainty in the EDS analysis result.

Figure 46: left: SEM image and Cr concentration profile (EDS) of specimen n° 26 cross section; right: Cr (red) and Fe (green) concentration profiles along the specimen section.

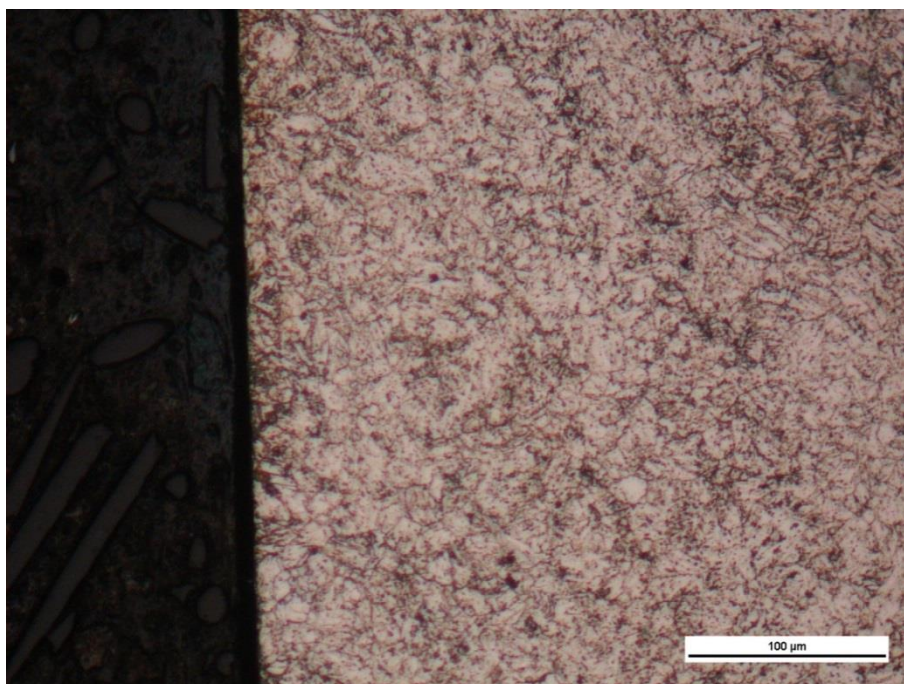
First of all, let's consider the Eurofer 97 specimens, starting with the one not submitted to the erosion-corrosion action by the flowing liquid Lithium (fresh specimens, n° 10). Figure 47 is an optical microscope image of the section, obtained in a region close to the exposed surface.

The material presents a fine, equigranular structure, with grains having dimensions on the order of 10 μm . This value agrees with the expected (commonly reported in literature) one. No meaningful differences appear between the inner region and the region close to the surface.

Figure 47: optical microscope image of the specimen n°10 cross section, after the chemical etching: detail of a region close to the exposed surface (black area on the left is the supporting resin).

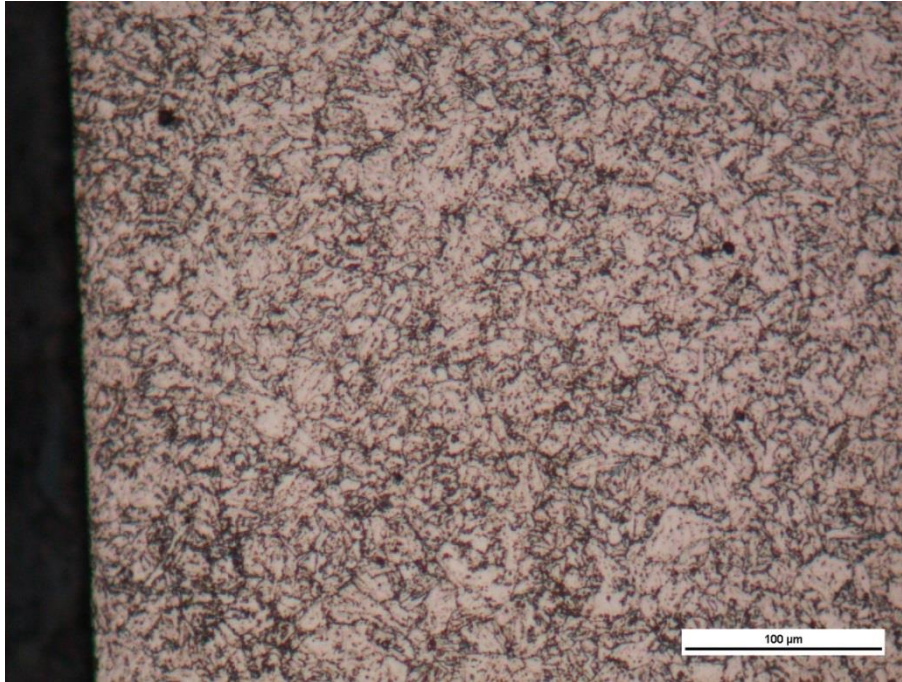
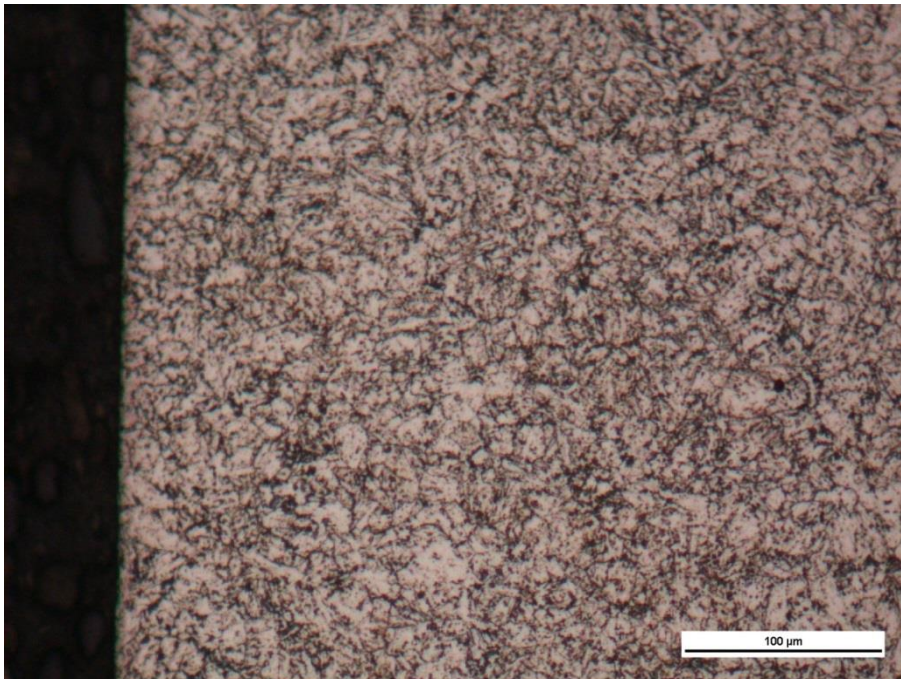
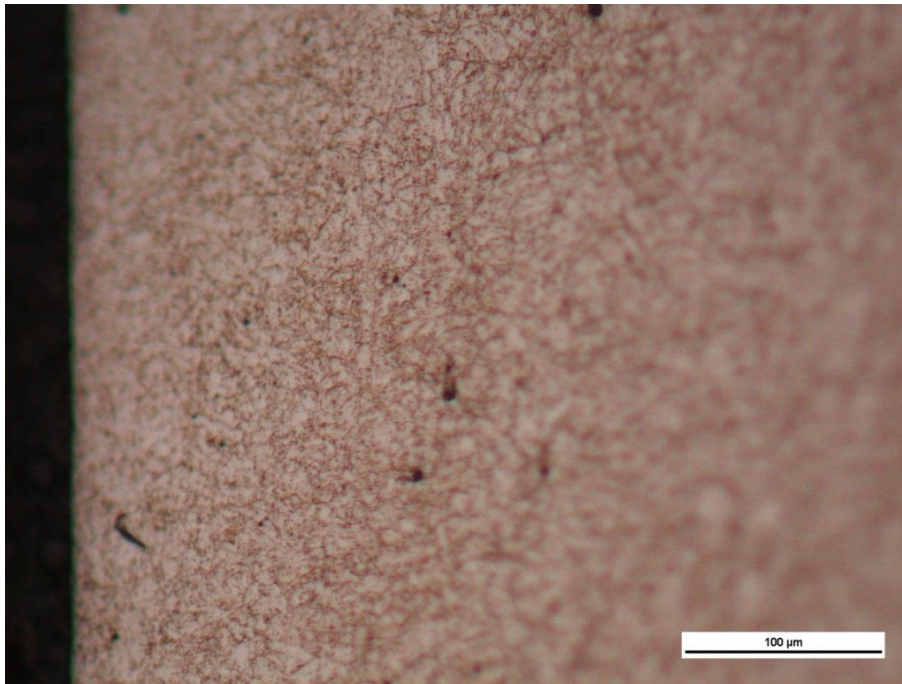
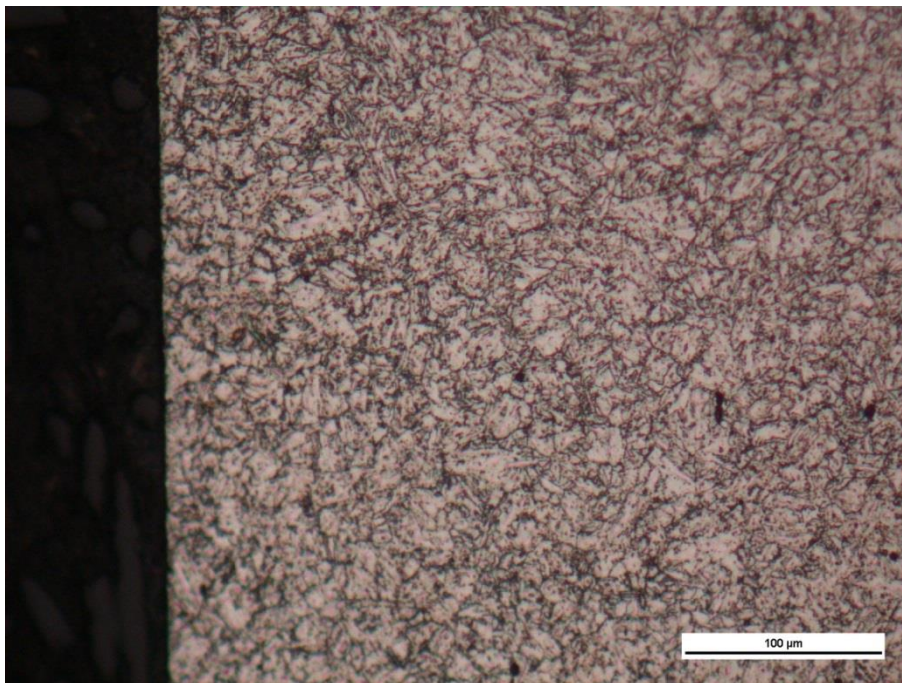
Next Figures 48 to 51 report instead the optical microscope images of the tested Eurofer 97 specimens (n° 2, n° 3, n° 4, n° 5). By comparing these images with the ones of the unexposed specimen, it can be stated that the grain structure of the tested specimen was not significantly affected by the 1222 hours of exposure to flowing Lithium. Particularly, the grains at the surfaces were not removed or evidently modified.

Figure 48: optical microscope image of the specimen n° 2 cross section, after the chemical etching: detail of a region close to the exposed surface (black area on the left is the supporting resin).

Figure 49: optical microscope image of the specimen n° 3 cross section, after the chemical etching: detail of a region close to the exposed surface (black area on the left is the supporting resin).

Figure 50: optical microscope image of the specimen n° 4 cross section, after the chemical etching: detail of a region close to the exposed surface (black area on the left is the supporting resin).

Figure 51: optical microscope image of the specimen n° 5 cross section, after the chemical etching: detail of a region close to the exposed surface (black area on the left is the supporting resin).

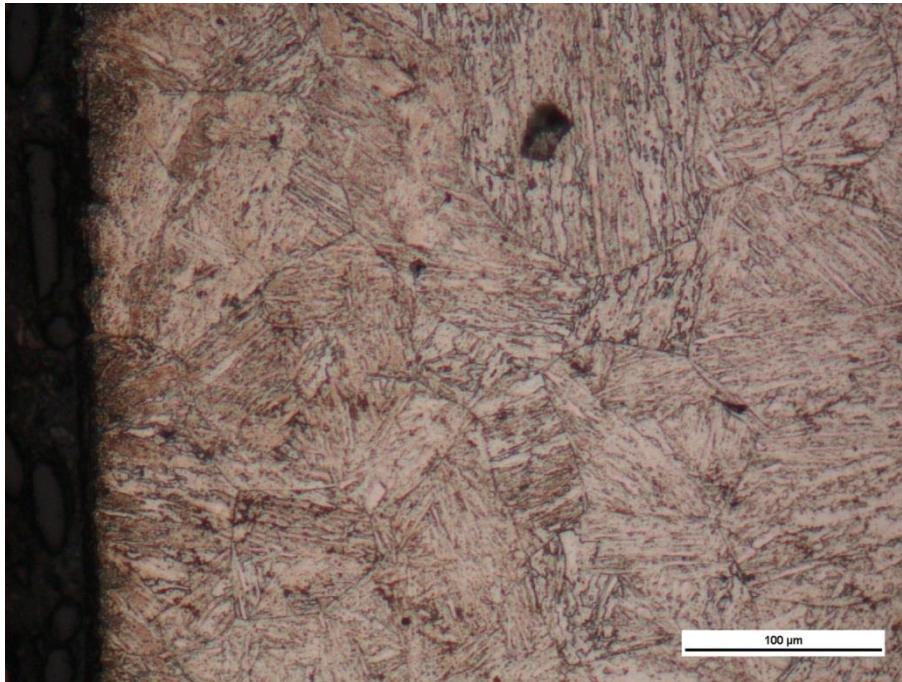
Let's consider now the F82H specimens, starting with the one not submitted to the erosion-corrosion action by the flowing liquid Lithium (fresh specimens, n° 31). Figure 52 is the optical microscope image of the section, obtained in a region close to the exposed surface of the sample.

The material present a granular structure different from Eurofer 97 one, being characterized on average by much larger grains (about 50-100 μm), which result, therefore, more clearly visible. Such a grain structure agrees with what expected for the F82H material. No meaningful differences appear between the inner region and the region close to the surface.

Figure 52: optical microscope image of the specimen n° 31 cross section, after the chemical etching: detail of a region close to the exposed surface (black area on the left is the supporting resin).

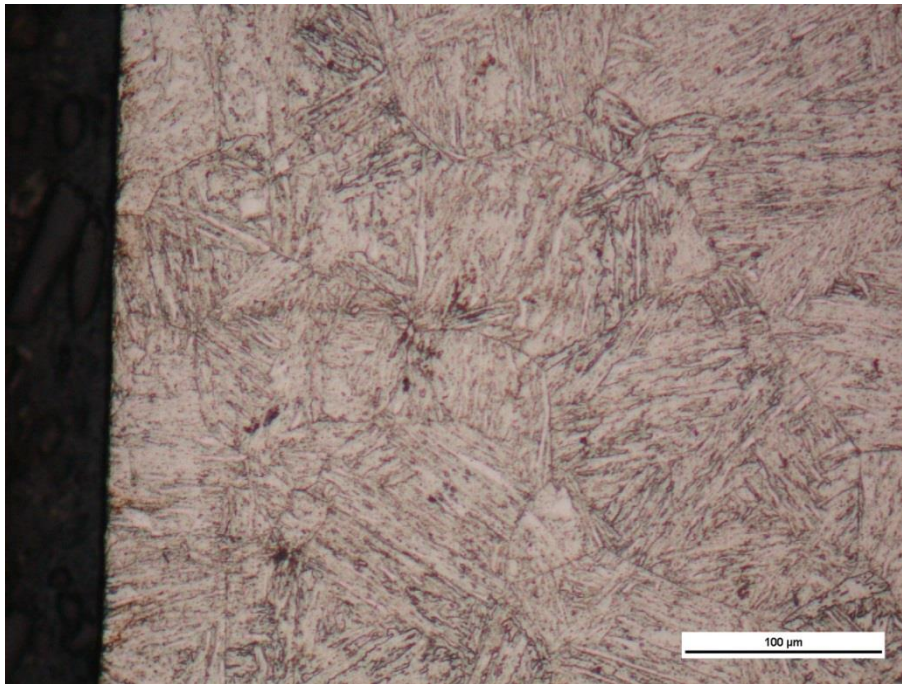
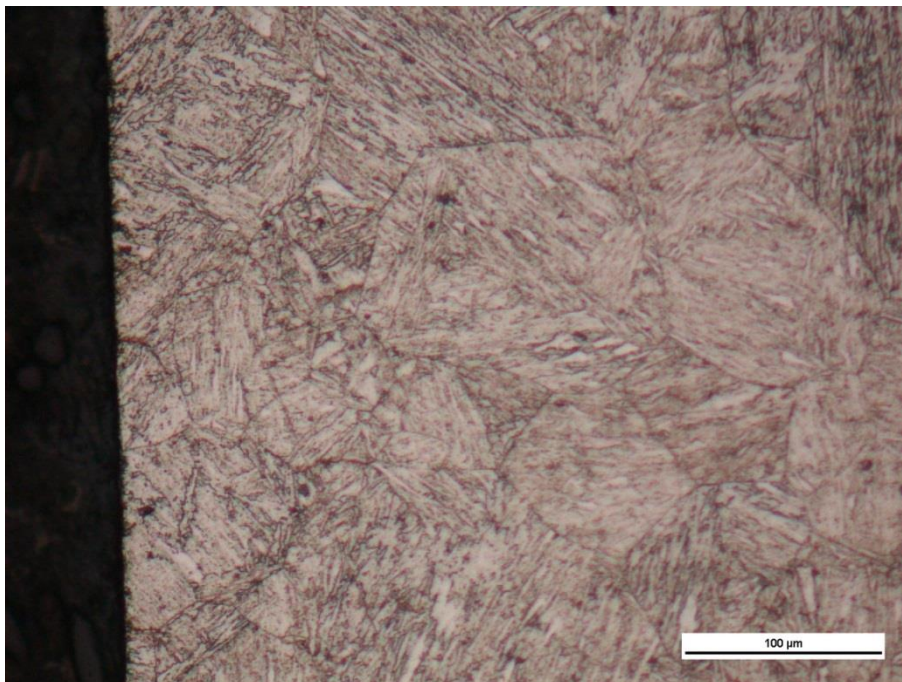
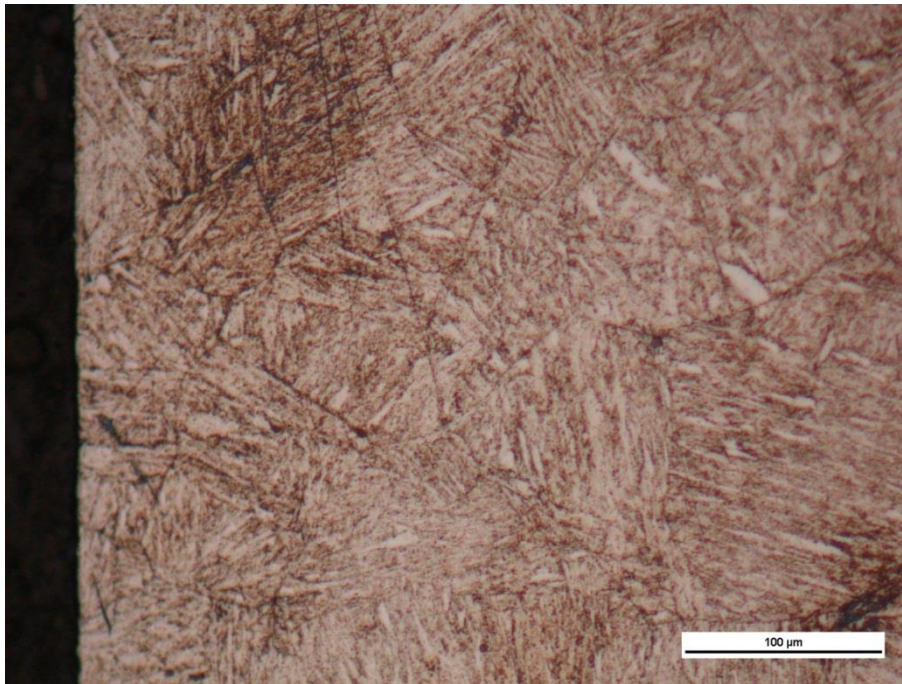
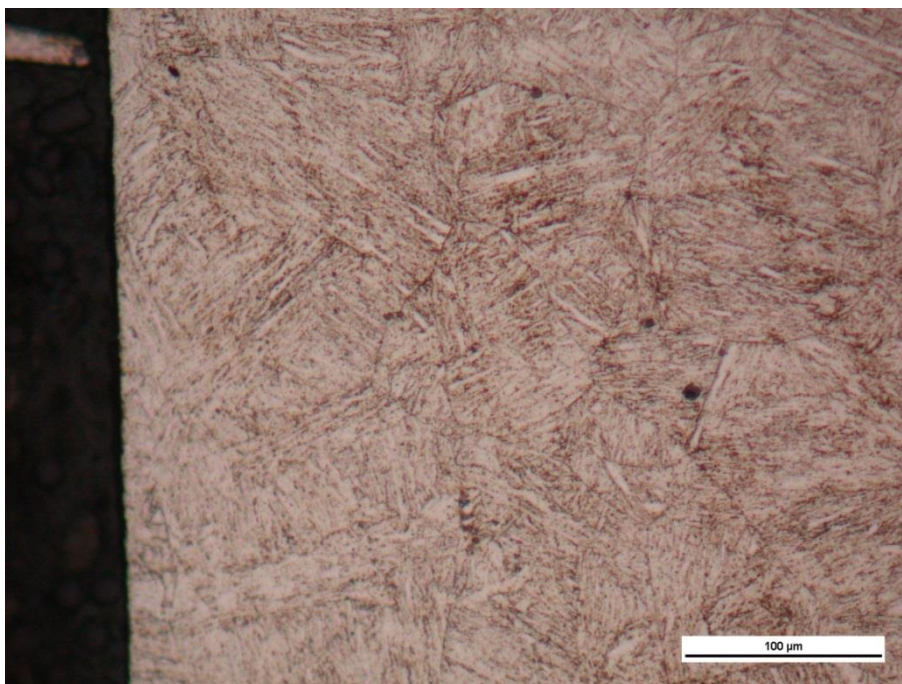
Next Figures 53 to 56 report instead the optical microscope images of the tested F82H specimens (n° 23, n° 24, n° 25, n° 26). By comparing these images with the ones of the unexposed specimen, it can be stated that the grain structure of the tested specimen was not significantly affected by the 1222 hours of exposure to flowing Lithium. Particularly, the grains at the surfaces were not removed or evidently modified.

Figure 53: optical microscope image of the specimen n° 23 cross section, after the chemical etching: detail of a region close to the exposed surface (black area on the left is the supporting resin).

Figure 54: optical microscope image of the specimen n° 24 cross section, after the chemical etching: detail of a region close to the exposed surface (black area on the left is the supporting resin).

Figure 55: optical microscope image of the specimen n° 25 cross section, after the chemical etching: detail of a region close to the exposed surface (black area on the left is the supporting resin).

Figure 56: optical microscope image of the specimen n° 26 cross section, after the chemical etching: detail of a region close to the exposed surface (black area on the left is the supporting resin).
