Ricerca di Sistema elettrico

Risultati relativi alla campagna sperimentale di medio termine sui fenomeni di erosione/corrosione da Litio liquido fluente nell'impianto Lifus 6

RISULTATI RELATIVI ALLA CAMPAGNA SPERIMENTALE DI MEDIO TERMINE SUI FENOMENI DI EROSIONE/CORROSIONE DA LITIO LIQUIDO FLUENTE NELL'IMPIANTO LIFUS 6

Settembre 2017

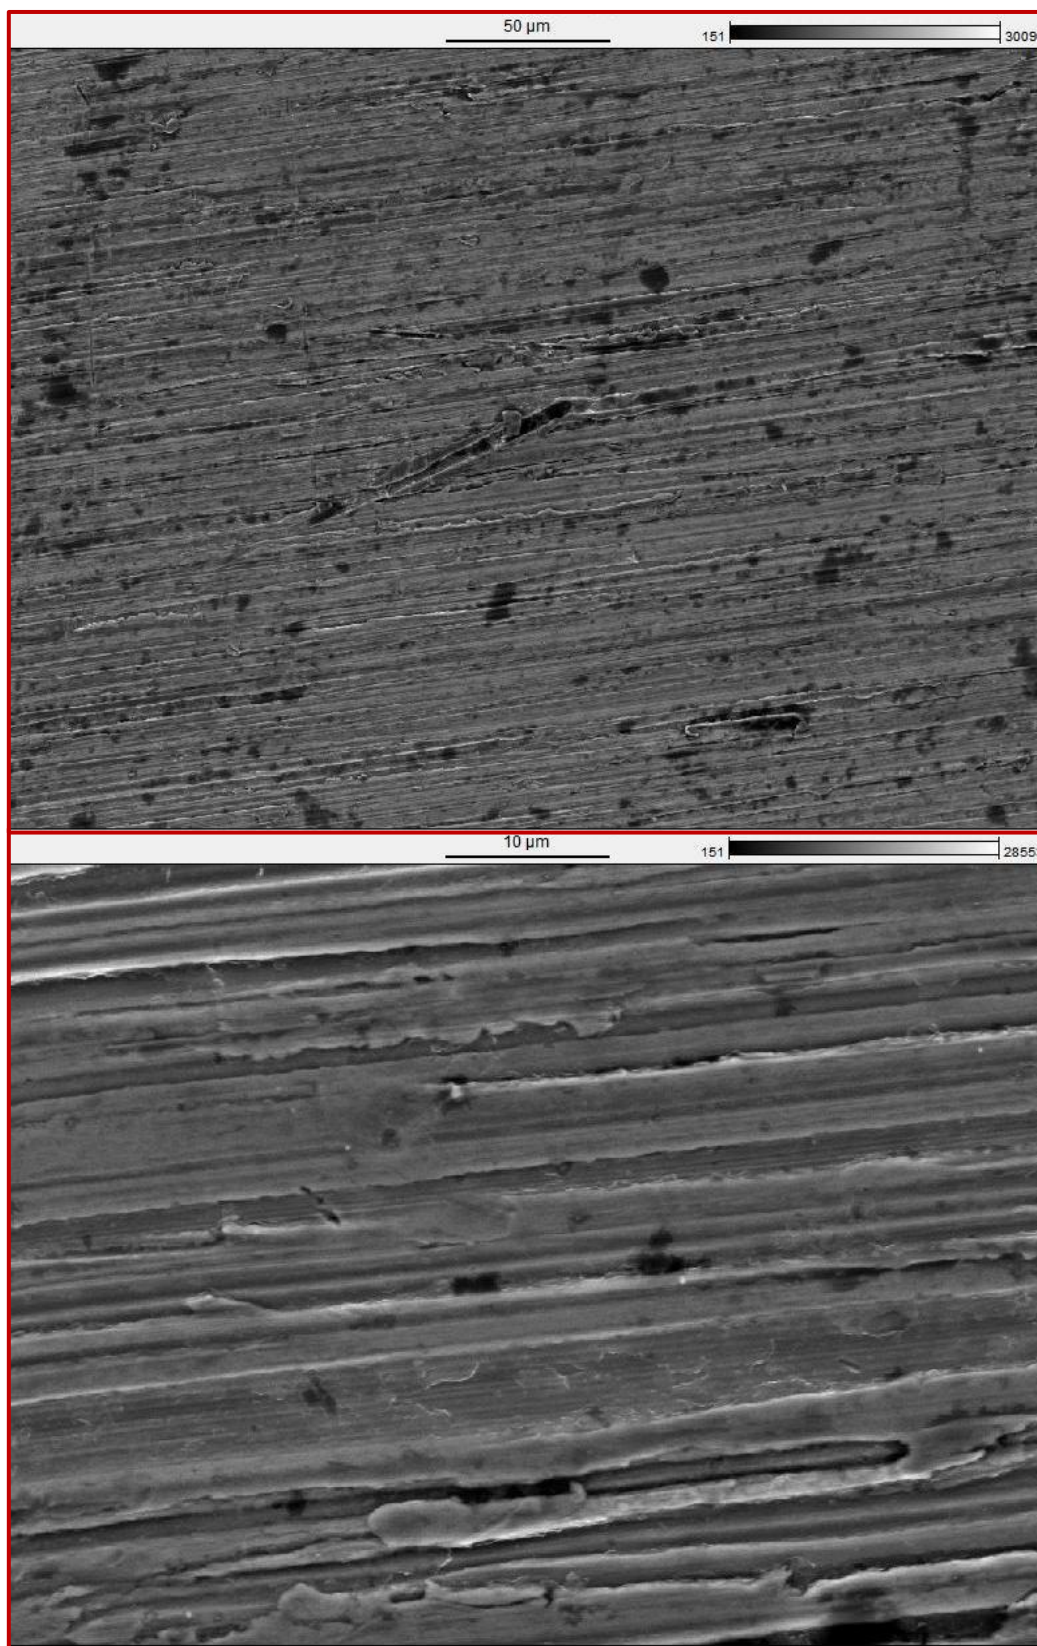
Figure 17 shows, at different magnitudes (400 X and 2000 X), the surface of a representative region of this specimen: the scrapes of the mechanical manufacturing are clearly visible.

Figure 17: SEM images of specimen #10 surface (secondary electrons) at magnitude 400 X (top) and 2000 X (bottom). Scale bars above the images.

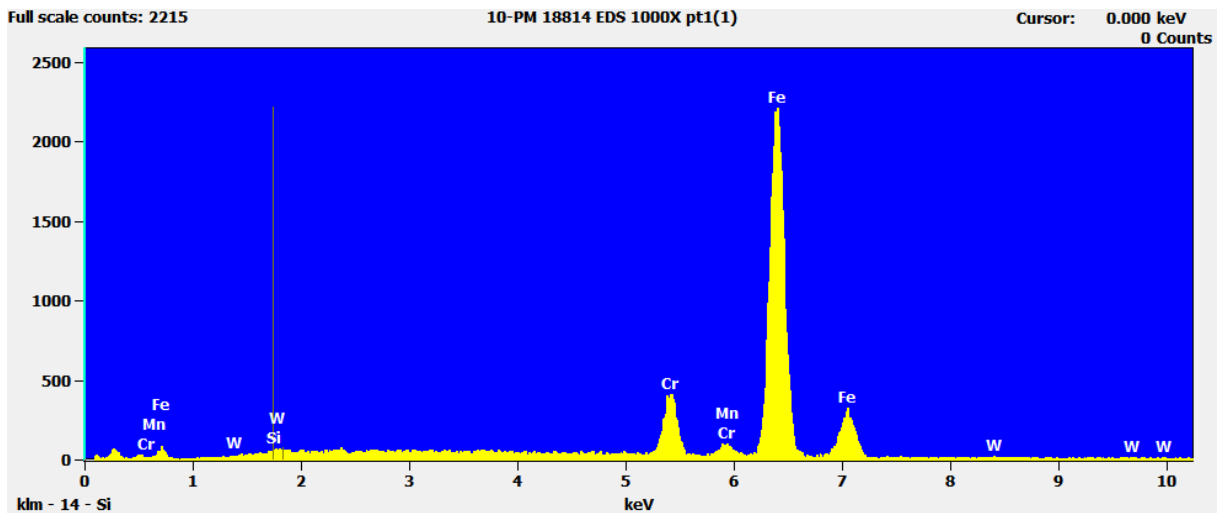
Figure 18: EDS spectrum obtained at specimen #10 surface

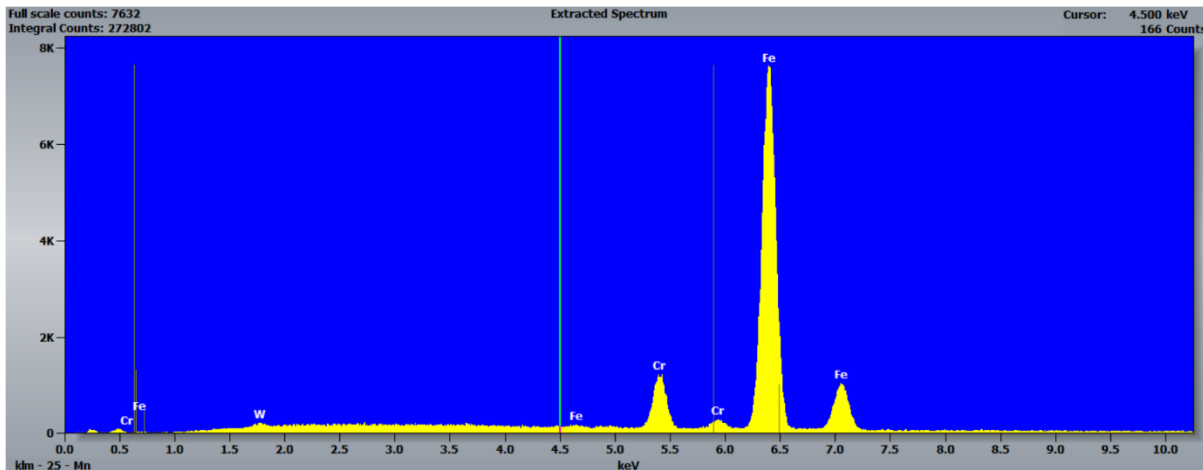
Figure 23: EDS spectrum obtained at specimen #12 surface

From the comparison with Table 5 values, it appears that Mn disappeared at the surface. A W peak is seen in Figure 23 spectrum, but it is very little and under the quantification limit, because almost indistinguishable from the background noise; it was therefore approximated as 0 in the table, indicating again a decrease from the unexposed specimen (#10) value. A depletion is finally measured also in Chromium content (-0.8% by weight). Iron is instead a bit increased, to compensate other elements diminutions.

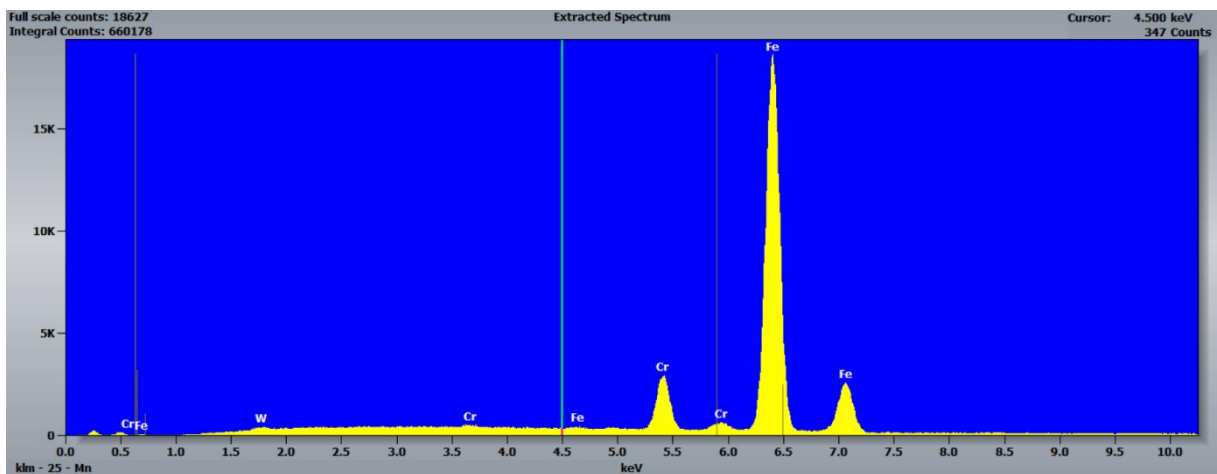
Figure 28: EDS spectrum obtained at specimen #13 surface

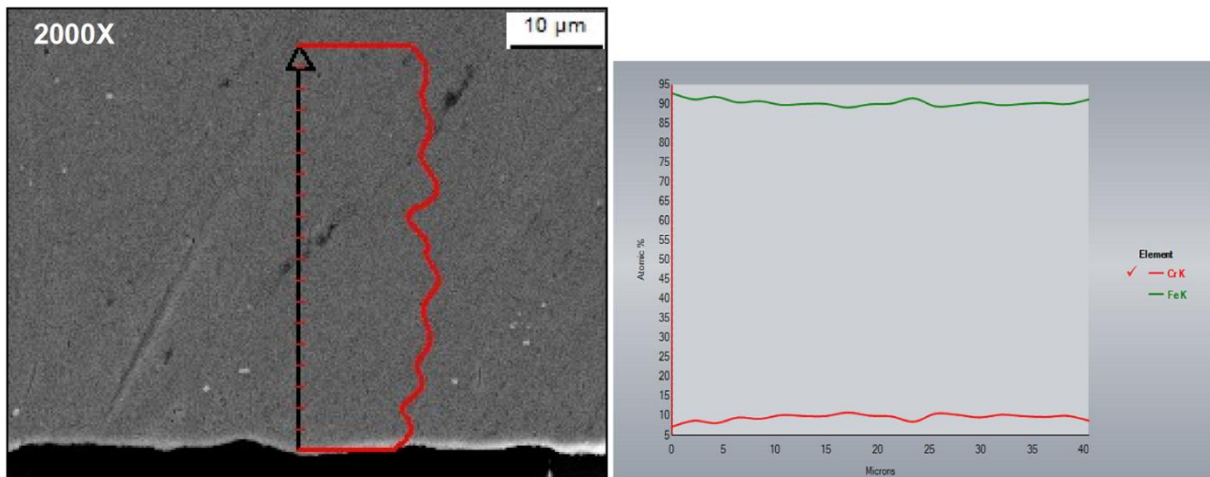
Finally, Figure 33 (left) shows a SEM image at 2000X of a representative cross section of specimen #7, together with the overlapped Chromium concentration vs depth profile, constructed by the EDS analysis of equidistant points (~ 2.0 μm spaced), in the arrow direction. On the right side of Figure 33 is instead reported a graph showing the profiles of both Chromium and Iron elements along the arrow direction, where y-axis is the atomic % concentration, while x-axis indicates the distance from the surface (the surface position is on the left boundary of the graph, in correspondence of x = 0). From the observation of Figure 33 left, it is possible to note that the internal specimen structure is in good condition, with no morphological alteration or grain detachment. The concentration profiles on the right indicate no increasing or decreasing trend of values moving inside the specimen; again, the first Cr value, on the left, results smaller than all the other, but only because it is associated to a measurement on the boundary of the sample, which is not physically meaningful. Small oscillations in Cr concentration are due to little local deviations from the theoretical alloy composition and/or to the analysis uncertainty; they are reflected by similar fluctuations of Iron concentrations, since, being other elements absent, Cr+Fe sum always makes 100.

Figure 33: left: SEM image and Cr concentration profile (EDS) of specimen #7 section; right: Cr (red) and Fe (green) concentration profiles along the specimen section.

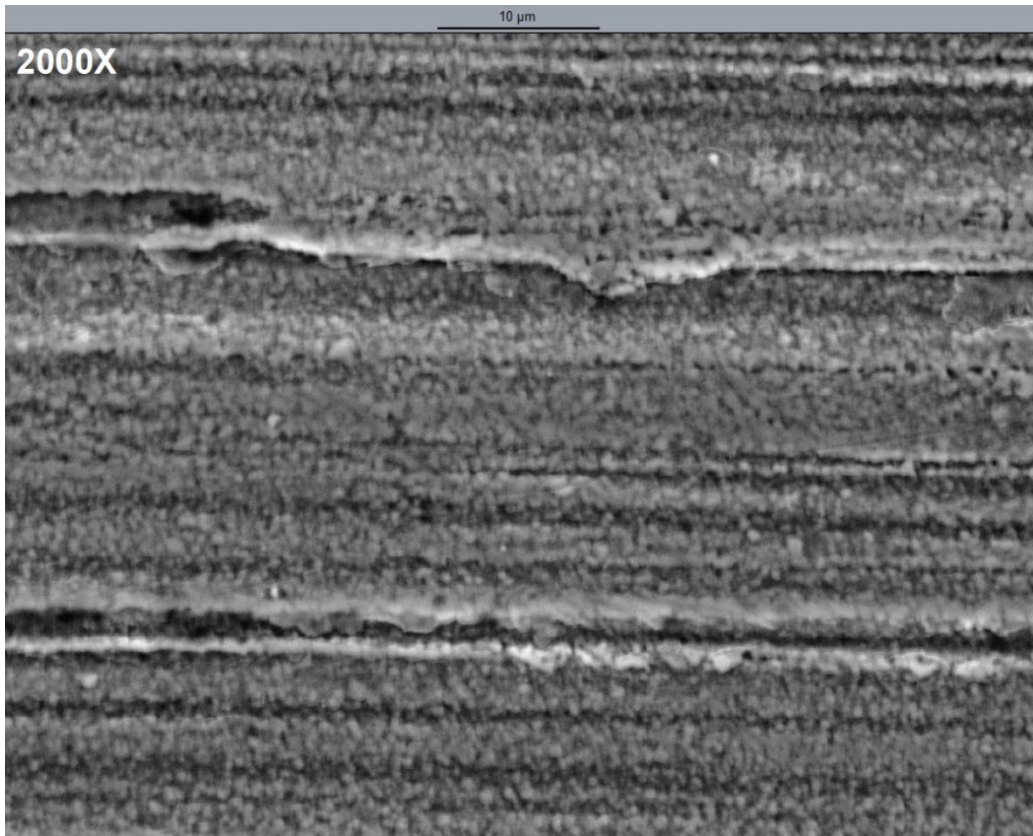
Figure 35 is instead a higher magnitude image (2000X) of another surface region. No alteration ascribable to corrosion phenomenon is detected here; it is however possible to note the general aspect of the surface, which results more granulose than before the exposure to the flowing liquid Lithium (by comparing with specimen #10 surface: Figure 17).

Figure 35: SEM image of specimen #8 surface (secondary electrons) at magnitude 400 X. Scale bar above the image.

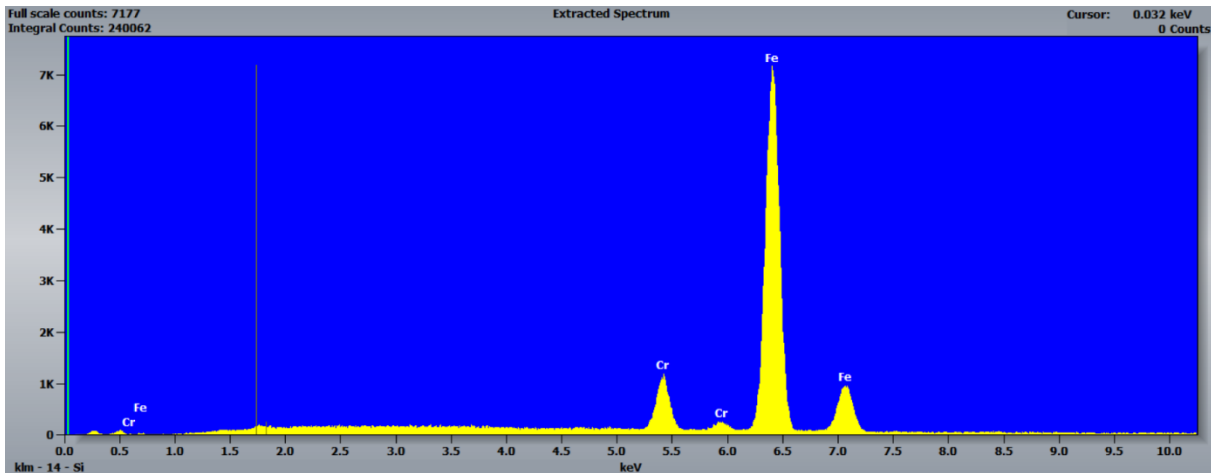
Figure 36 reports the average EDS spectrum of a large surface region; Table 9 summarizes the values of the related compositional analysis. The concentration values reported in this table are exactly the same reported in Table 8: same considerations hold.

Figure 36: EDS spectrum obtained at specimen #8 surface

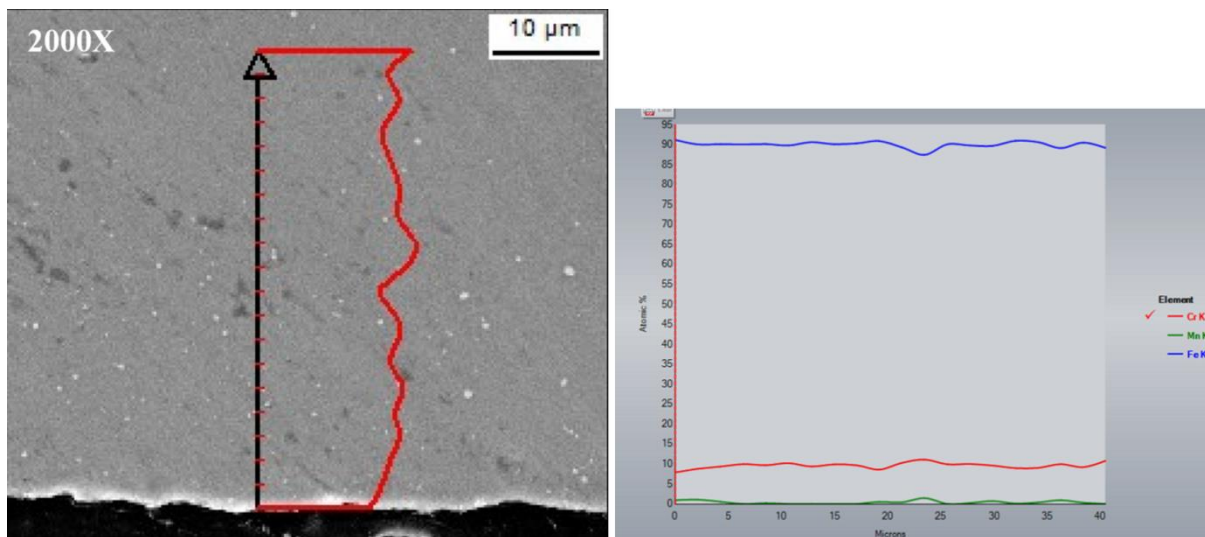
Finally, Figure 37 (left) shows a SEM image at 2000X of a representative cross section of specimen #8, together with the overlapped Chromium concentration vs depth profile, constructed by the EDS analysis of equidistant points (~ 2.2 μm spaced), in the arrow direction. On the right side of Figure 37 is instead reported a graph showing the profiles of Chromium, Iron and (this time) also Mn elements along the arrow direction, where y-axis is the atomic % concentration, while x-axis indicates the distance from the surface (the surface position is on the left boundary of the graph, in correspondence of x = 0). From the observation of Figure 37 left, it is possible to note that the internal specimen structure is in good condition, with no morphological alteration or grain detachment. The concentration profiles on the right indicate no increasing or decreasing trend of values moving inside the specimen. Small oscillations in Cr concentration are due to little local deviations from the theoretical alloy composition and/or to the analysis uncertainty; Mn concentration assumes of course very small values, according to the theoretical alloy composition and only in few cases it can be considered different from 0.

Figure 37: left: SEM image and Cr concentration profile (EDS) of specimen #8 section; right: Cr (red), Fe (blue) and Mn (green) concentration profiles along the specimen section.

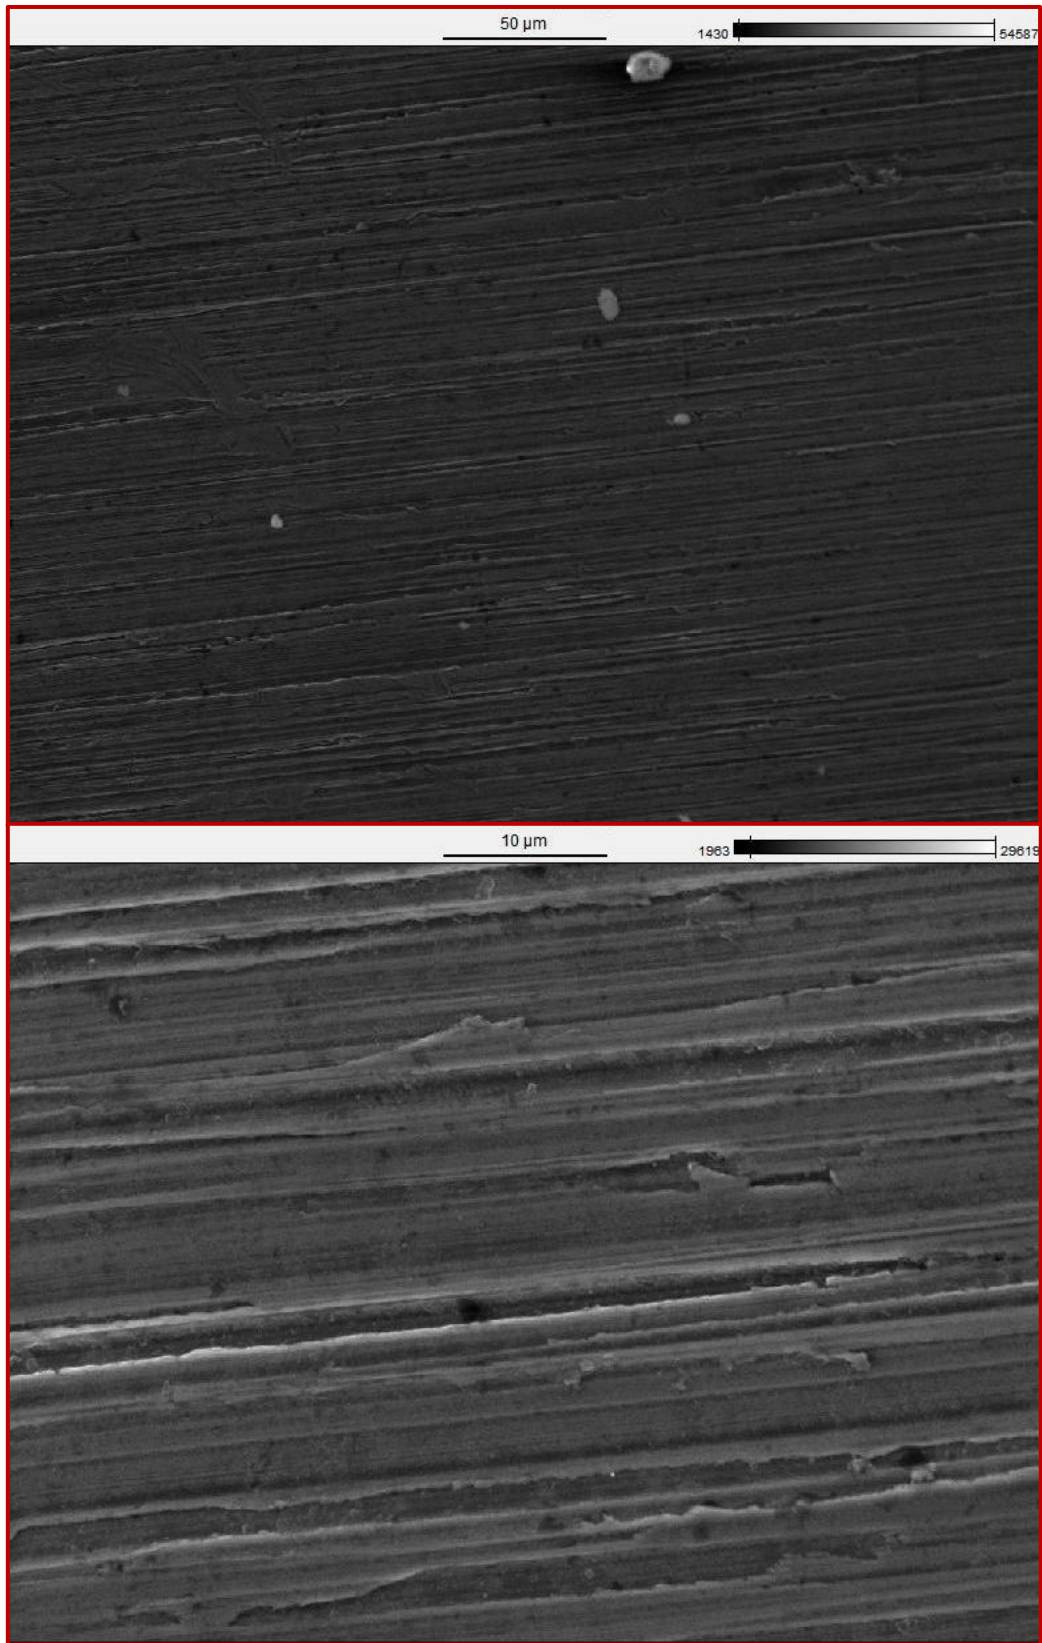
Figure 38 shows, at different magnitudes, the surface of a representative region of this specimen. As already observed for the Eurofer 97 specimens, also here the sample surface is characterized by the presence of signs due to the mechanical manufacturing, while surface alterations due to erosion-corrosion by Lithium are (of course) absent.

In [3] it was also shown that, differently from the above average composition, white particles like the ones visible in the top part of Figure 38 are characterized by a significant concentration of O, Na and mostly C and Ca (maybe some residue of alkaline carbonate). Since specimen #31 was not exposed to Lithium, surely the presence of the just mentioned elements must be ascribed to the sample handling and its treatment before the execution of the analysis. In any case this conclusion allows to exclude, also for the following, exposed specimens, that similar surface anomalies are somehow consequence of the action exerted by the liquid Lithium.

Figure 38: SEM images of specimen #31 surface (secondary electrons) at magnitude 400X (top) and 2000X (bottom).
Scale bars above the images.

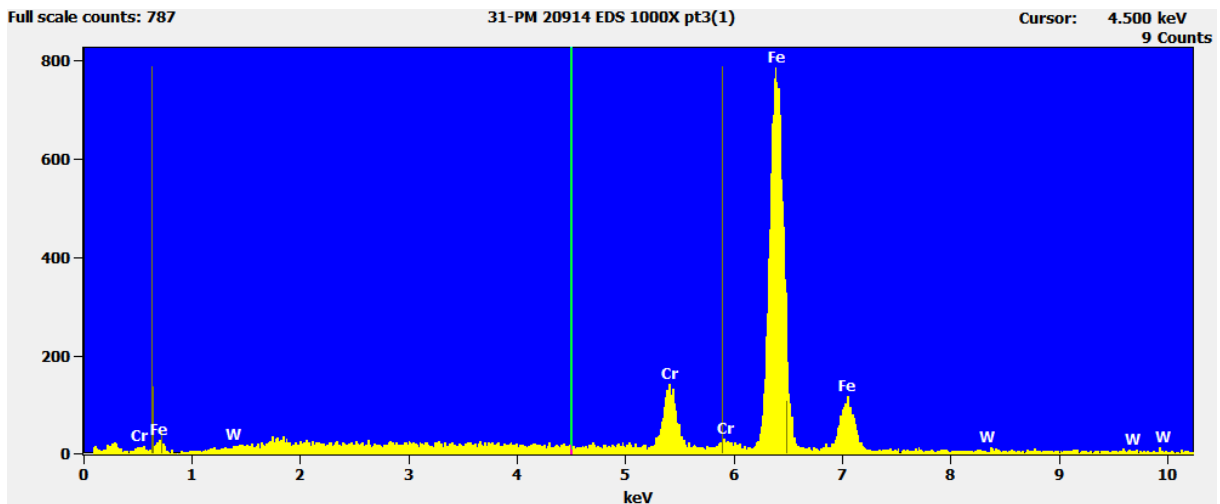
Figure 39: EDS spectrum obtained at specimen #31 surface

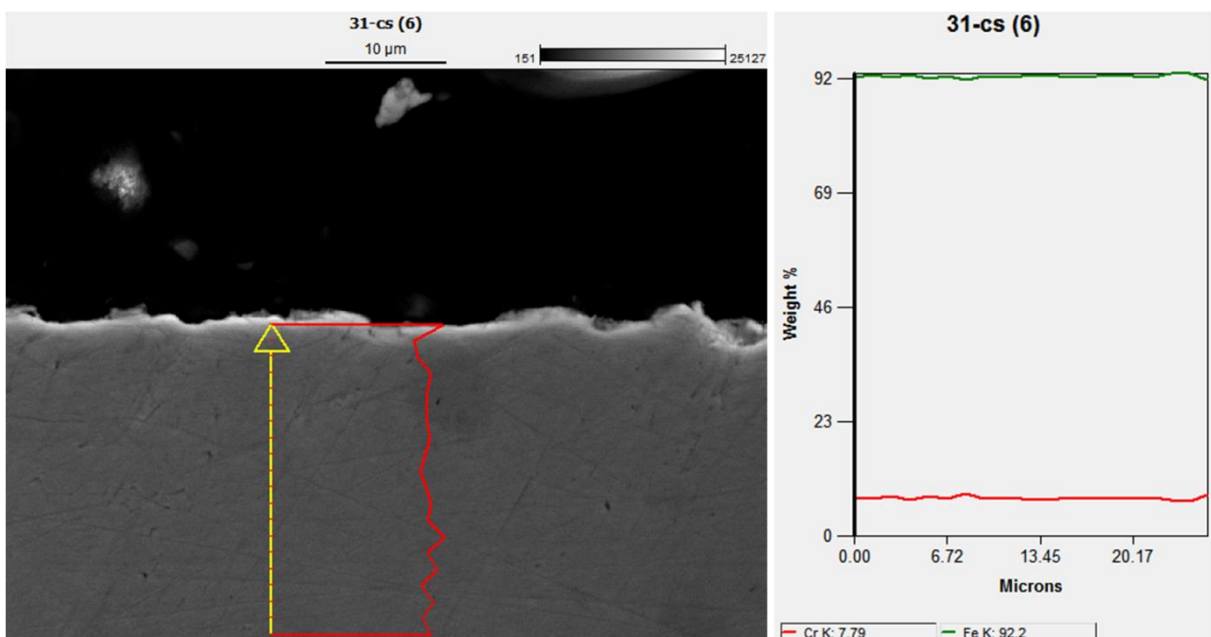
Finally, Figure 40 shows on the left a SEM representative image of specimen #31 section, with the red Chromium concentration profile overlapped, as determined by the EDS analysis of distinct points (spaced ~ 1.5 µm) in the yellow arrow direction; on the right side is instead reported a graph showing the profiles of both Chromium and Iron weight concentrations. x = 0 in this graph corresponds to the inner position inside the specimen (origin of the arrow).

From the observation of the Figure, it is possible to note that the internal specimen structure is in good condition, with only some sign due to the cut and preparation of the sample, but no erosion-corrosion damage: this is of course what expected, since specimen #31 is an unexposed specimen. The concentration profiles indicate a substantial constancy of values, with minimal fluctuations due to the uncertainty in the EDS analysis result.

Figure 40: left: SEM image and Cr concentration profile (EDS) of specimen #31 cross section; right: Cr (red) and Fe (green) concentration profiles along the specimen section.

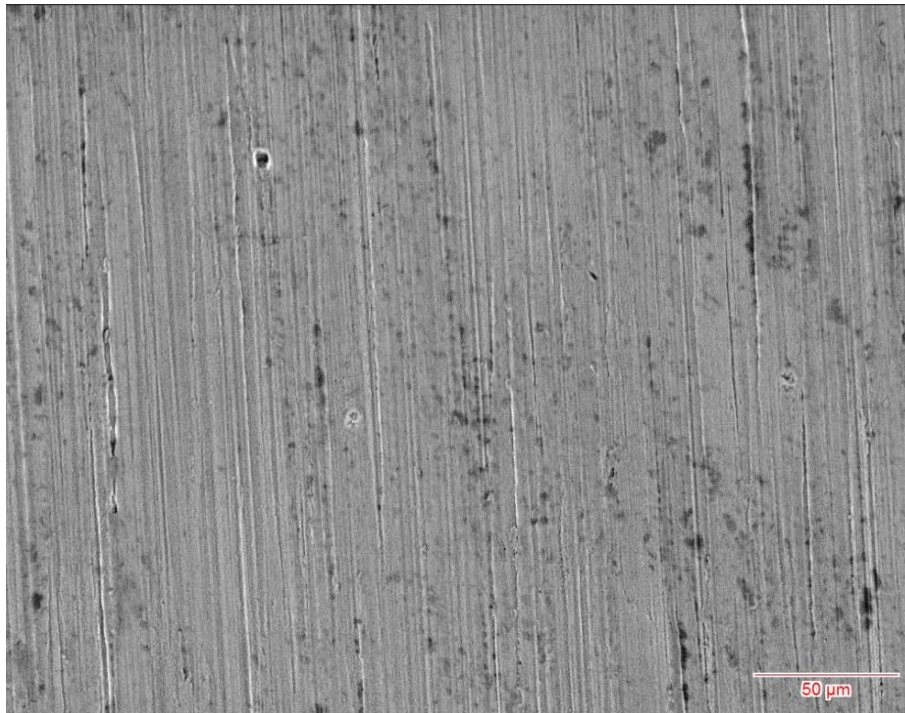
Figure 41: SEM image of specimen #32 surface (secondary electrons) at magnitude 400X. Scale bar above the image.

Apart from the usual stripes produced during the mechanical manufacturing of the sample, no significant morphological alteration, ascribable to corrosion phenomena, is seen. By comparing Figure 42 with the bottom half of Figure 38 (observations made at the same magnitude) it appears anyway a more 'granulose' profile of the specimen #32 surface compared to the fresh one.

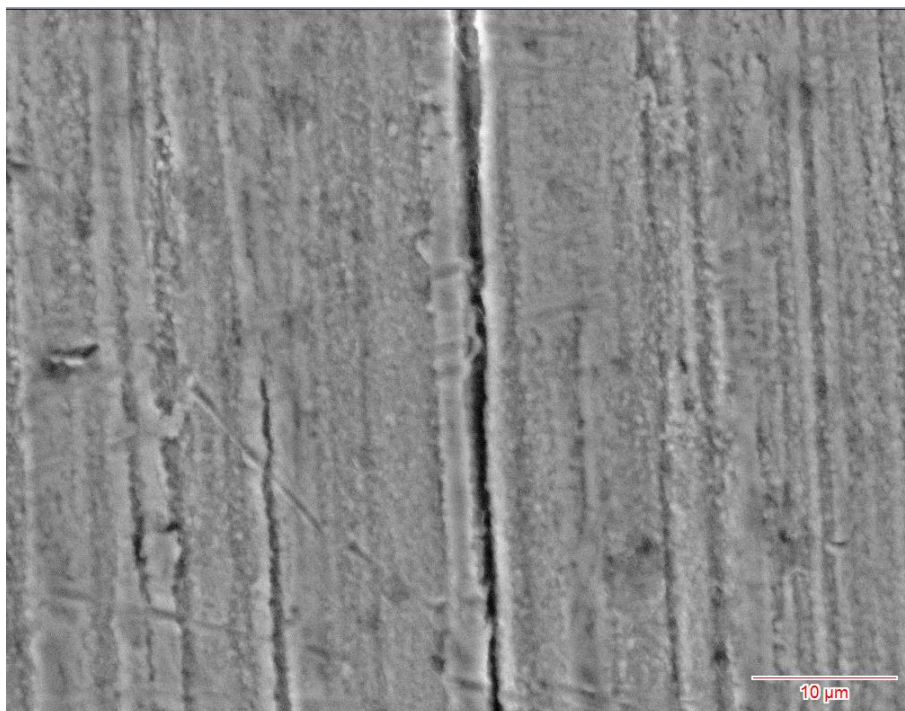
Figure 42: SEM image of spec. #32 surface (secondary electrons) at magnitude 2000X. Scale bar above the image.

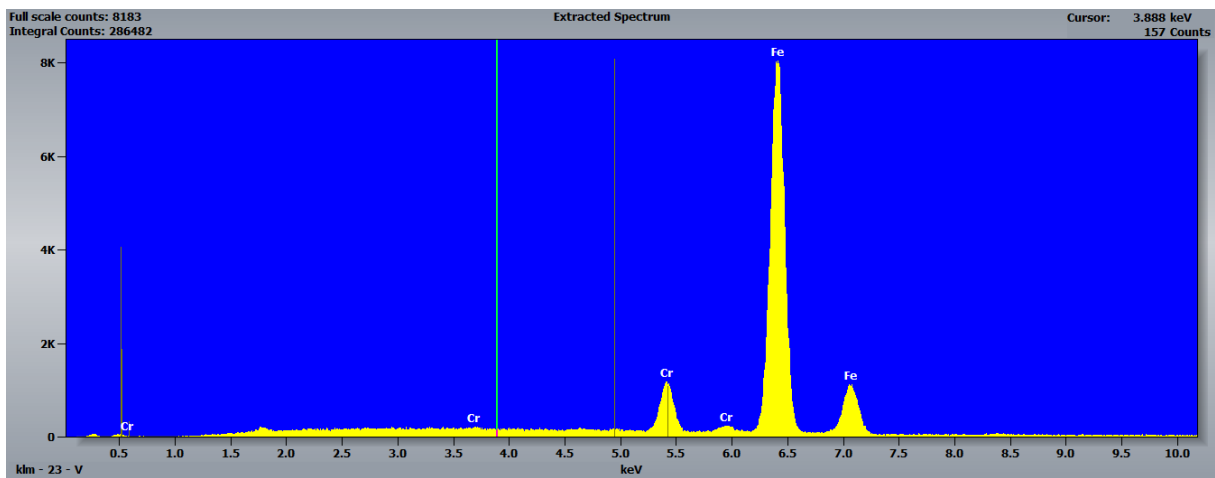
Figure 43 reports the average EDS spectrum of an external surface region; Table 11 summarizes the values of the related compositional analysis. Looking at the Figure, the peak of W is not easily distinguishable from the background noise, therefore this element concentration was not reported in Table 11. By comparing this table values with Table 10 ones, a Chromium depletion at the surface is also noted, corresponding to -1.1% by weight; Iron is instead a bit increased, to compensate other elements diminutions.

Figure 43: EDS spectrum obtained at specimen #32 surface

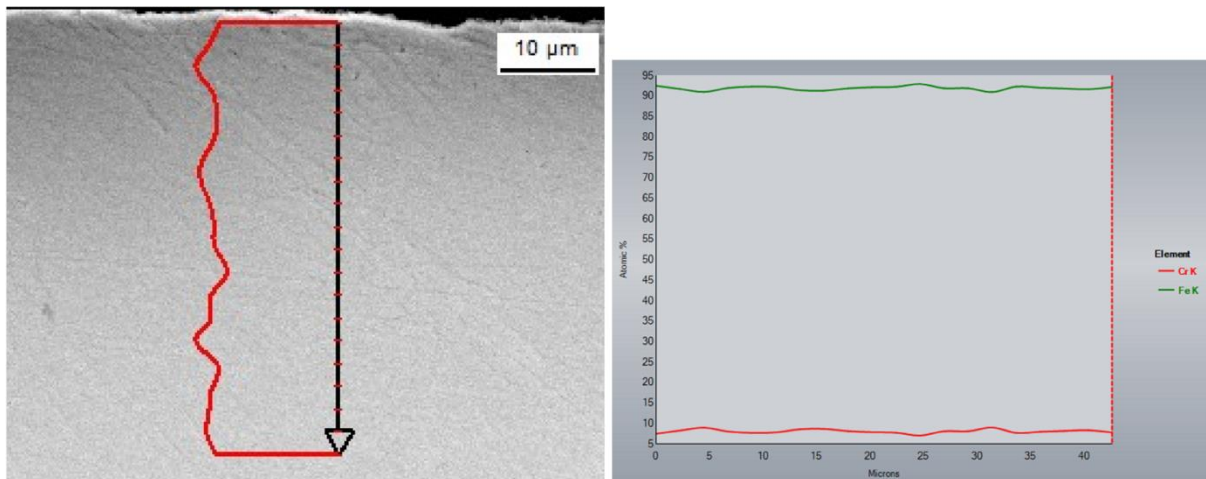
Finally, Figure 44 (left) shows a SEM image at 2000X of a representative cross section of specimen #32, together with the overlapped Chromium concentration vs depth profile, constructed by the EDS analysis of equidistant points (~ 2.2 μm spaced), in the arrow direction. On the right side of Figure 44 is instead reported a graph showing the profiles of Chromium and Iron elements along the arrow direction, where y-axis is the atomic % concentration, while x-axis indicates the distance from the surface (the surface position is on the left boundary of the graph, in correspondence of x = 0). From the observation of Figure 44 left, it is possible to note that the internal specimen structure is in good condition, with no morphological alteration or grain detachment. The concentration profiles on the right indicate no increasing or decreasing trend of values moving inside the specimen. Small oscillations in Cr concentration are due to little local deviations from the theoretical alloy composition and/or to the analysis uncertainty; specular fluctuations are seen in Fe concentration values, since the sum of Cr and Fe makes always 100.

Figure 44: left: SEM image and Cr concentration profile (EDS) of specimen #32 section; right: Cr (red) and Fe (green) concentration profiles along the specimen section.

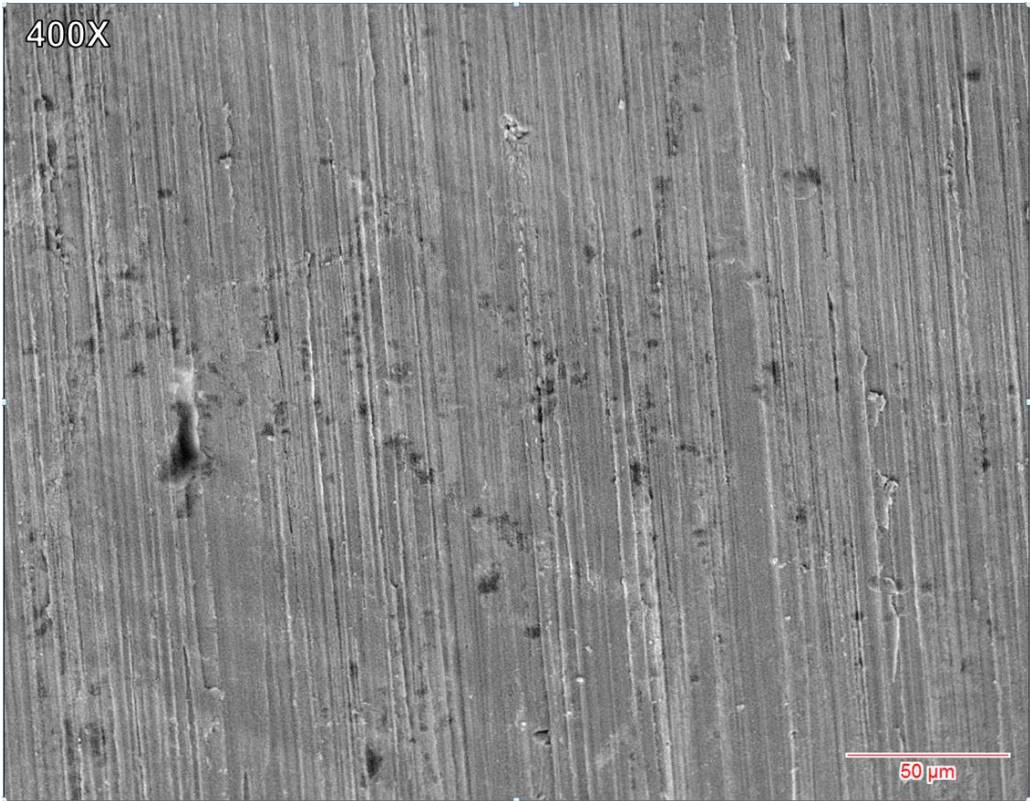
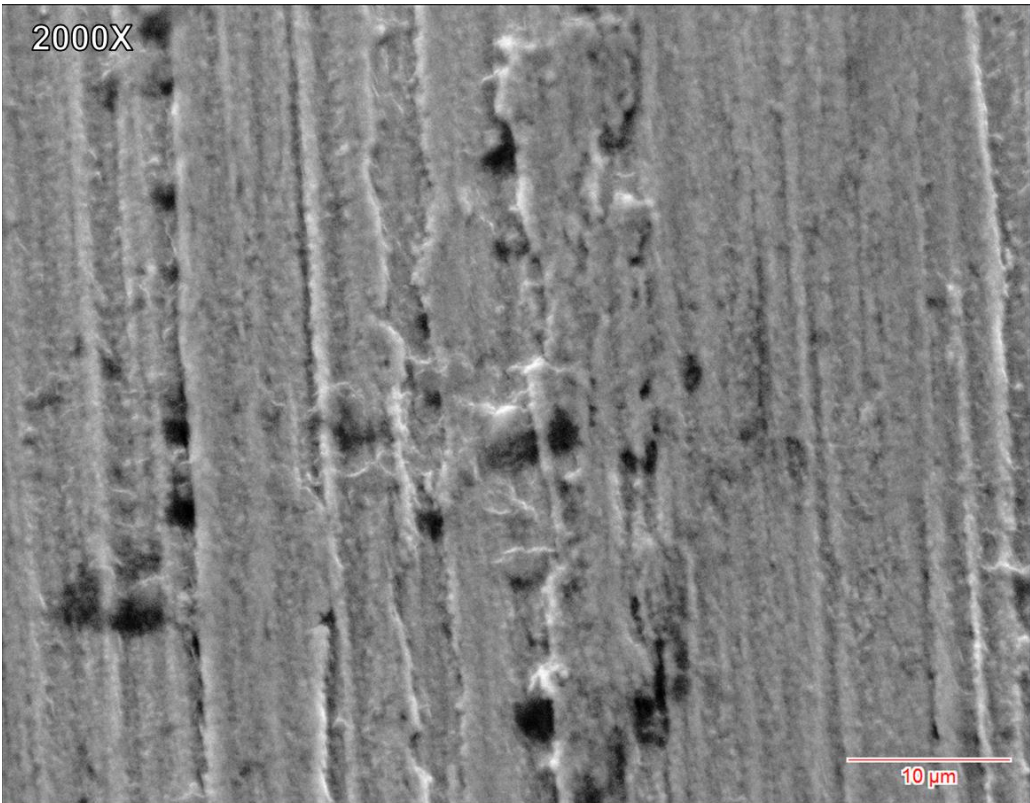
Figures 45 and 46 show, respectively at magnitude 400 and 2000X, 2 portions of the external surface of this specimen. In both these figures are visible the usual signs produced by mechanical manufacturing of the specimens, in the form of vertical stripes, which, at large magnifications, appear as narrow and shallow channels, as well as the black spots associated to sticked organic substances. By comparing Figure 46 with the bottom half of Figure 38 (observations made at the same magnitude), a more 'granulose' profile of the specimen #34 surface compared to the fresh one also appears.

Figure 45: SEM image of specimen #34 surface (secondary electrons) at magnitude 400X. Scale bar above the image.

Figure 46: SEM image of spec. #34 surface (secondary electrons) at magnitude 2000X. Scale bar above the image.

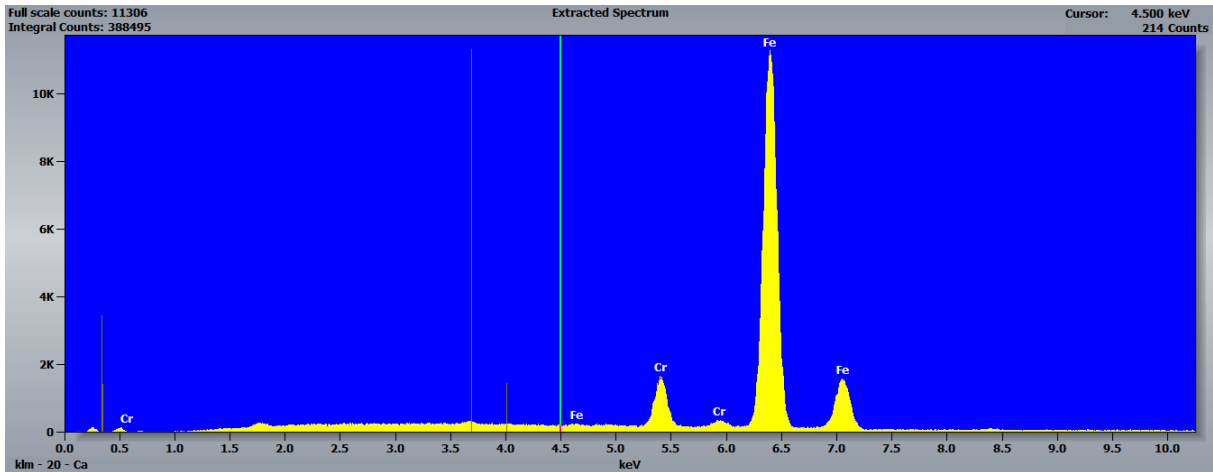
Figure 49 reports the average EDS spectrum of the whole region; Table 12 summarizes the values of the related compositional analysis. By comparing this table values with Table 10 ones, a Chromium depletion at the surface is also noted, corresponding to -1.5% by weight; Tungsten is below the quantification limit; Iron is instead a bit increased, to compensate other elements diminutions.

Figure 49: EDS spectrum obtained at specimen #34 surface

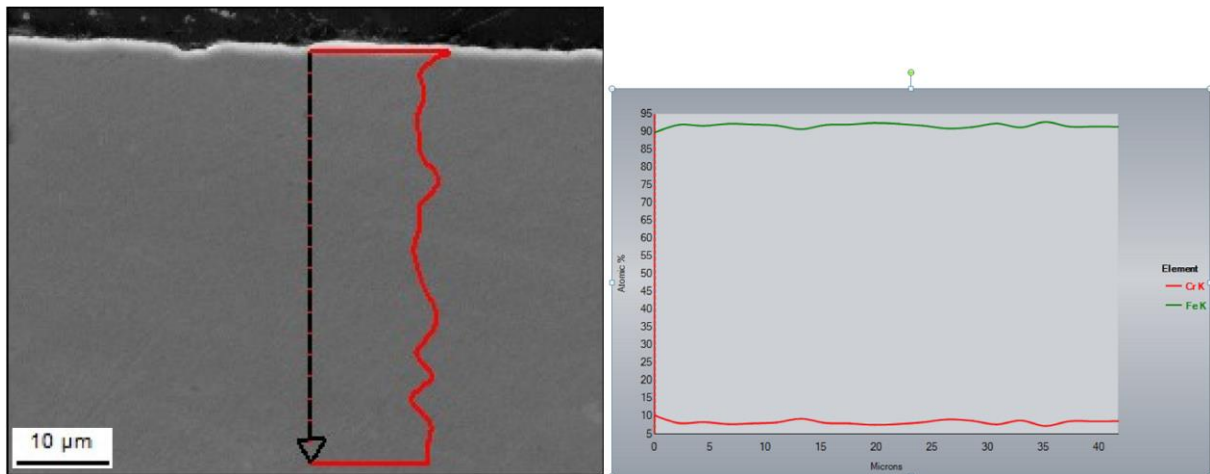
Finally, Figure 50 (left) shows a SEM image at 2000X of a representative cross section of specimen #34, together with the overlapped Chromium concentration vs depth profile, constructed by the EDS analysis of equidistant points (~ 2.2 μm spaced), in the arrow direction. On the right side of Figure 50 is instead reported a graph showing the profiles of Chromium and Iron elements along the arrow direction, where y-axis is the atomic % concentration, while x-axis indicates the distance from the surface (the surface position is on the left boundary of the graph, in correspondence of x = 0). From the observation of Figure 50 left, it is possible to note that the internal specimen structure is in good condition, with no morphological alteration or grain detachment. The concentration profiles on the right indicate no increasing or decreasing trend of values moving inside the specimen. Small oscillations in Cr concentration are due to little random deviations from the theoretical alloy composition and/or to the analysis uncertainty; specular fluctuations are seen in Fe concentration values, since the sum of Cr and Fe makes always 100.

Figure 50: left: SEM image and Cr concentration profile (EDS) of specimen #34 section; right: Cr (red) and Fe (green) concentration profiles along the specimen section.

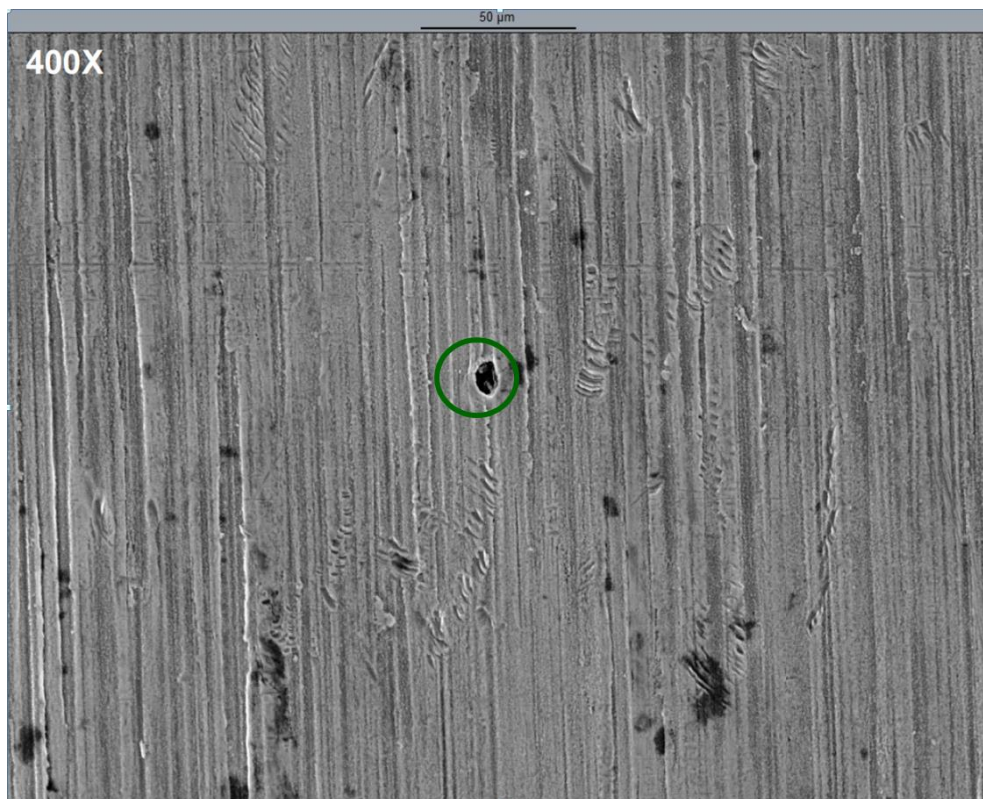
Now let's look at the F82H specimens exposed to flowing Lithium for a total time of 4000 hours, starting with specimen #28. Figure 51 shows, at magnitude 400X, a region of the external surface of this specimen. Apart from the usual vertical stripes produced during the manufacturing of the sample, additional mechanical alterations like scratches and abrasions are visible, which are not indicative however of a corrosion action exerted by Lithium. In the centre of Figure 51 is instead detected a roundish dark object (circled in green), which, especially when observed at higher magnification (Figure 52, 2000X), reveals its nature of cavity originated in response to a corrosion phenomenon.

Figure 51: SEM image of specimen #28 surface (secondary electrons) at magnitude 400X. Scale bar above the image

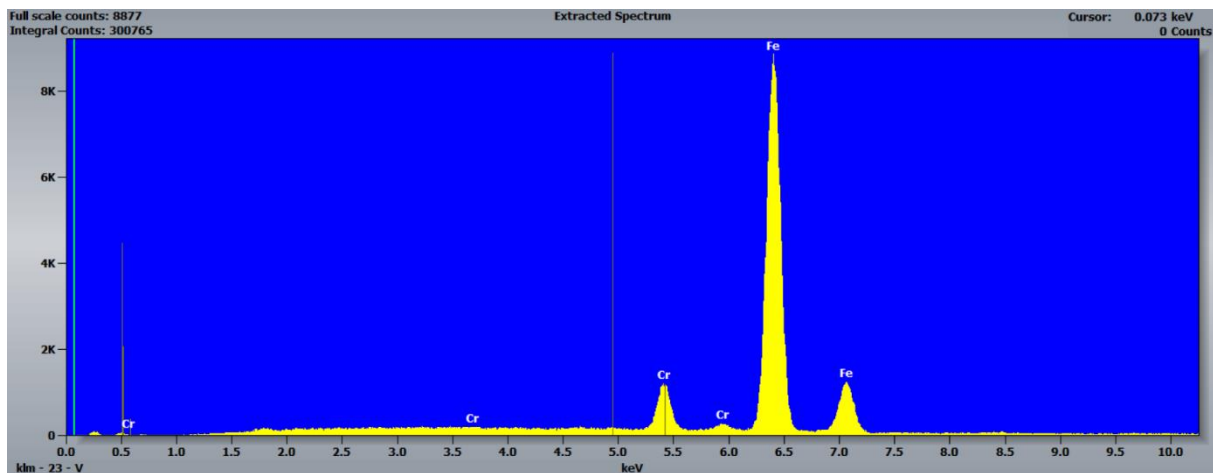
The average EDS spectrum of a large surface region ($\sim 160 \times 130 \mu\text{m}^2$) around the discussed cavity is shown in Figure 53; Table 13 reports the concentration values calculated from those peaks. Again, as for the previously discussed specimens, the Tungsten surface concentration decreased below the quantification limit, a Chromium depletion was observed (-1.6% by weight) and Iron increased a bit, to compensate other elements diminutions.

Figure 53: EDS spectrum obtained at specimen #28 surface

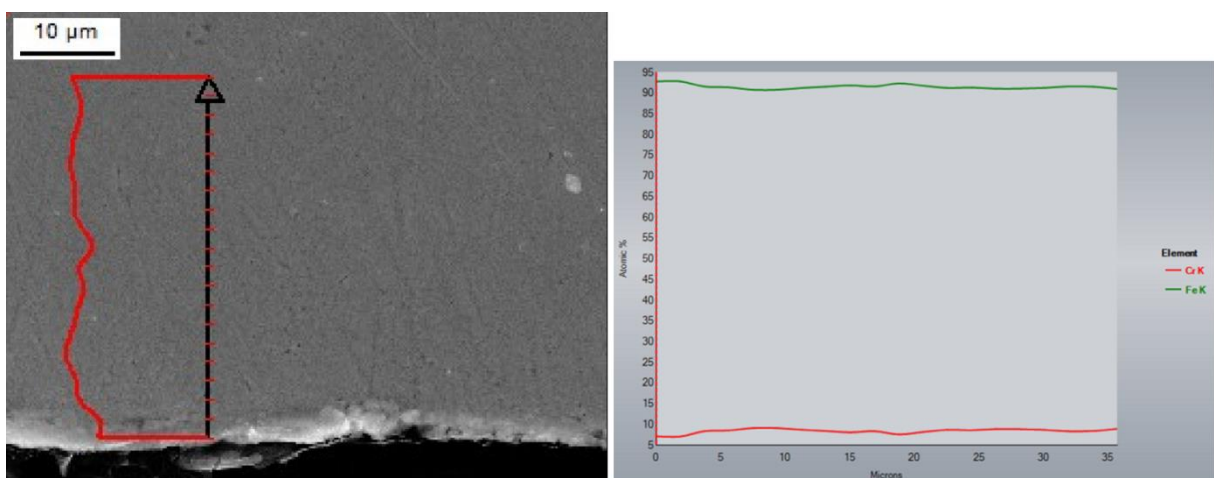
Finally, Figure 54 (left) shows a SEM image at 2000X of a representative cross section of specimen #28, together with the overlapped Chromium concentration vs depth profile, constructed by the EDS analysis of equidistant points ($\sim 2 \mu\text{m}$ spaced), in the arrow direction. On the right side of Figure 54 is instead reported a graph showing the profiles of Chromium and Iron elements along the arrow direction, where y-axis is the atomic % concentration, while x-axis indicates the distance from the surface (the surface position is on the left boundary of the graph, in correspondence of $x = 0$). From the observation of Figure 54 left, it is possible to note that the internal specimen structure is in good condition, with no morphological alteration or grain detachment. The concentration profiles on the right indicate no increasing or decreasing trend of values moving inside the specimen (the first Cr point, on the left extremity, corresponds the smallest concentration value, but it is not physically sure, since measured too close to the border of the specimen). Small oscillations in Cr concentration are due to little local deviations from the theoretical alloy composition and/or to the analysis uncertainty; specular fluctuations are seen in Fe concentration values, since the sum of Cr and Fe makes always 100.

Figure 54: left: SEM image and Cr concentration profile (EDS) of specimen #28 section; right: Cr (red) and Fe (green) concentration profiles along the specimen section.

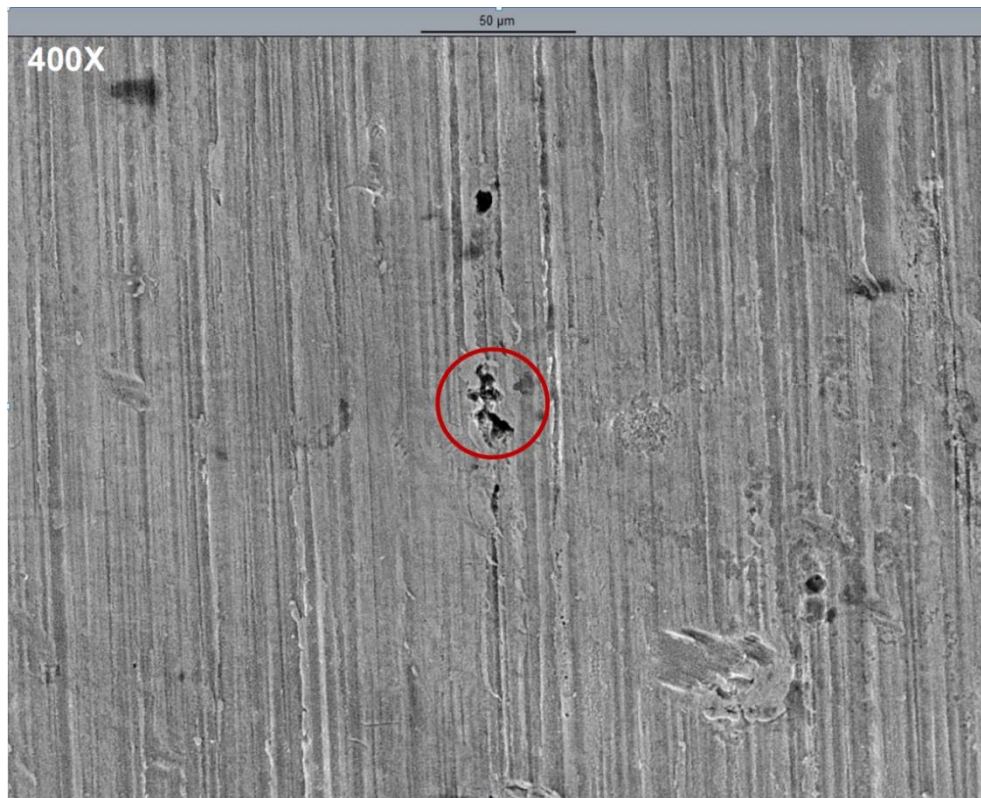
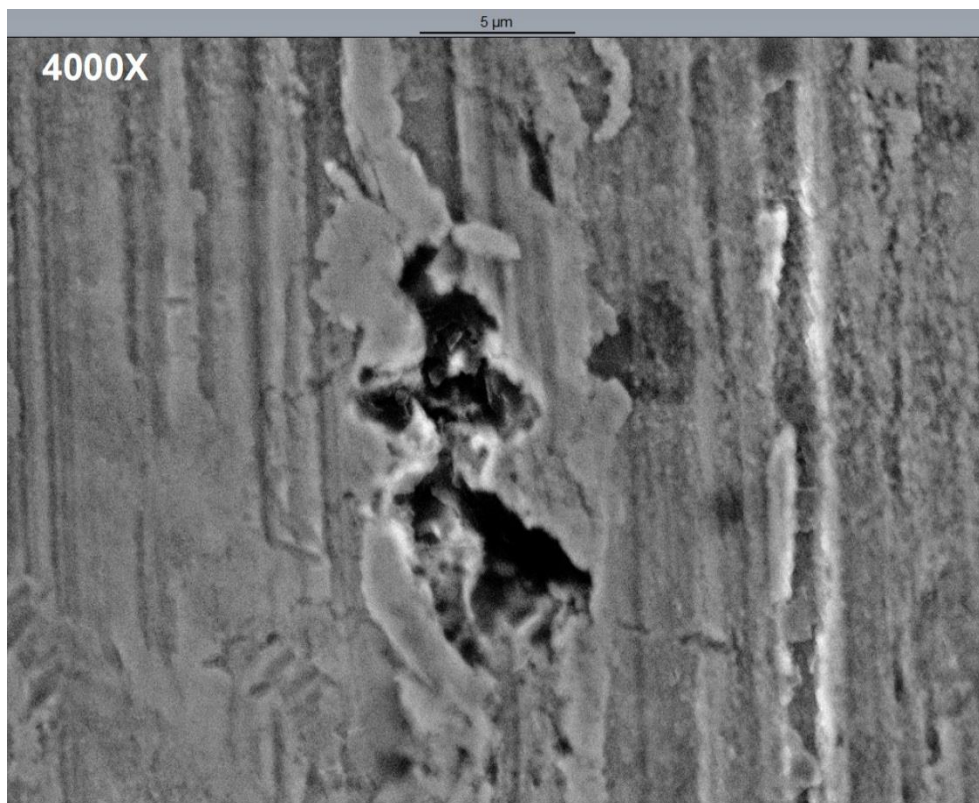
Last, but not least, specimen #29. Figure 55 shows, at magnitude 400X, a region of the external surface of this specimen. The general appearance of the surface is good, and characterized by the usual vertical stripes originated during the manufacturing of the sample. Anyway some localized alterations produced by corrosion phenomena are also visible, in the form of small pits and ulcerations; one of them, circled in red in Figure 55, can be better observed in the enlargement (4000X) reported in Figure 56.

Figure 55: SEM image of specimen #29 surface (secondary electrons) at magnitude 400X. Scale bar above the image.

Figure 56: SEM image of specimen #29 surface (secondary electrons) at magnitude 4000X (enlargement of Figure 55). Scale bar above the image.
