Ricerca di Sistema elettrico

Risultati relativi alla campagna sperimentale di medio termine sui fenomeni di erosione/corrosione da Litio liquido fluente nell'impianto Lifus 6

RISULTATI RELATIVI ALLA CAMPAGNA SPERIMENTALE DI MEDIO TERMINE SUI FENOMENI DI EROSIONE/CORROSIONE DA LITIO LIQUIDO FLUENTE NELL'IMPIANTO LIFUS 6

Settembre 2017

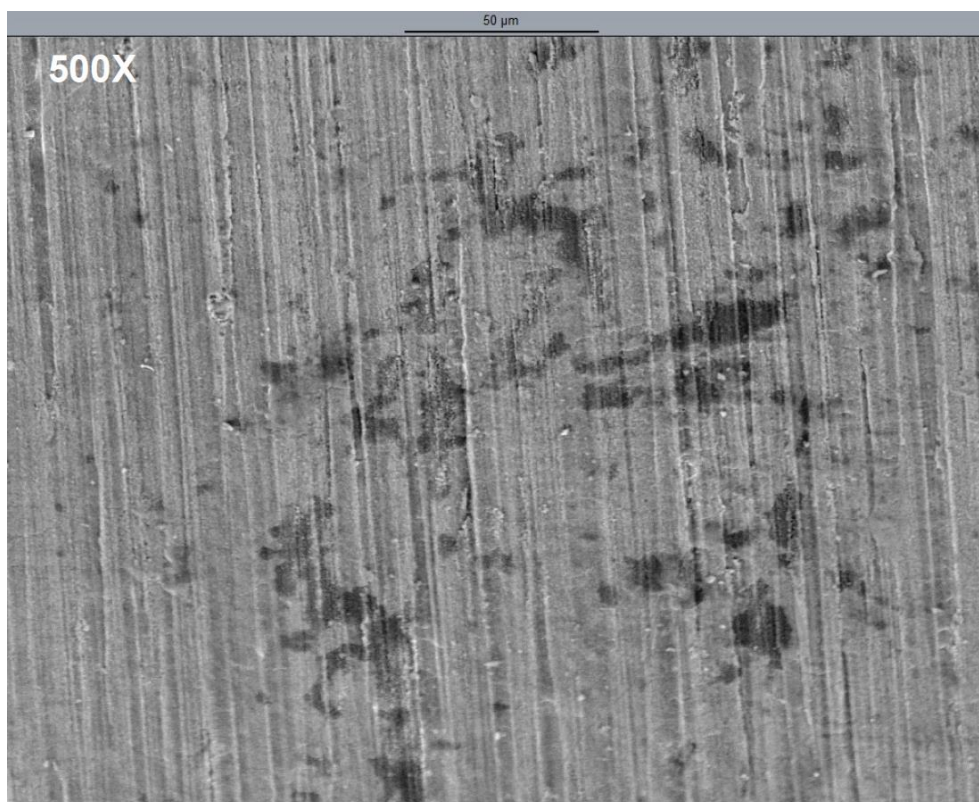
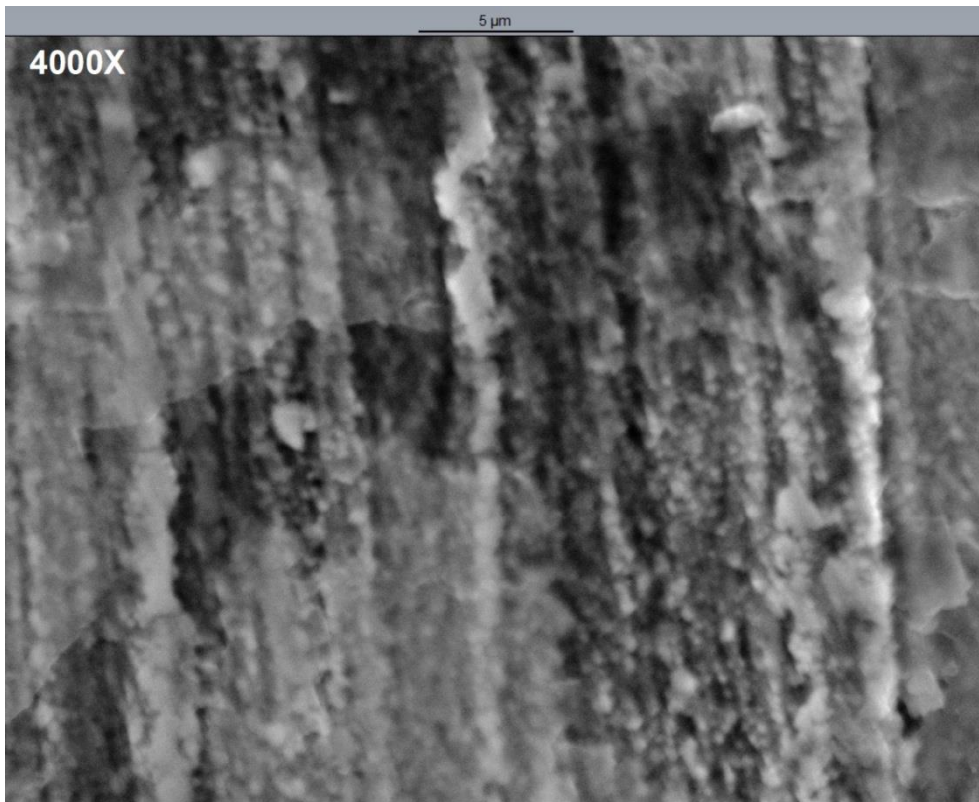
On the surface of specimen #29 are present also a lot of dark spots, probably due to organic substance, as evidenced by Figure 57 (500X); moreover, when enlarging the centro-left/bottom of this figure to Figure 58 (4000X), in correspondance of these spots the surface seems also affected by a more pronounced degradation.

Figure 57: SEM image of an other portion of specimen #29 surface (secondary electrons) at magnitude 500X. Scale bar above the image.

Figure 58: SEM image of specimen #29 surface (secondary electrons) at magnitude 4000X (enlargement of Figure 57). Scale bar above the image.

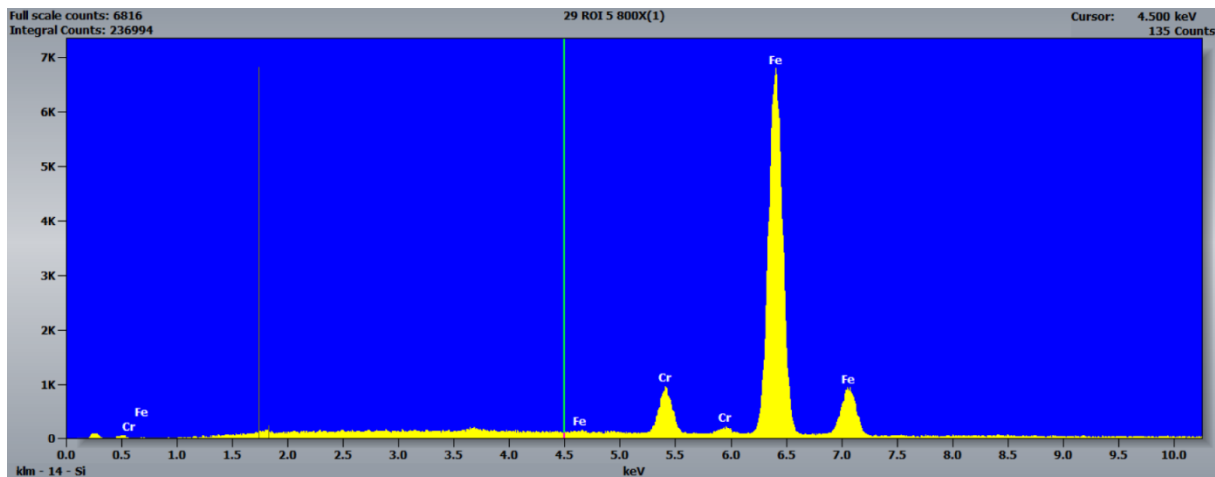
Figure 59 summarizes the EDS analysis outcome reporting the average spectrum of a large, intact, surface region; Table 14 converts it in weight % concentration numbers. The average chemical composition at the surface is very similar to the one measured for specimen #28 after the erosion-corrosion test (Table 10) and indicates a Chromium depletion equal to -1.6% by weight. Other elements are not found in a quantifiable amount. The rest of the analyzed material is then Iron.

Figure 59: EDS spectrum obtained at specimen #29 surface

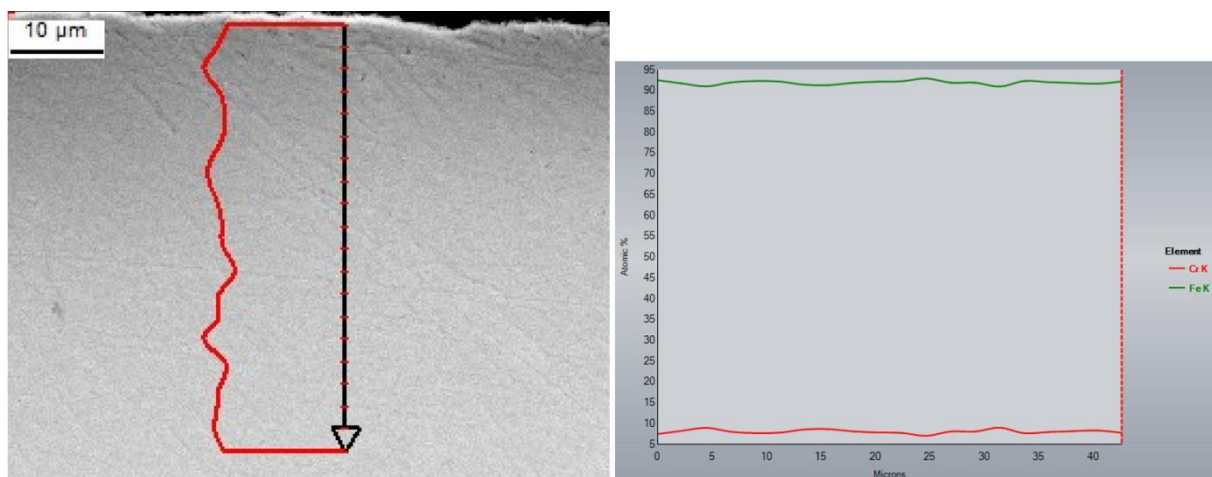
Finally, Figure 60 (left) shows a SEM image at 2000X of a representative cross section of specimen #29, together with the overlapped Chromium concentration vs depth profile, constructed by the EDS analysis of equidistant points (~ 2 μm spaced), in the arrow direction. On the right side of Figure 60 is instead reported a graph showing the profiles of Chromium and Iron elements along the arrow direction, where y-axis is the atomic % concentration, while x-axis indicates the distance from the surface (the surface position is on the left boundary of the graph, in correspondence of x = 0). From the observation of Figure 60 left, it is possible to note that the internal specimen structure is in good condition, with no morphological alteration or grain detachment. The concentration profiles on the right indicate no increasing or decreasing trend of values moving inside the specimen. Small oscillations in Cr concentration are due to little local deviations from the theoretical alloy composition and/or to the analysis uncertainty; specular fluctuations are seen in Fe concentration values, since the sum of Cr and Fe makes always 100.

Figure 60: left: SEM image and Cr concentration profile (EDS) of specimen #29 section; right: Cr (red) and Fe (green) concentration profiles along the specimen section.
